COMMUNITY BOND ADVISORY COMMITTEE MEETING #3

Central Linn School District
March 19, 2024

FACILITY ASSESSMENT EXECUTIVE SUMMARY

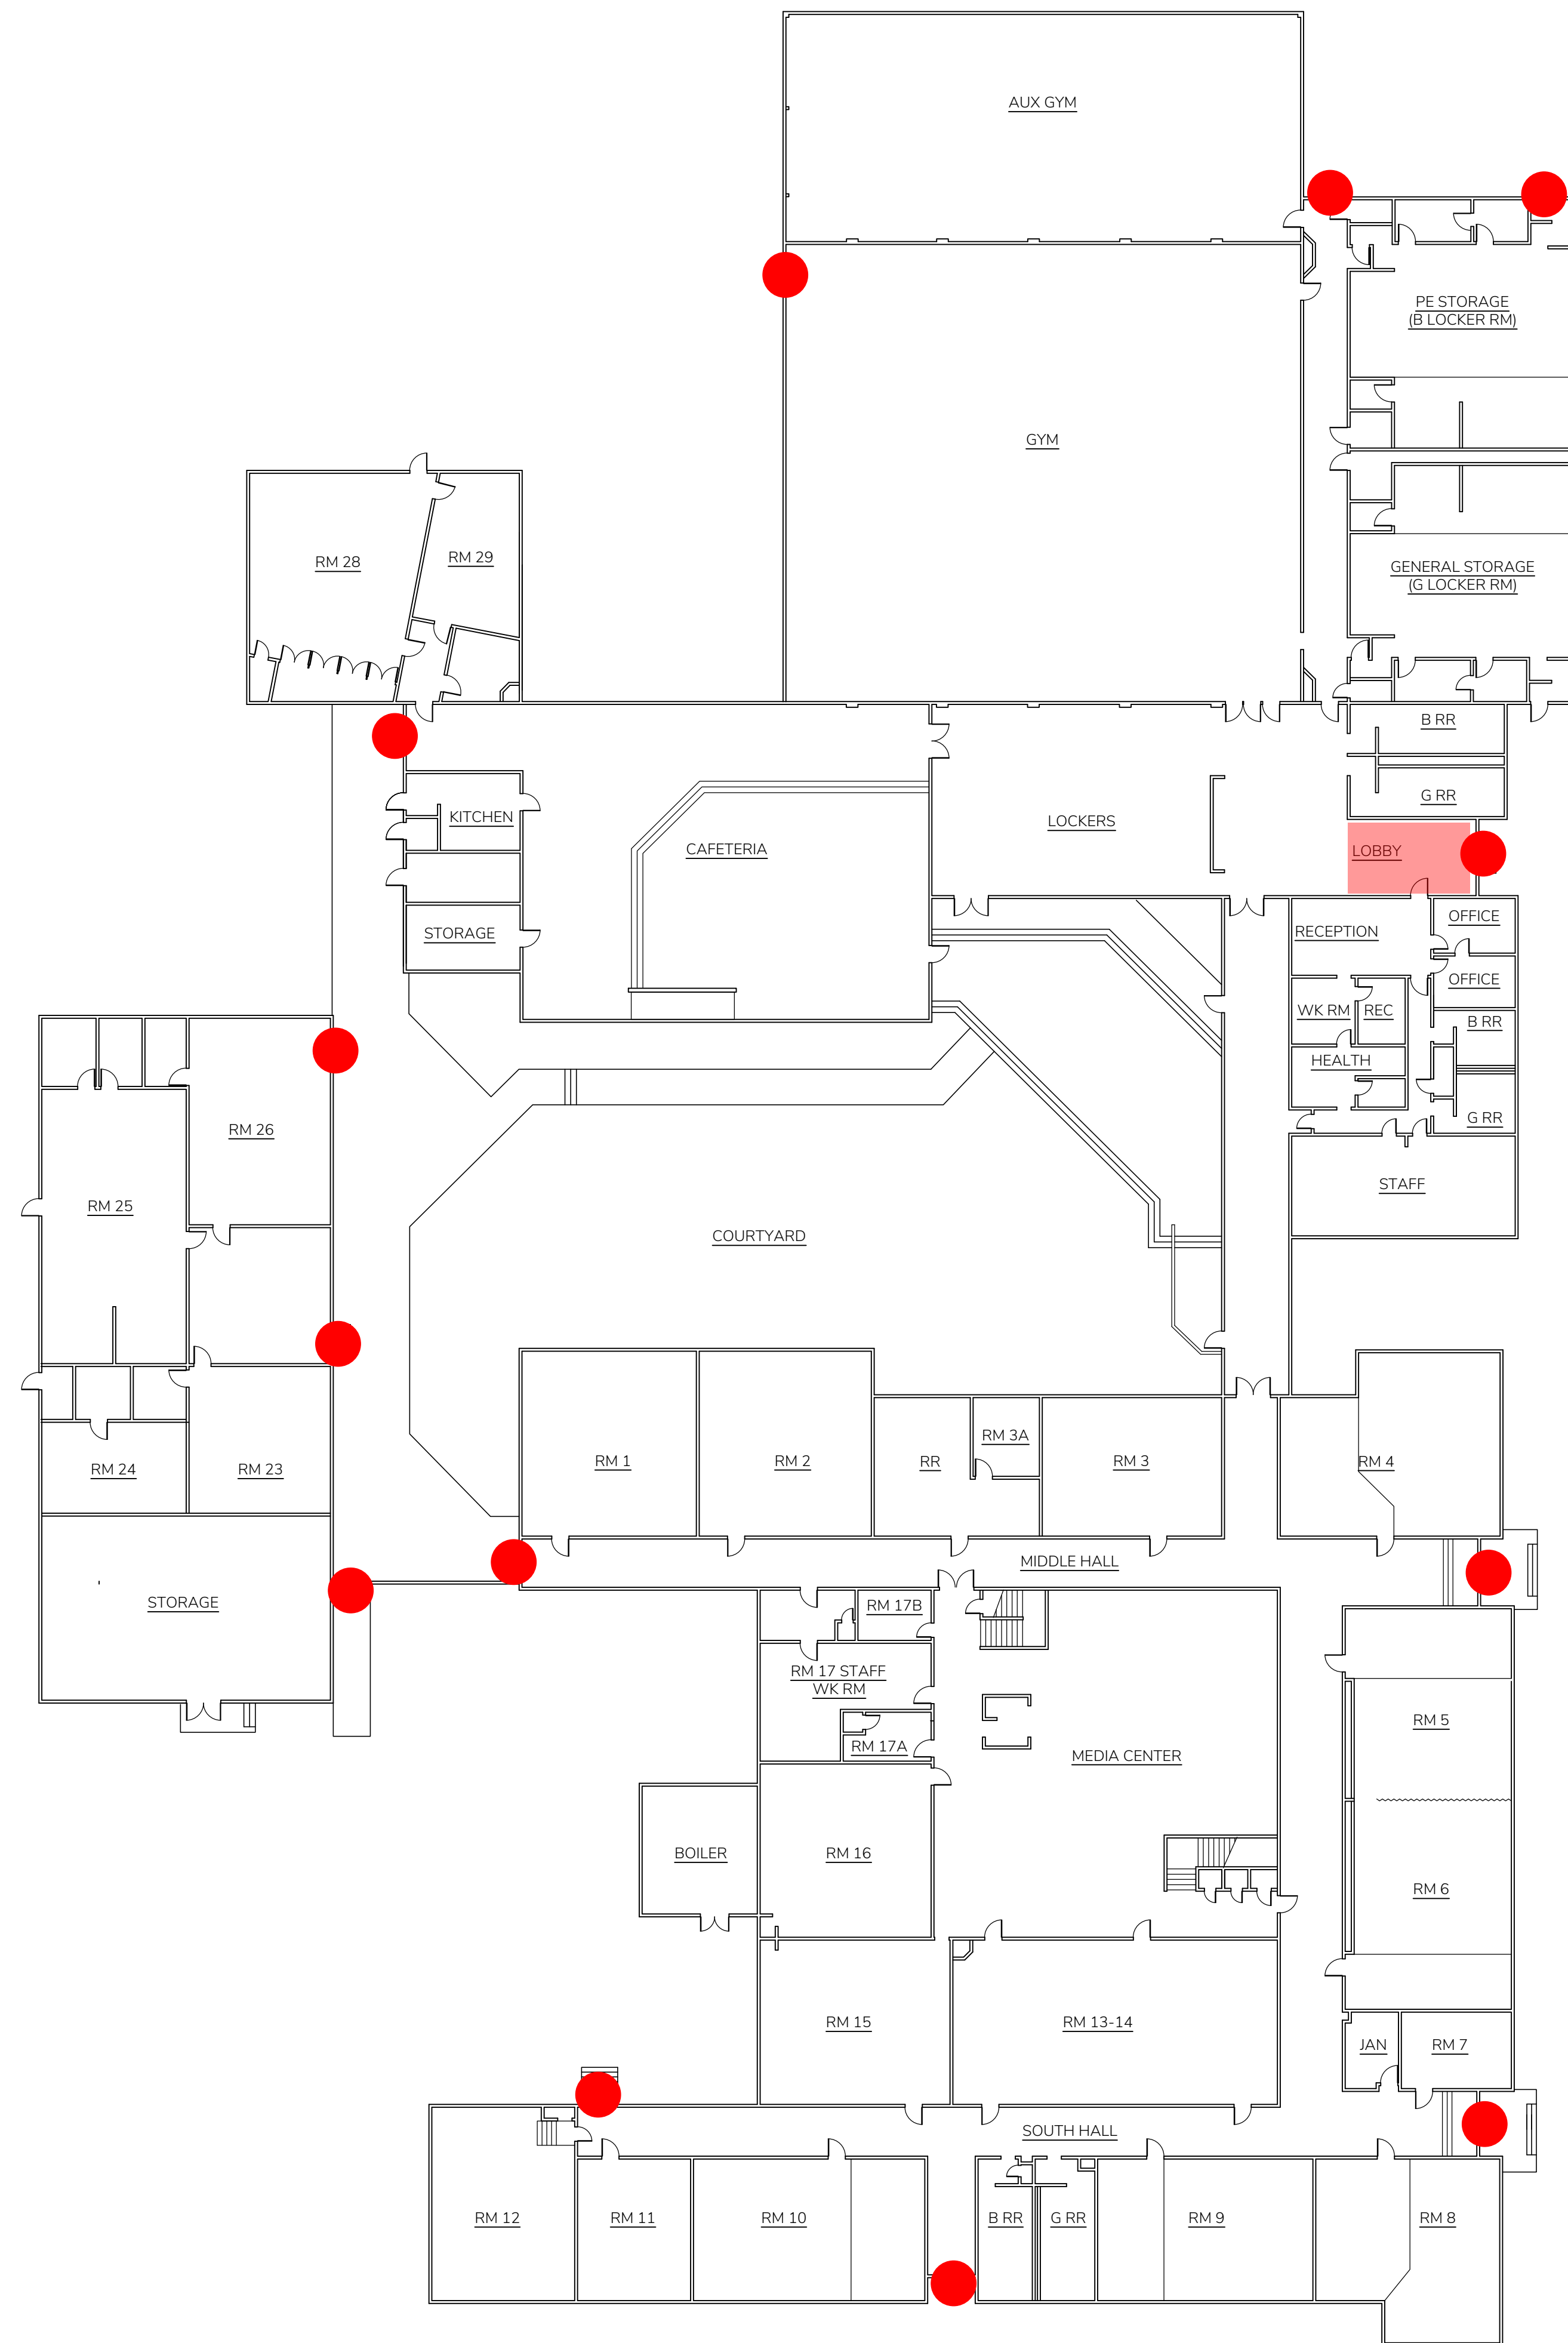
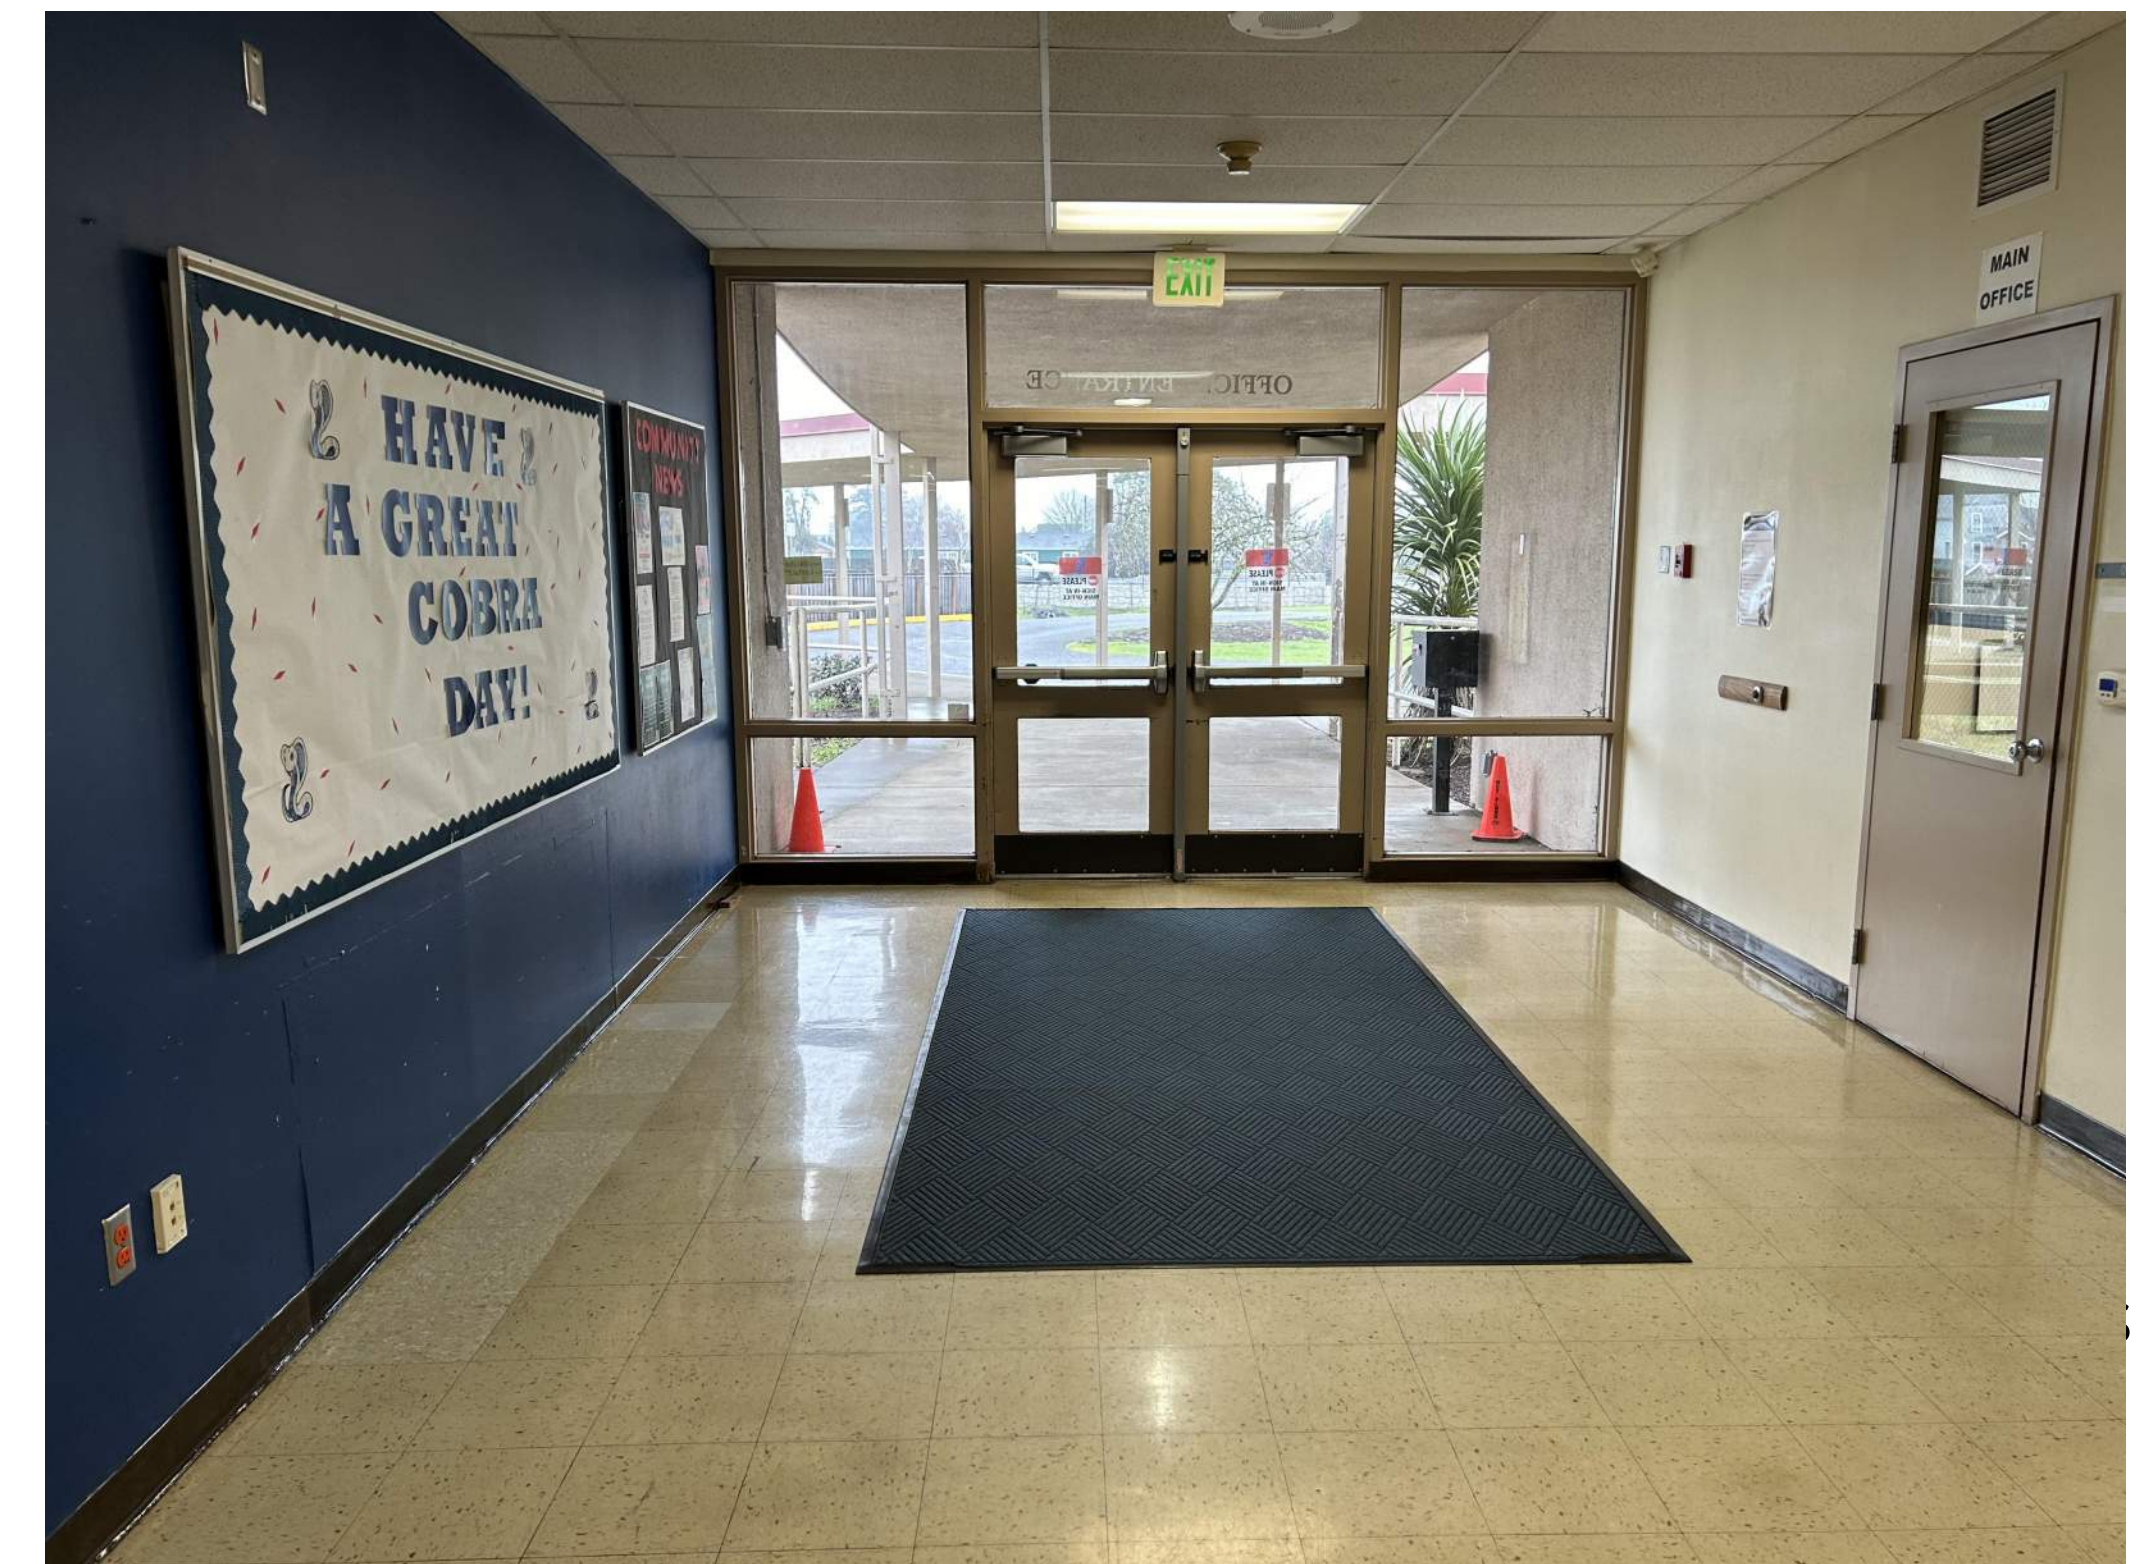
Secure main entry, improve security systems

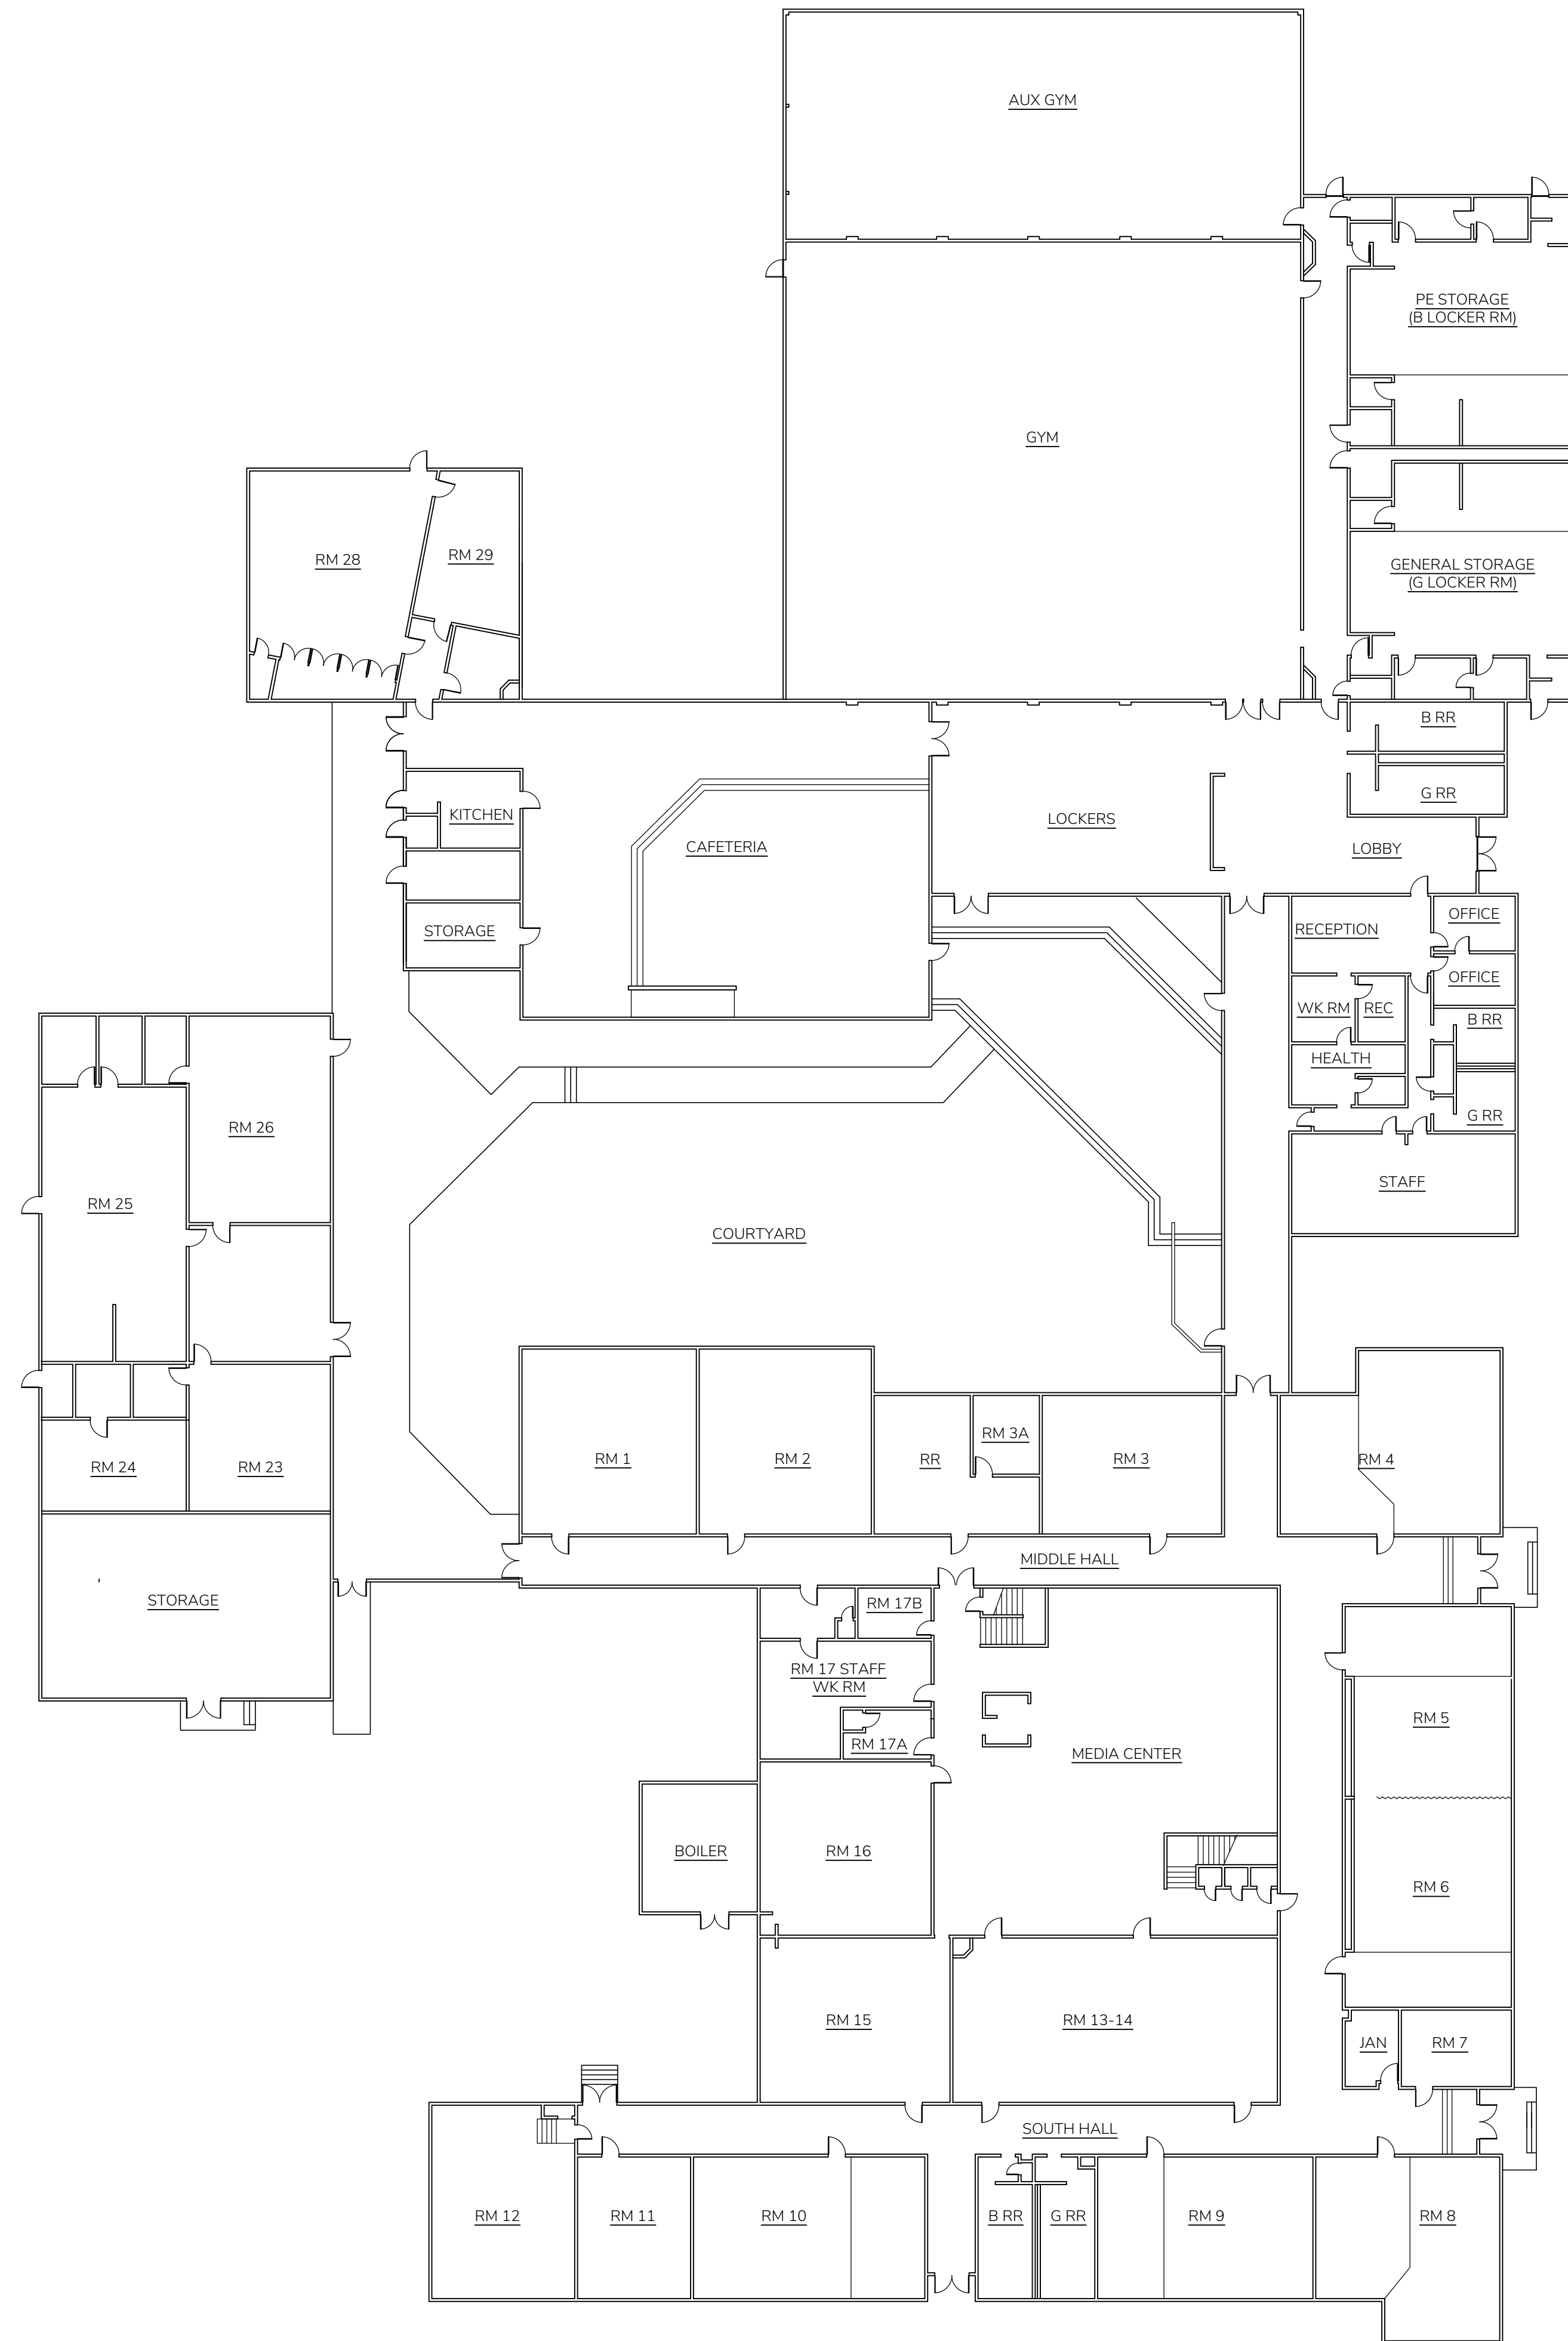
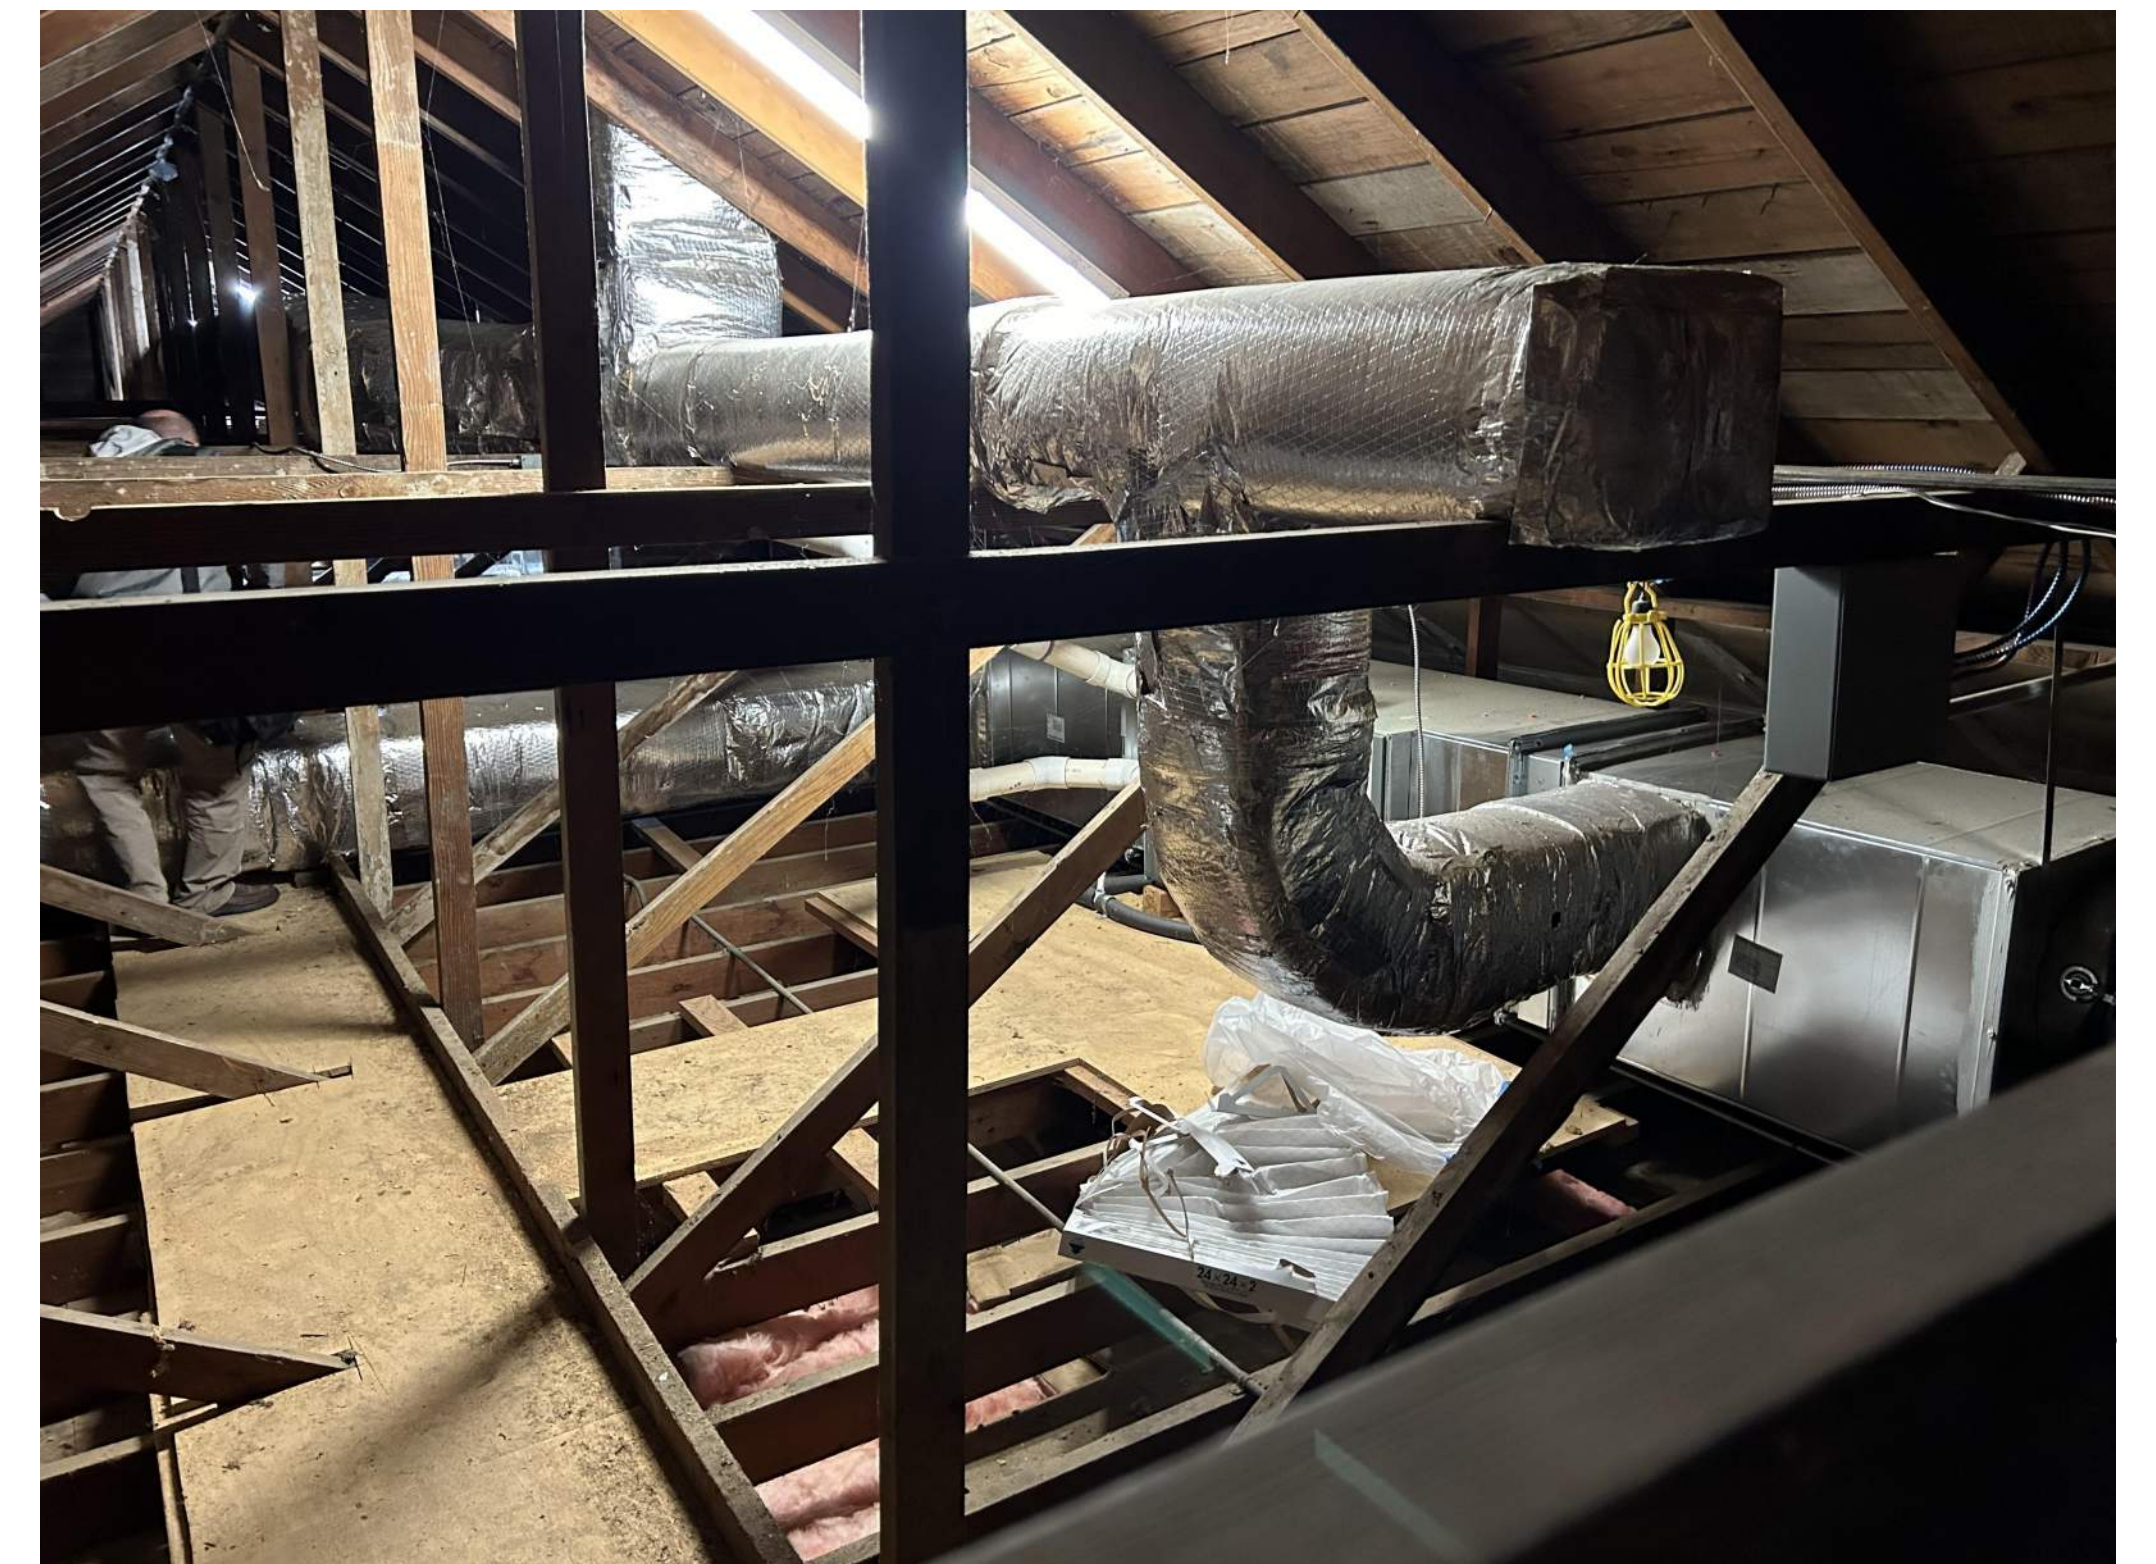
Some mechanical operating at or beyond service life

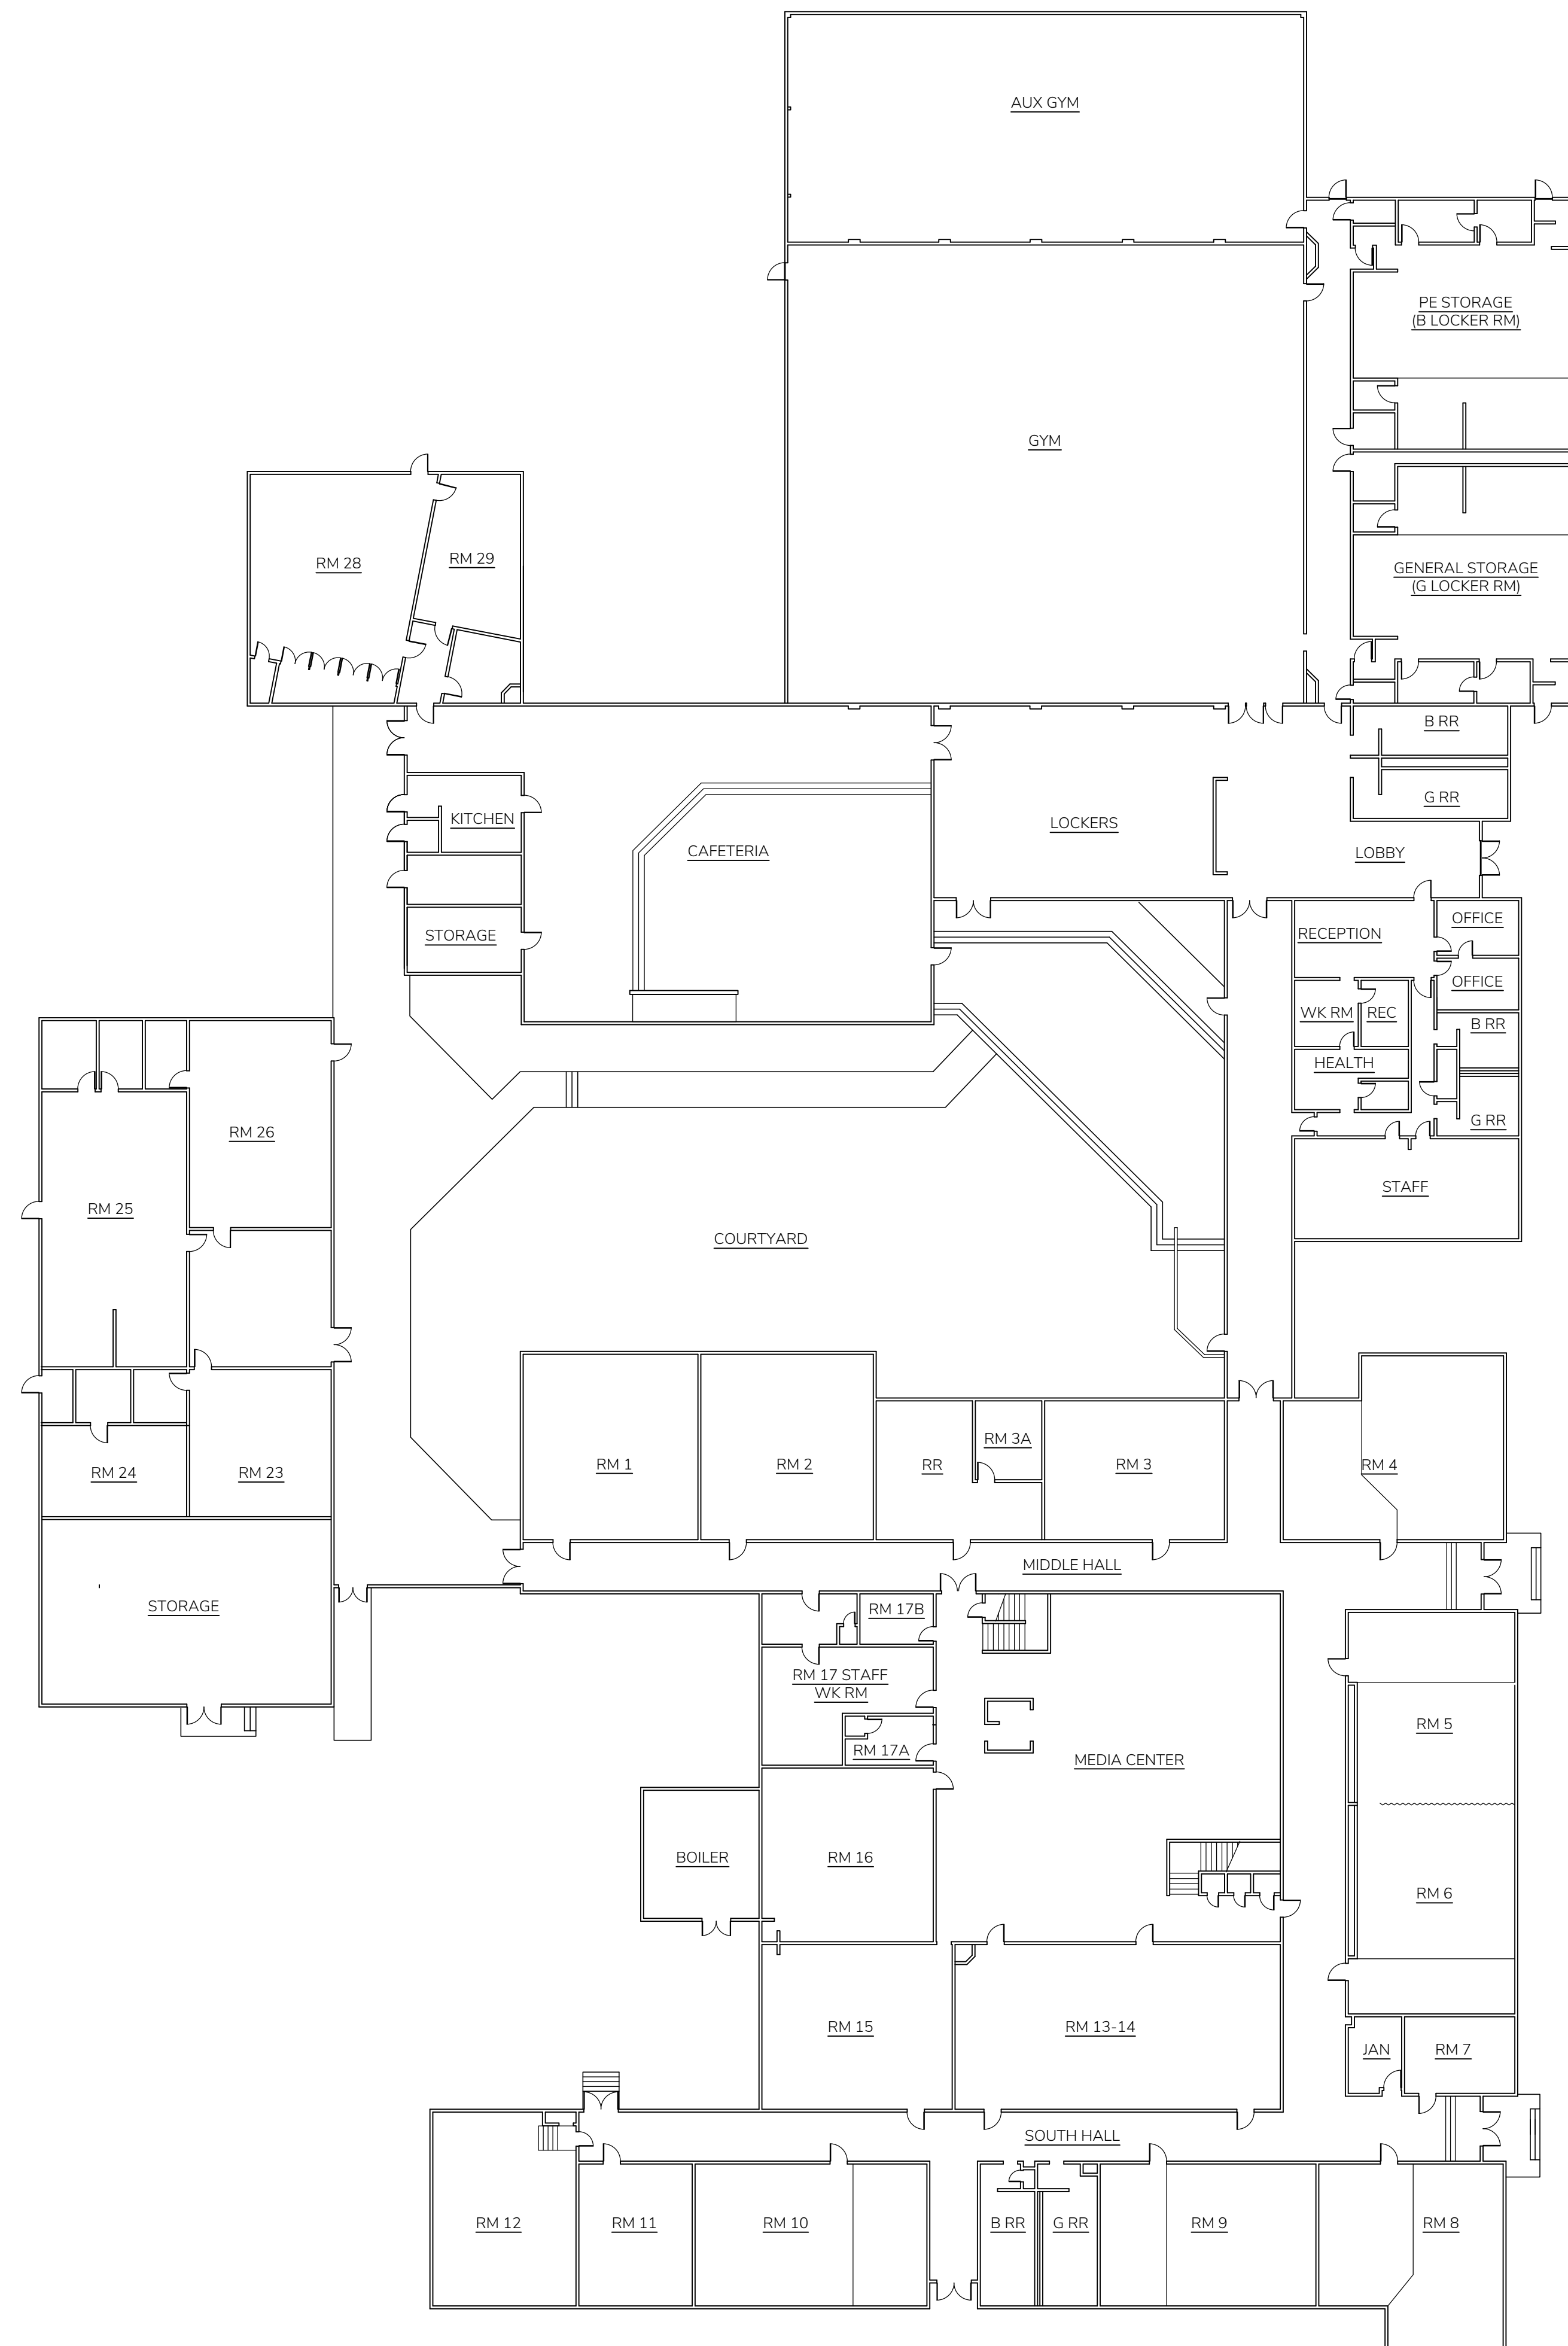
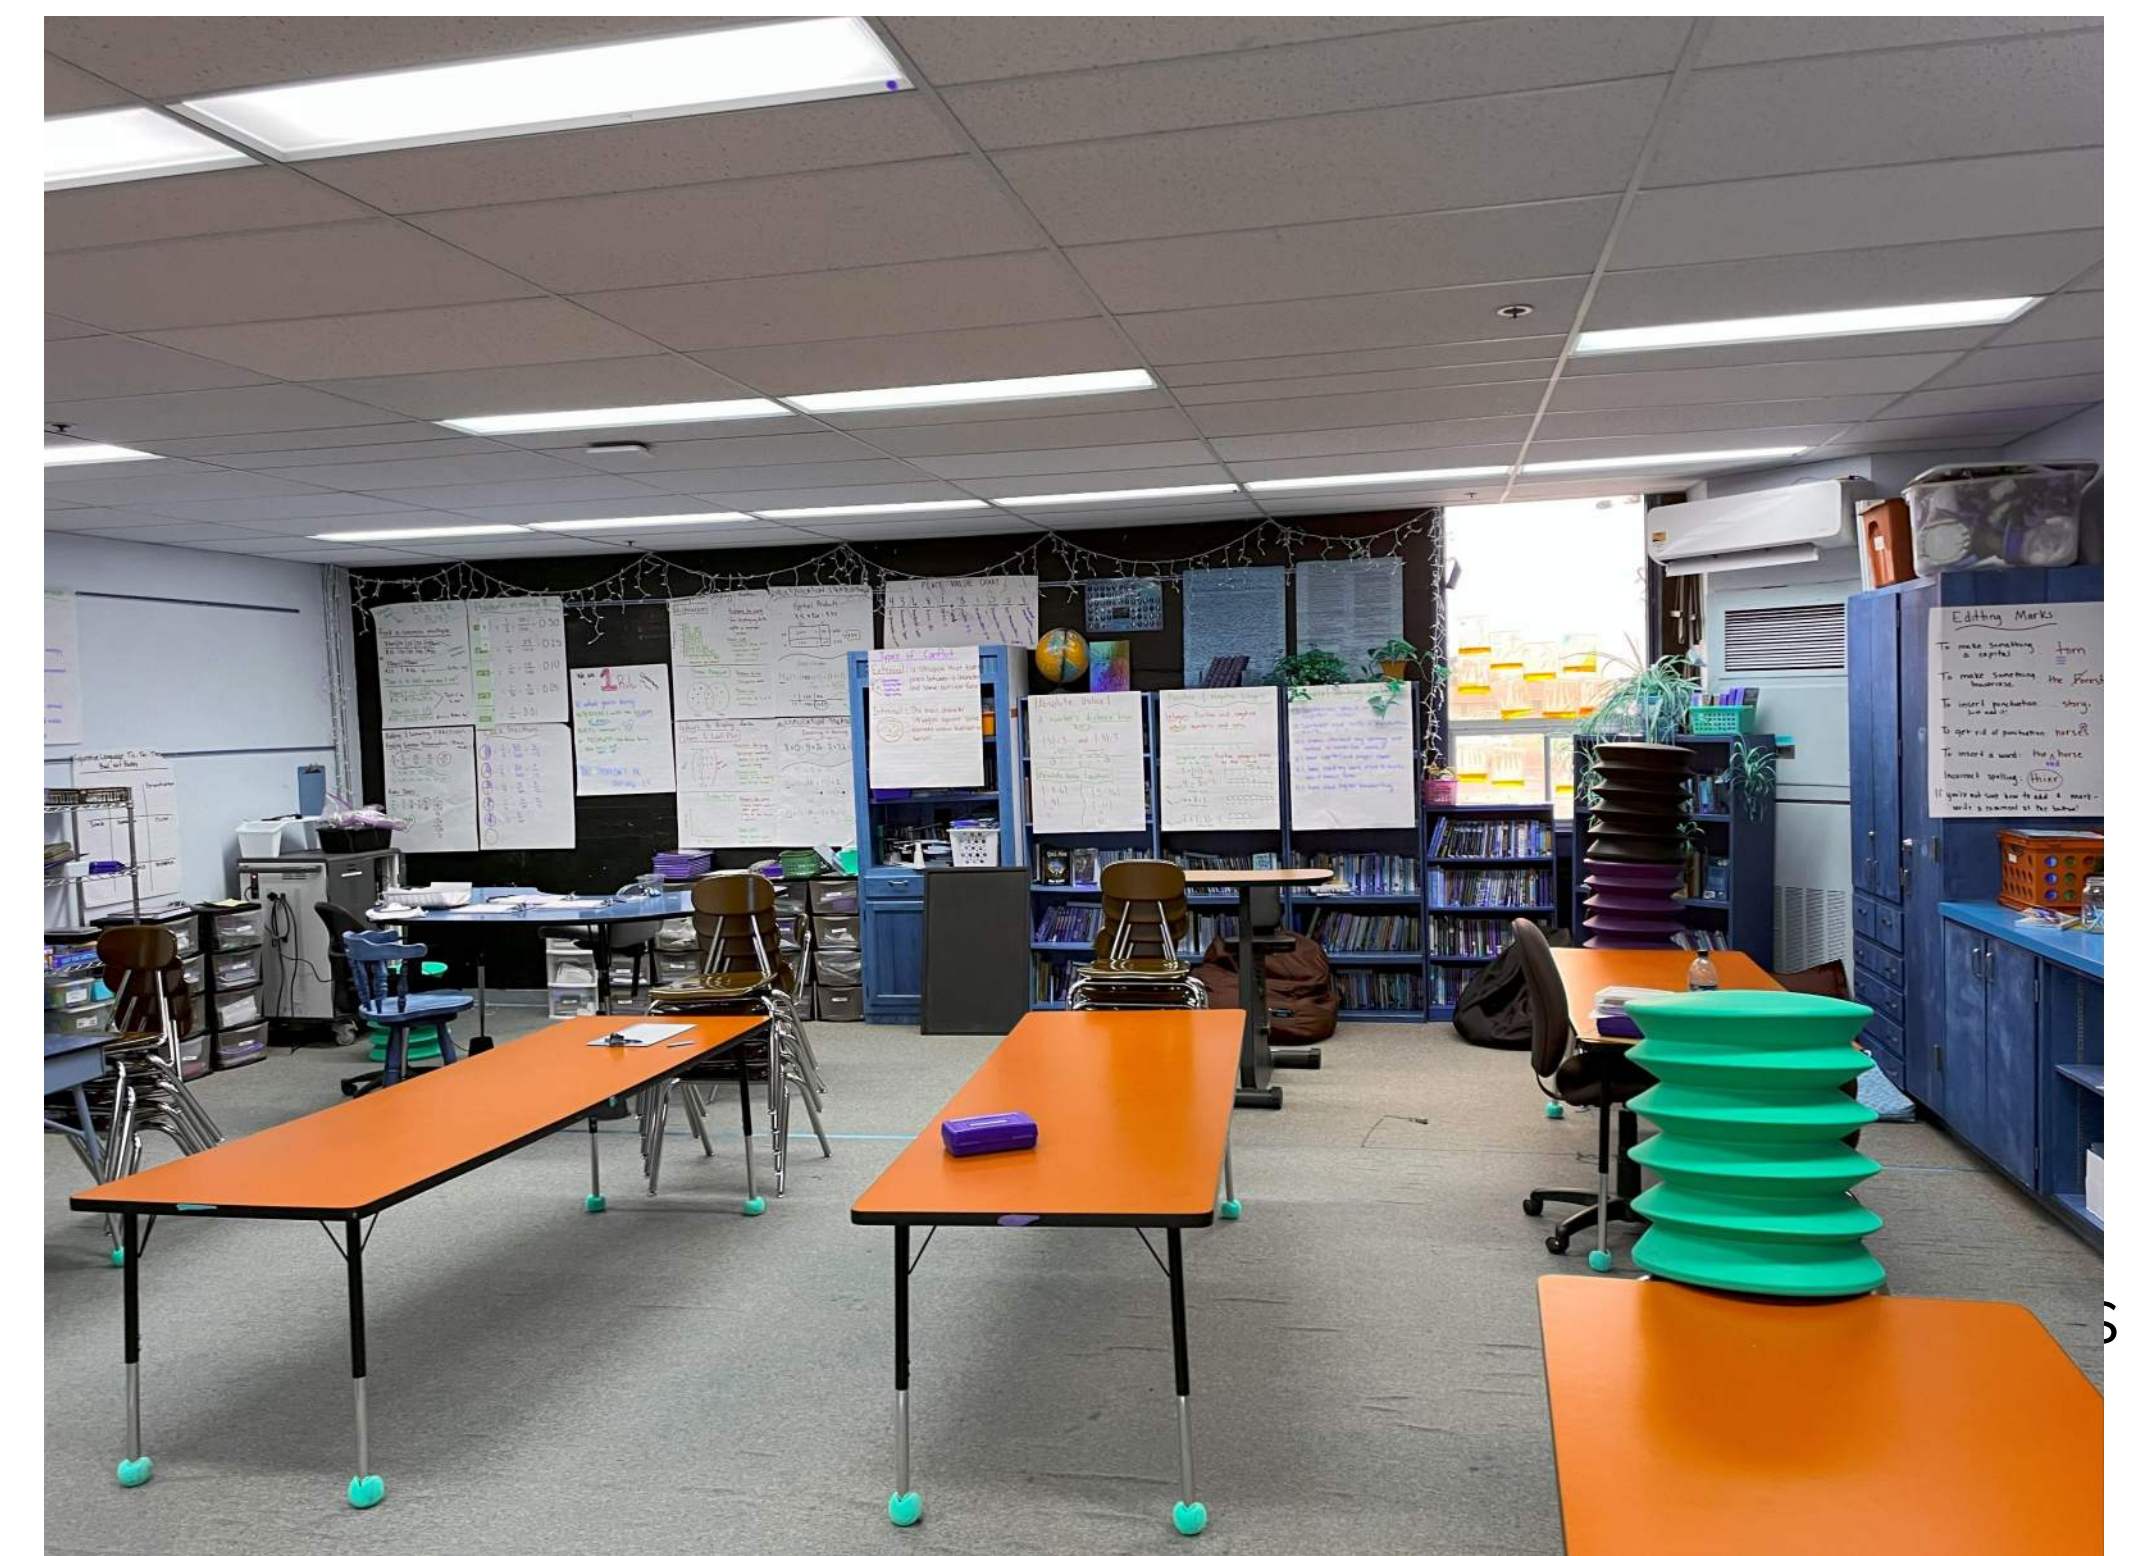
Lack of ventilation in classroom with ductless heat pump units
