COMMUNITY BOND ADVISORY COMMITTEE MEETING #3

Central Linn School District
March 19, 2024

FACILITY ASSESSMENT EXECUTIVE SUMMARY

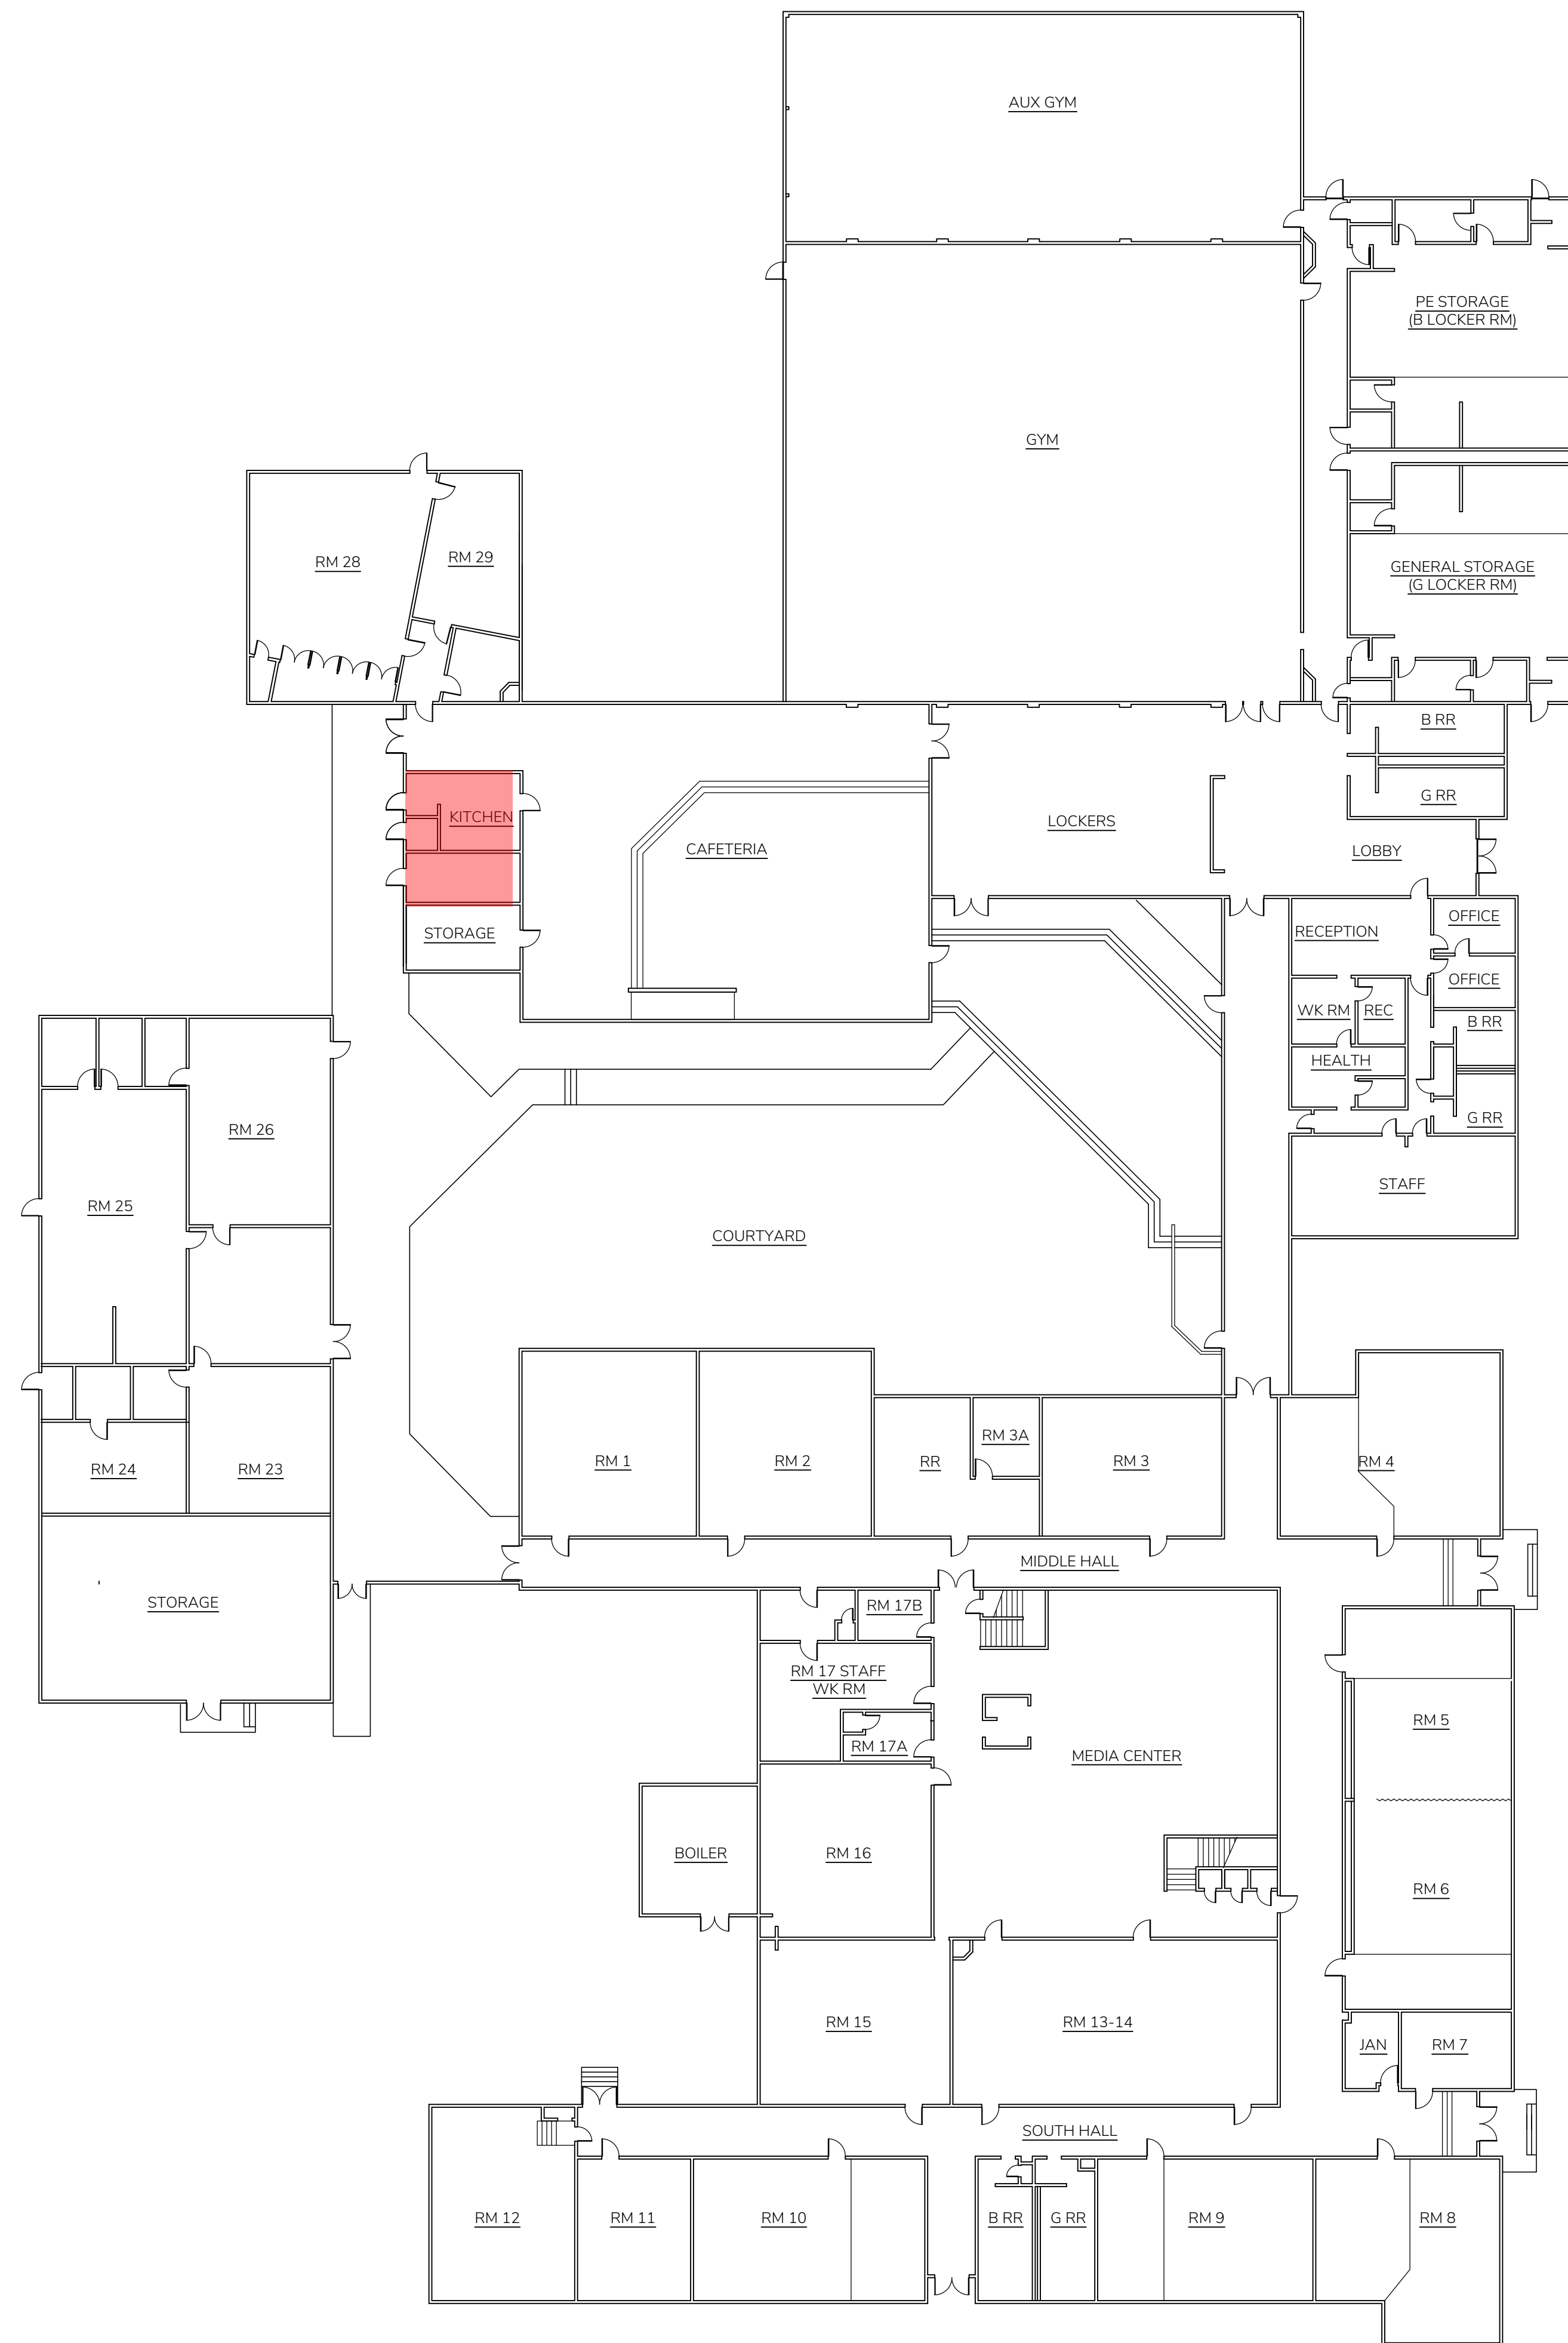
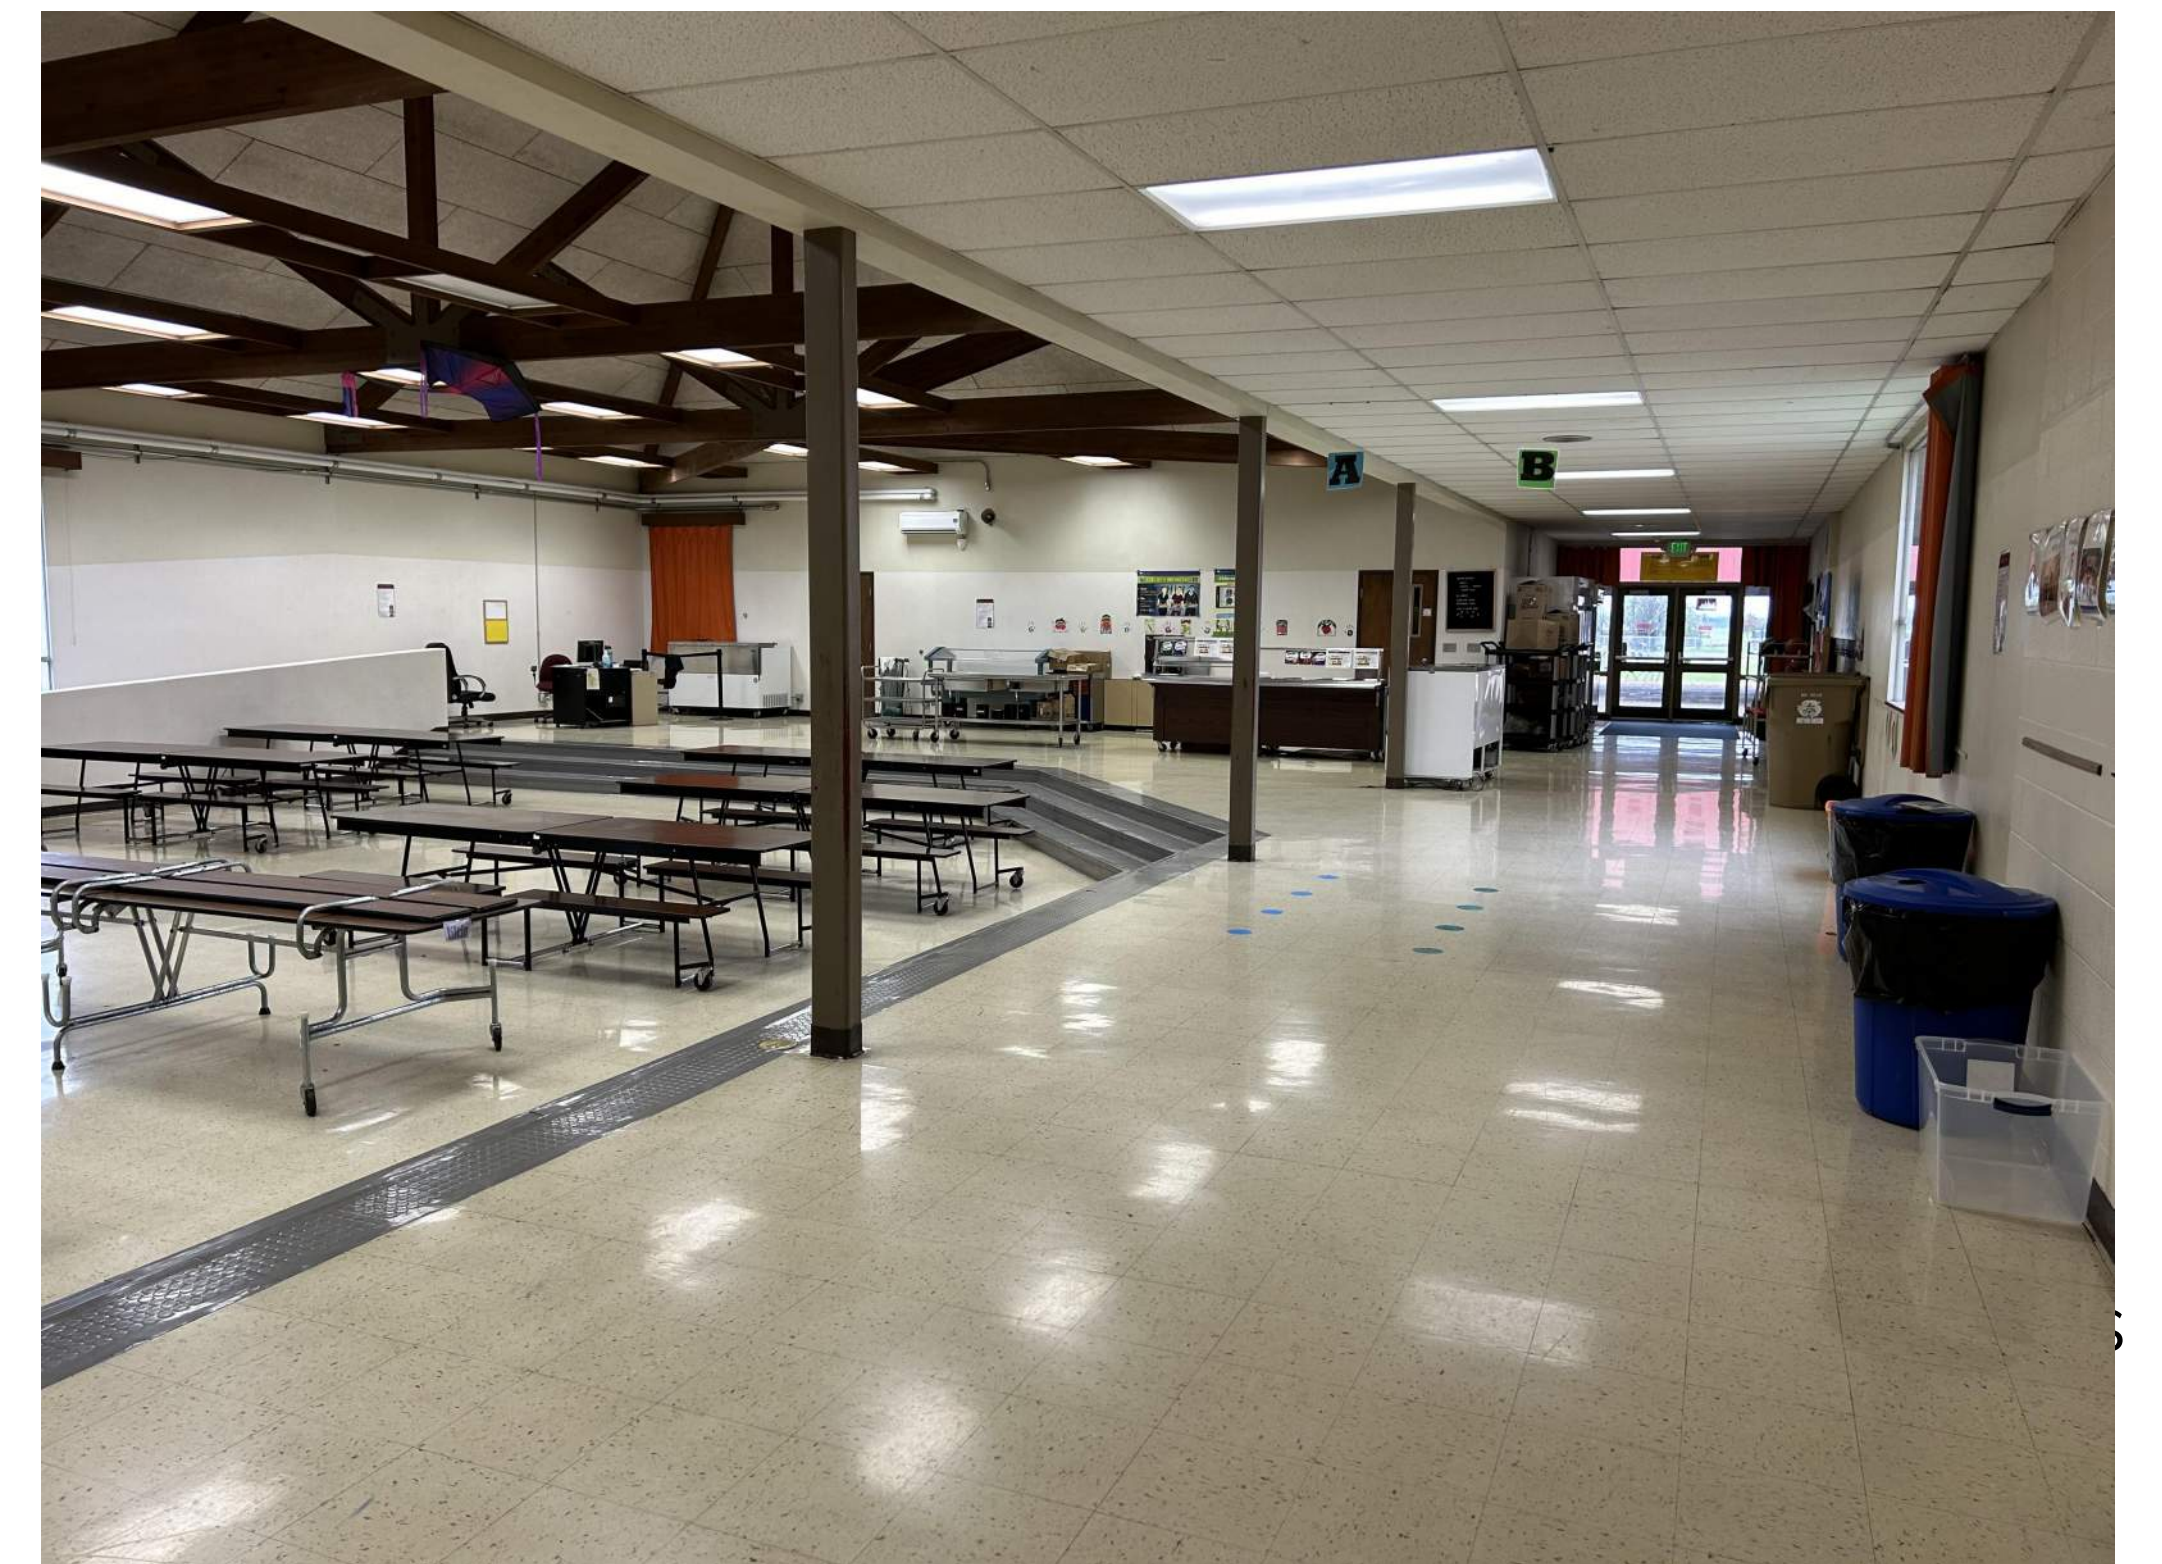
Kitchen area as designed not suitable for full meal preparation

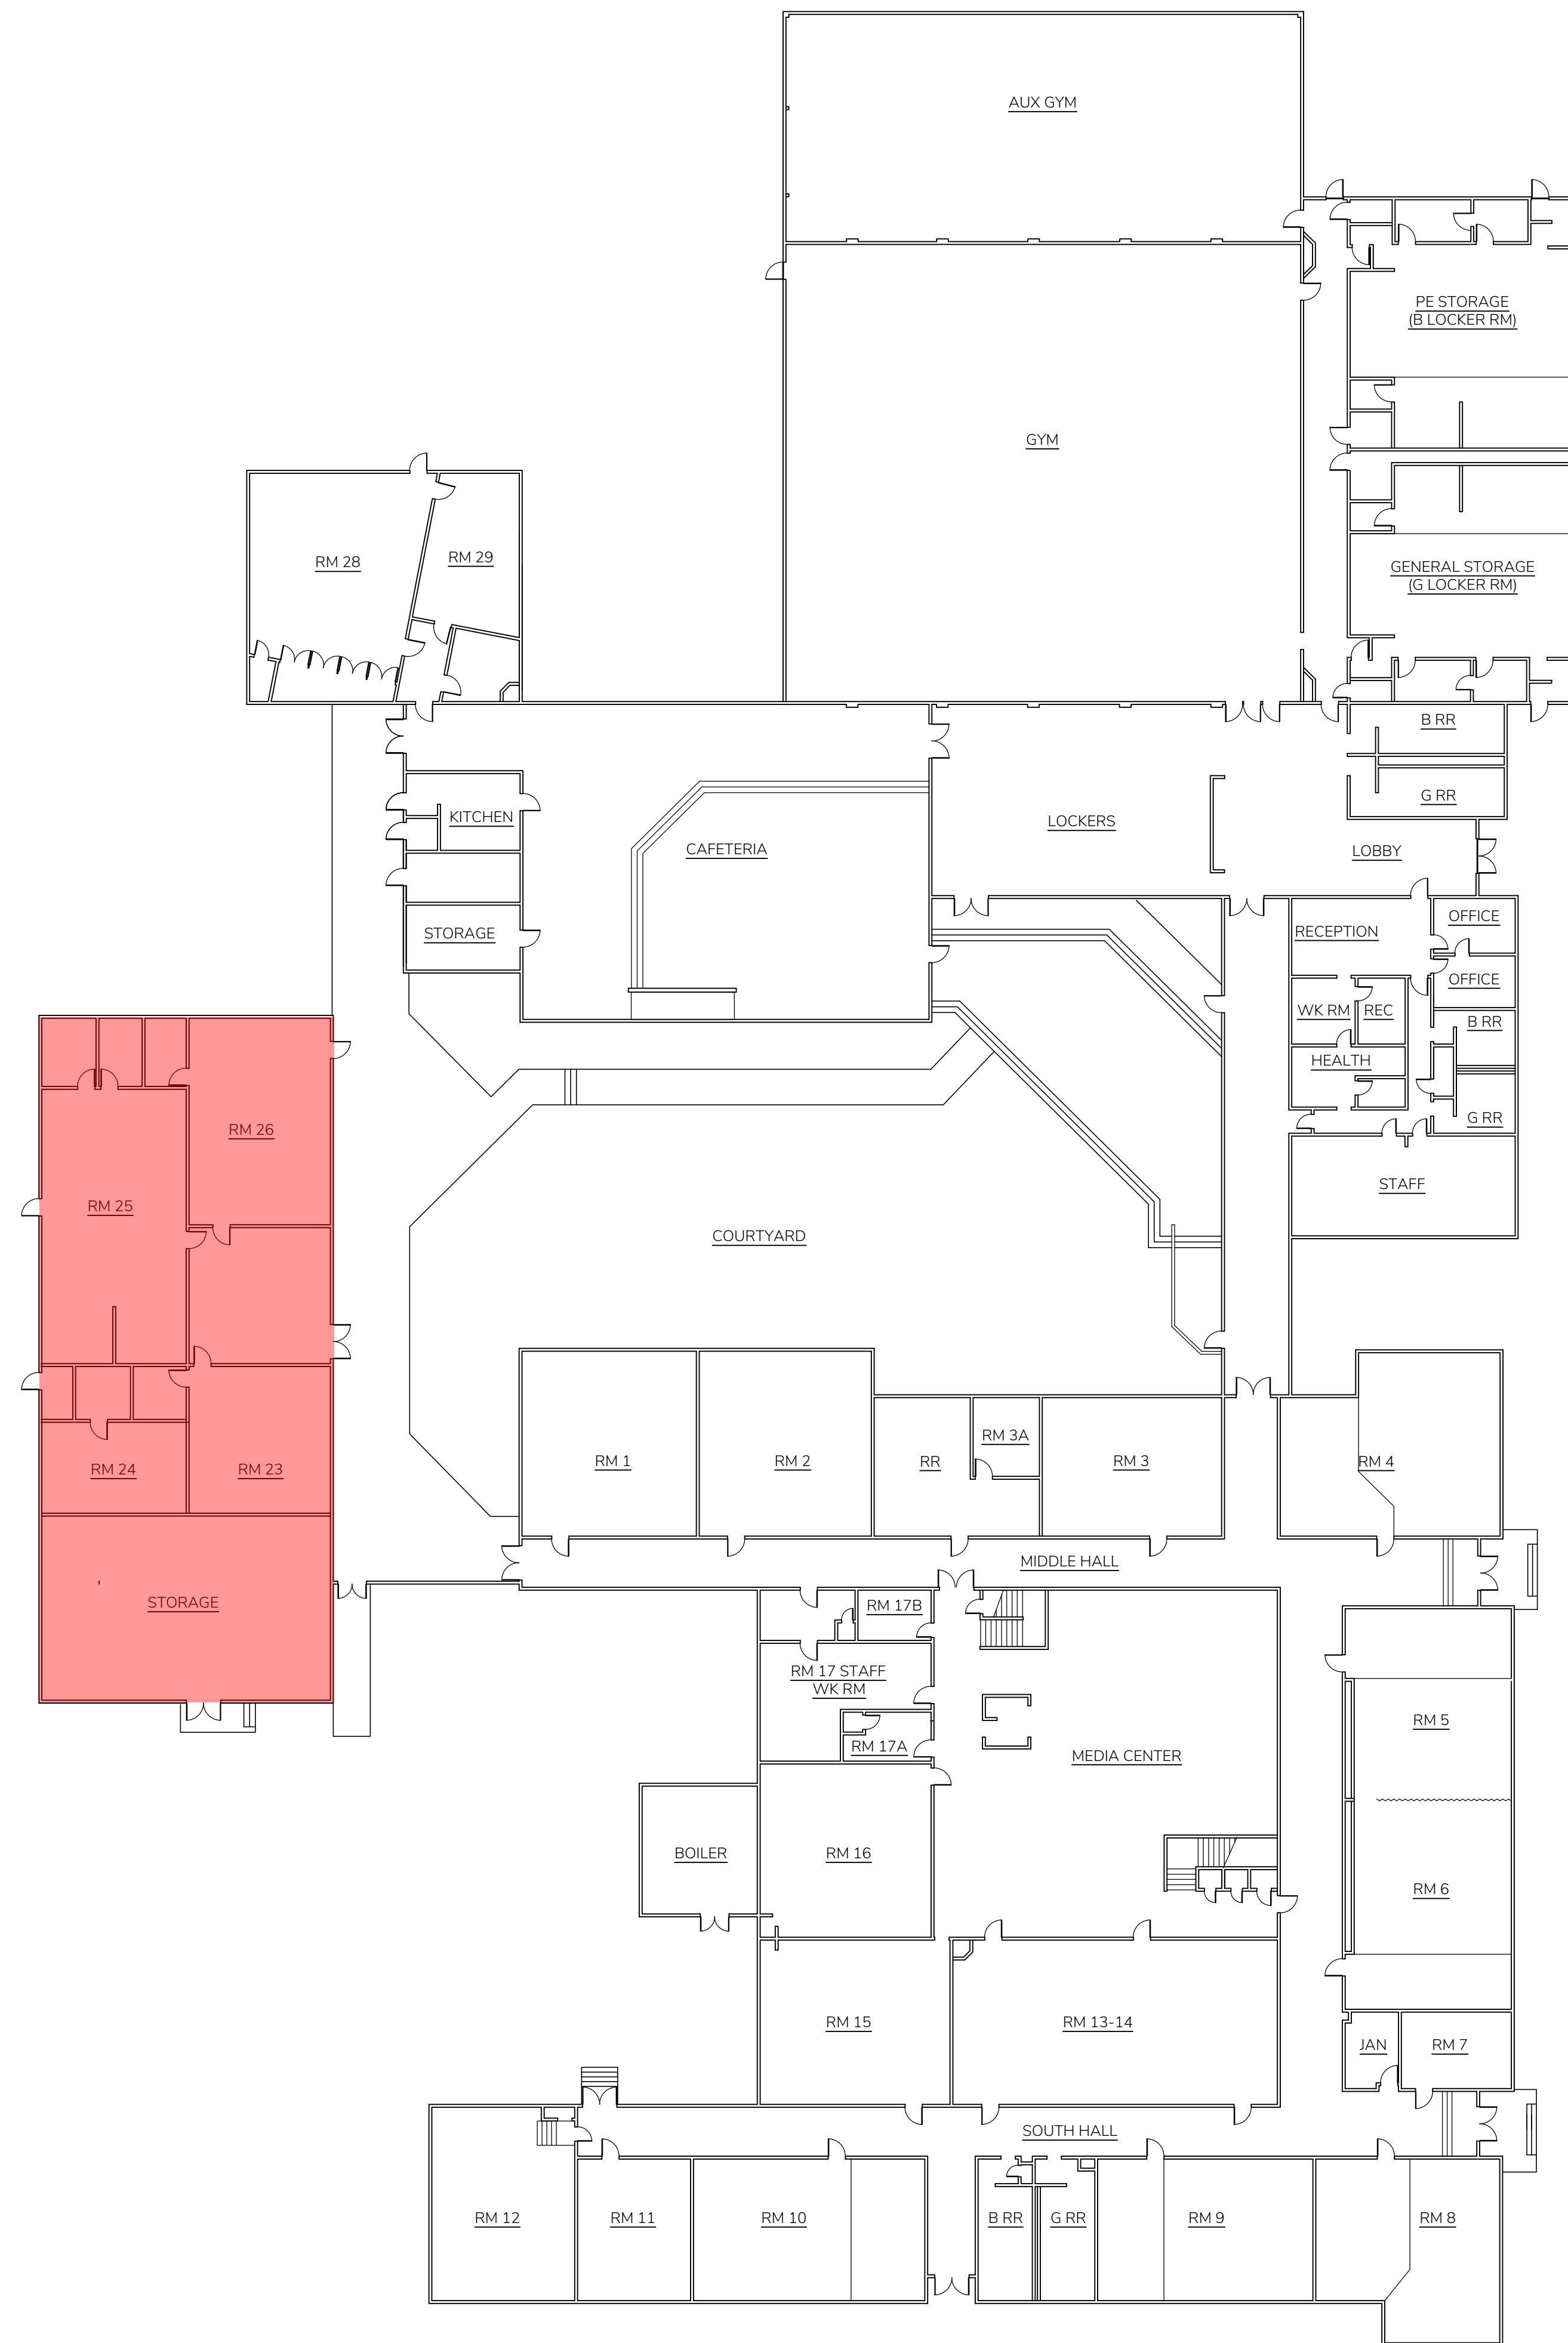
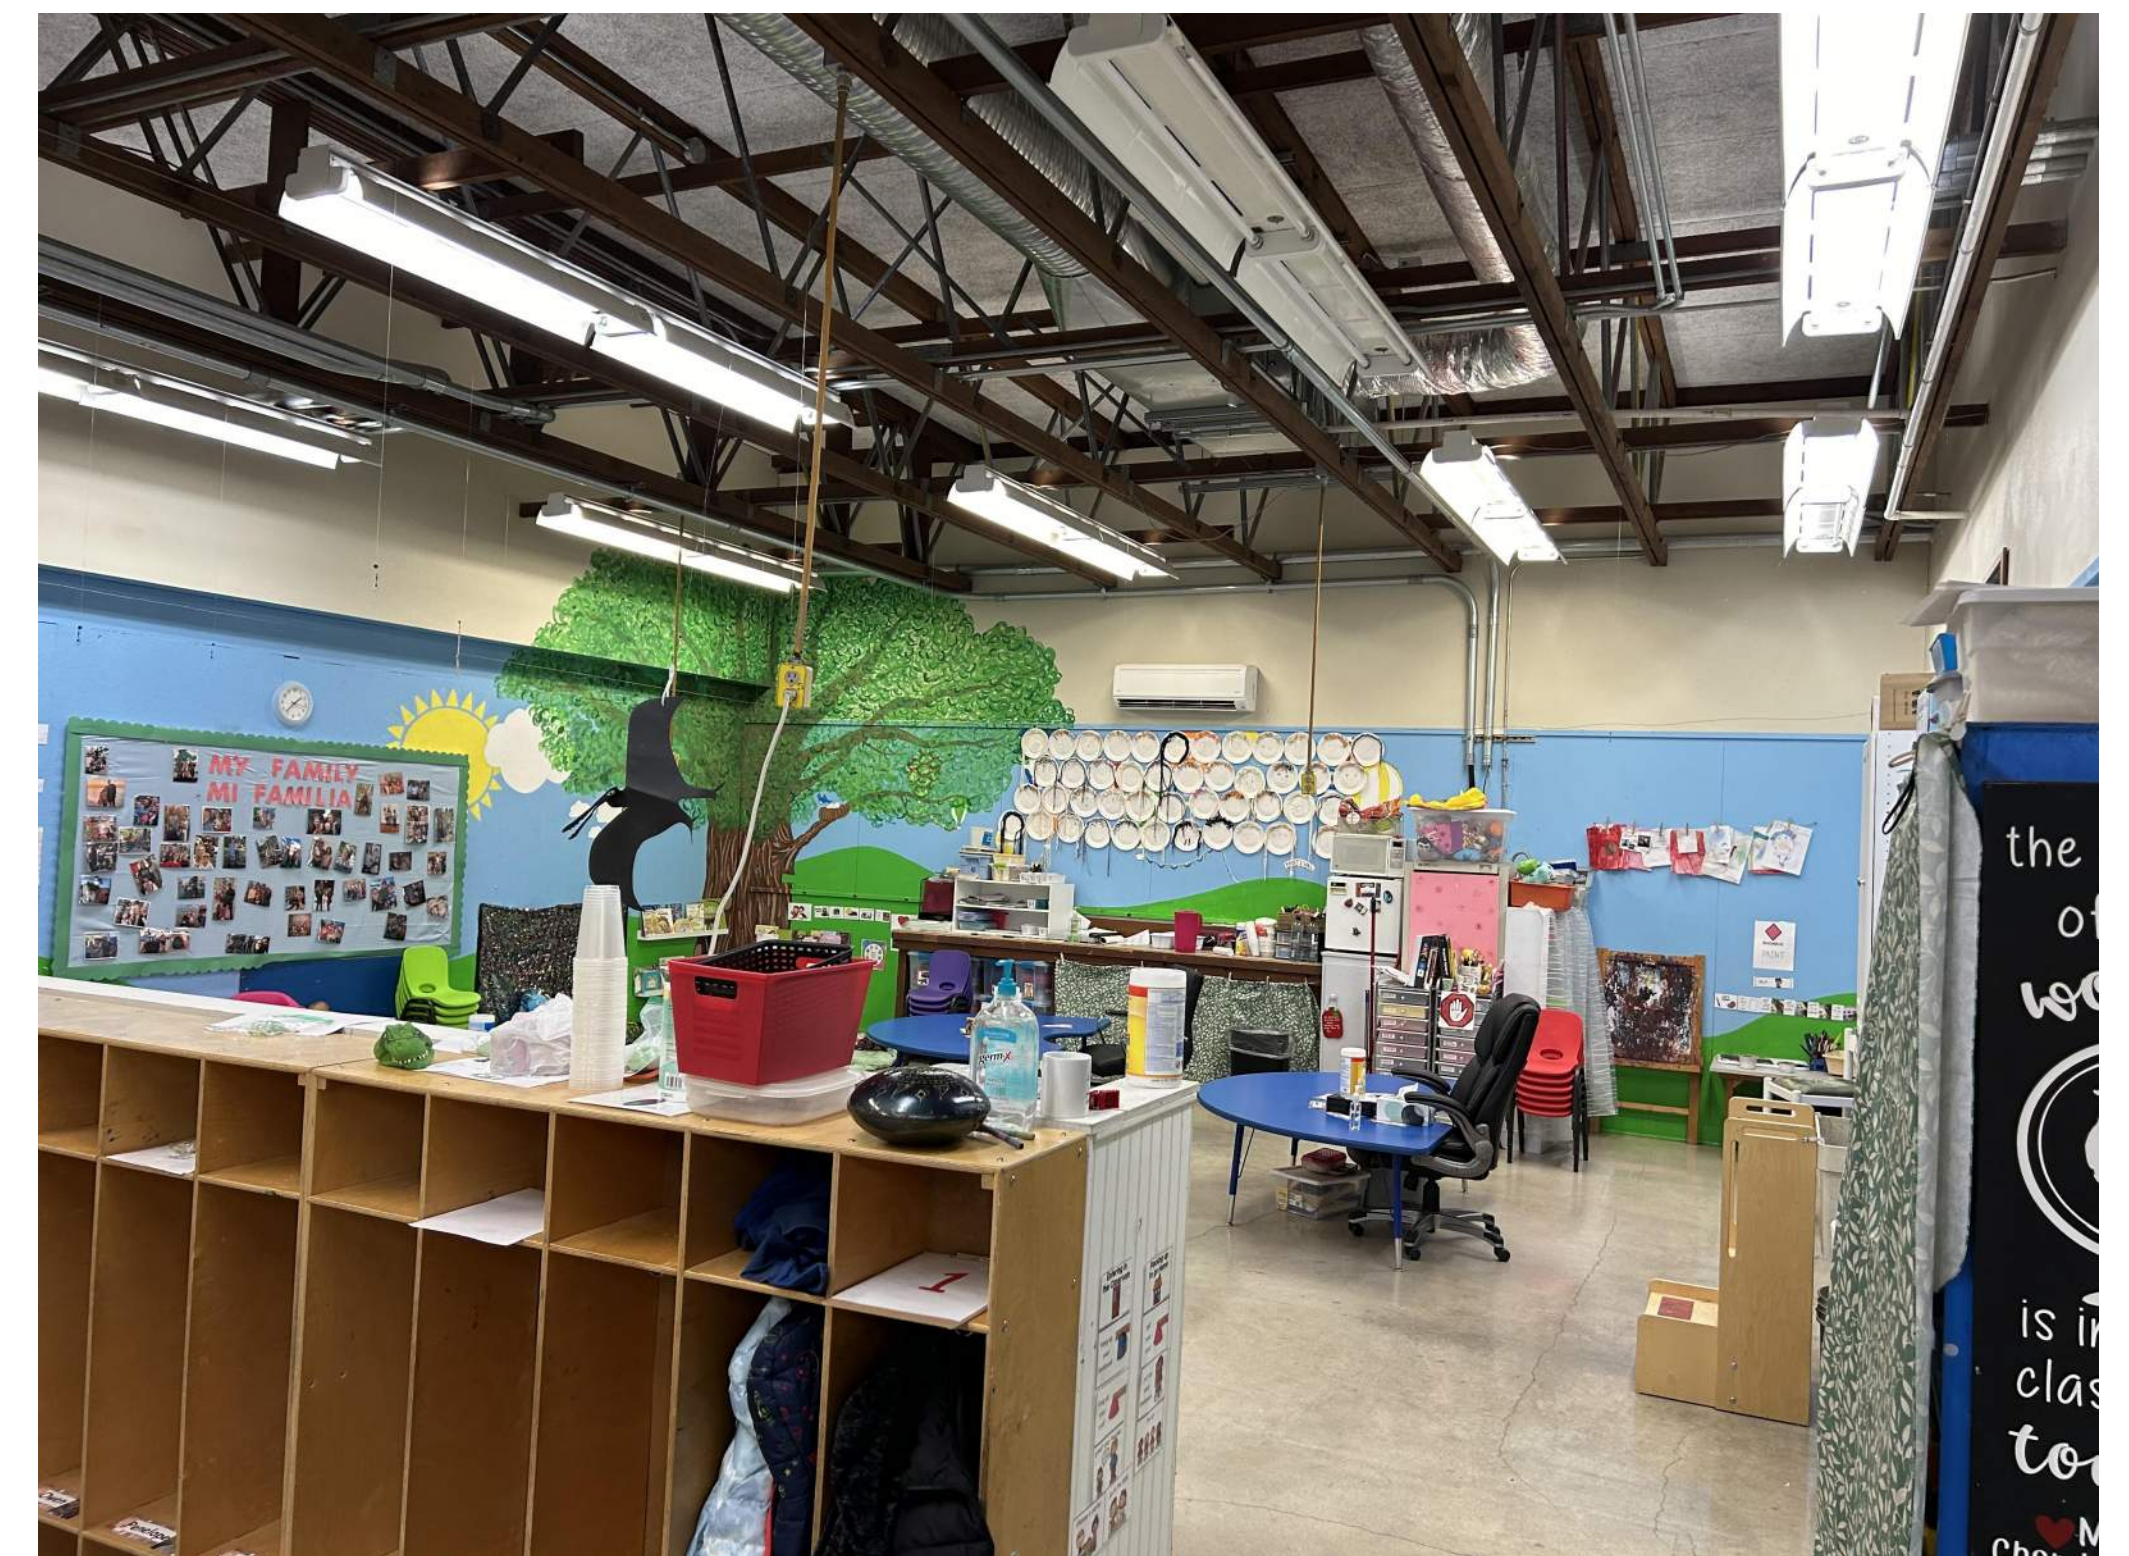
No restrooms in Kinder-First Grade out building.

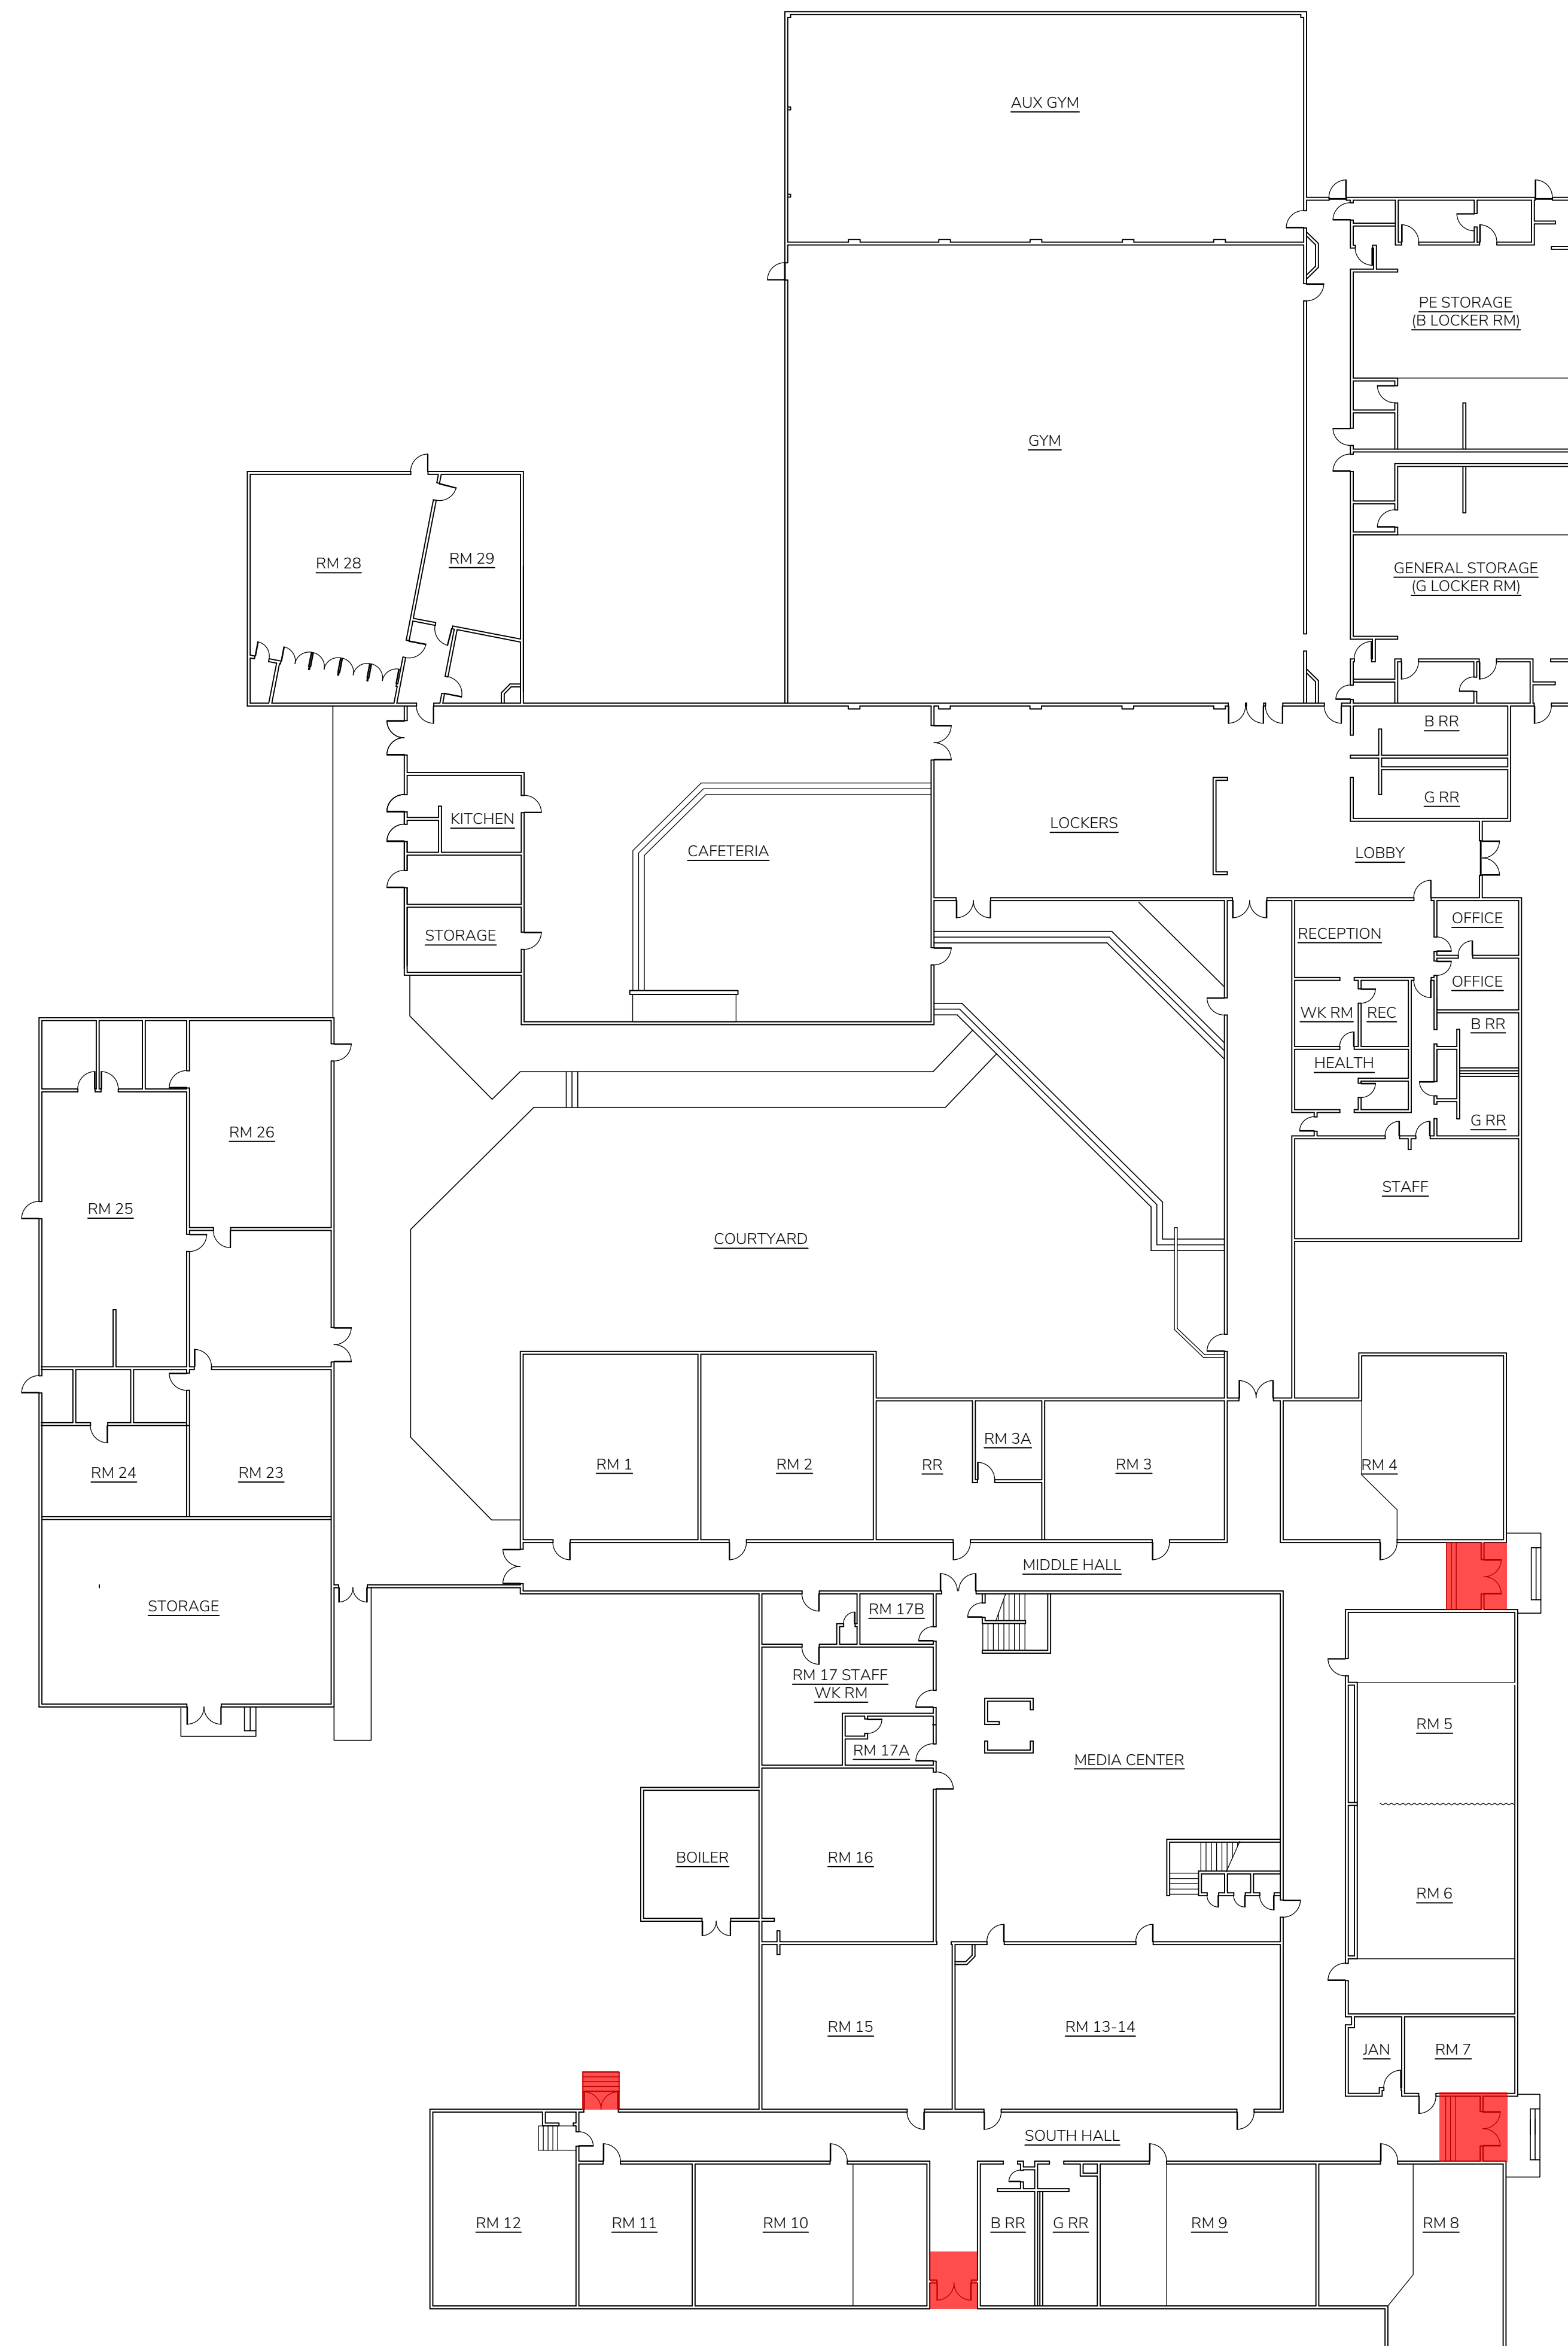
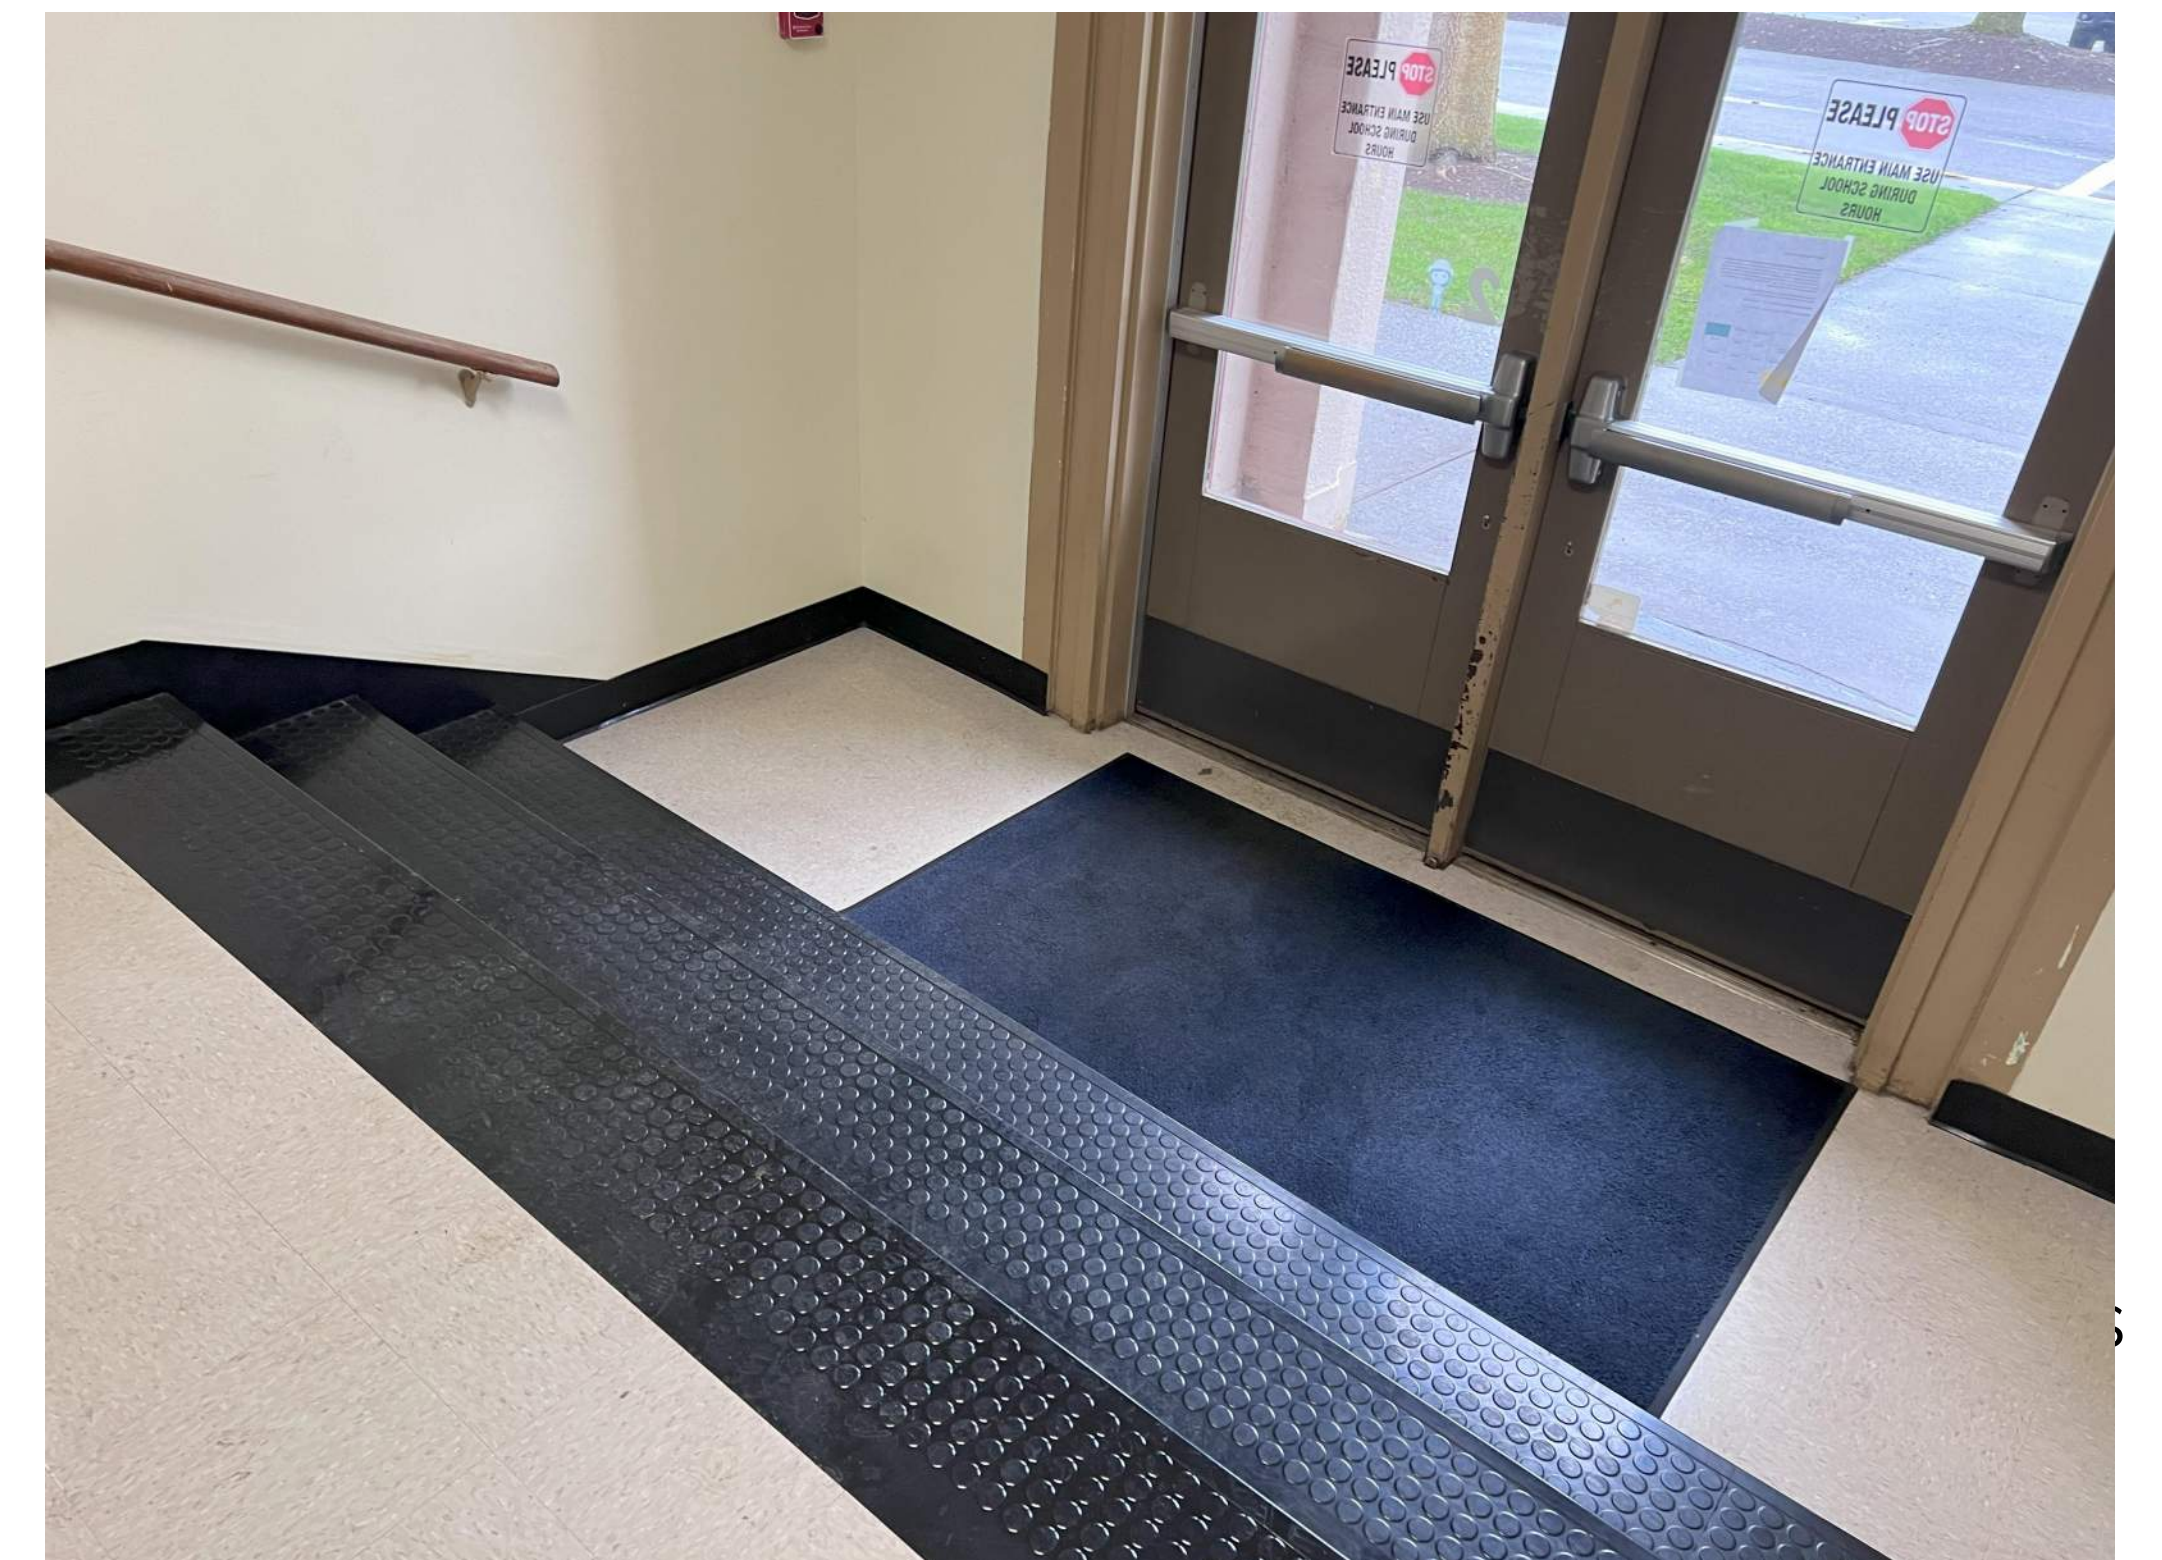
Accessibility challenges at exterior exits
