COMMUNITY BOND ADVISORY COMMITTEE MEETING #3

Central Linn School District
March 19, 2024

FACILITY ASSESSMENT EXECUTIVE SUMMARY

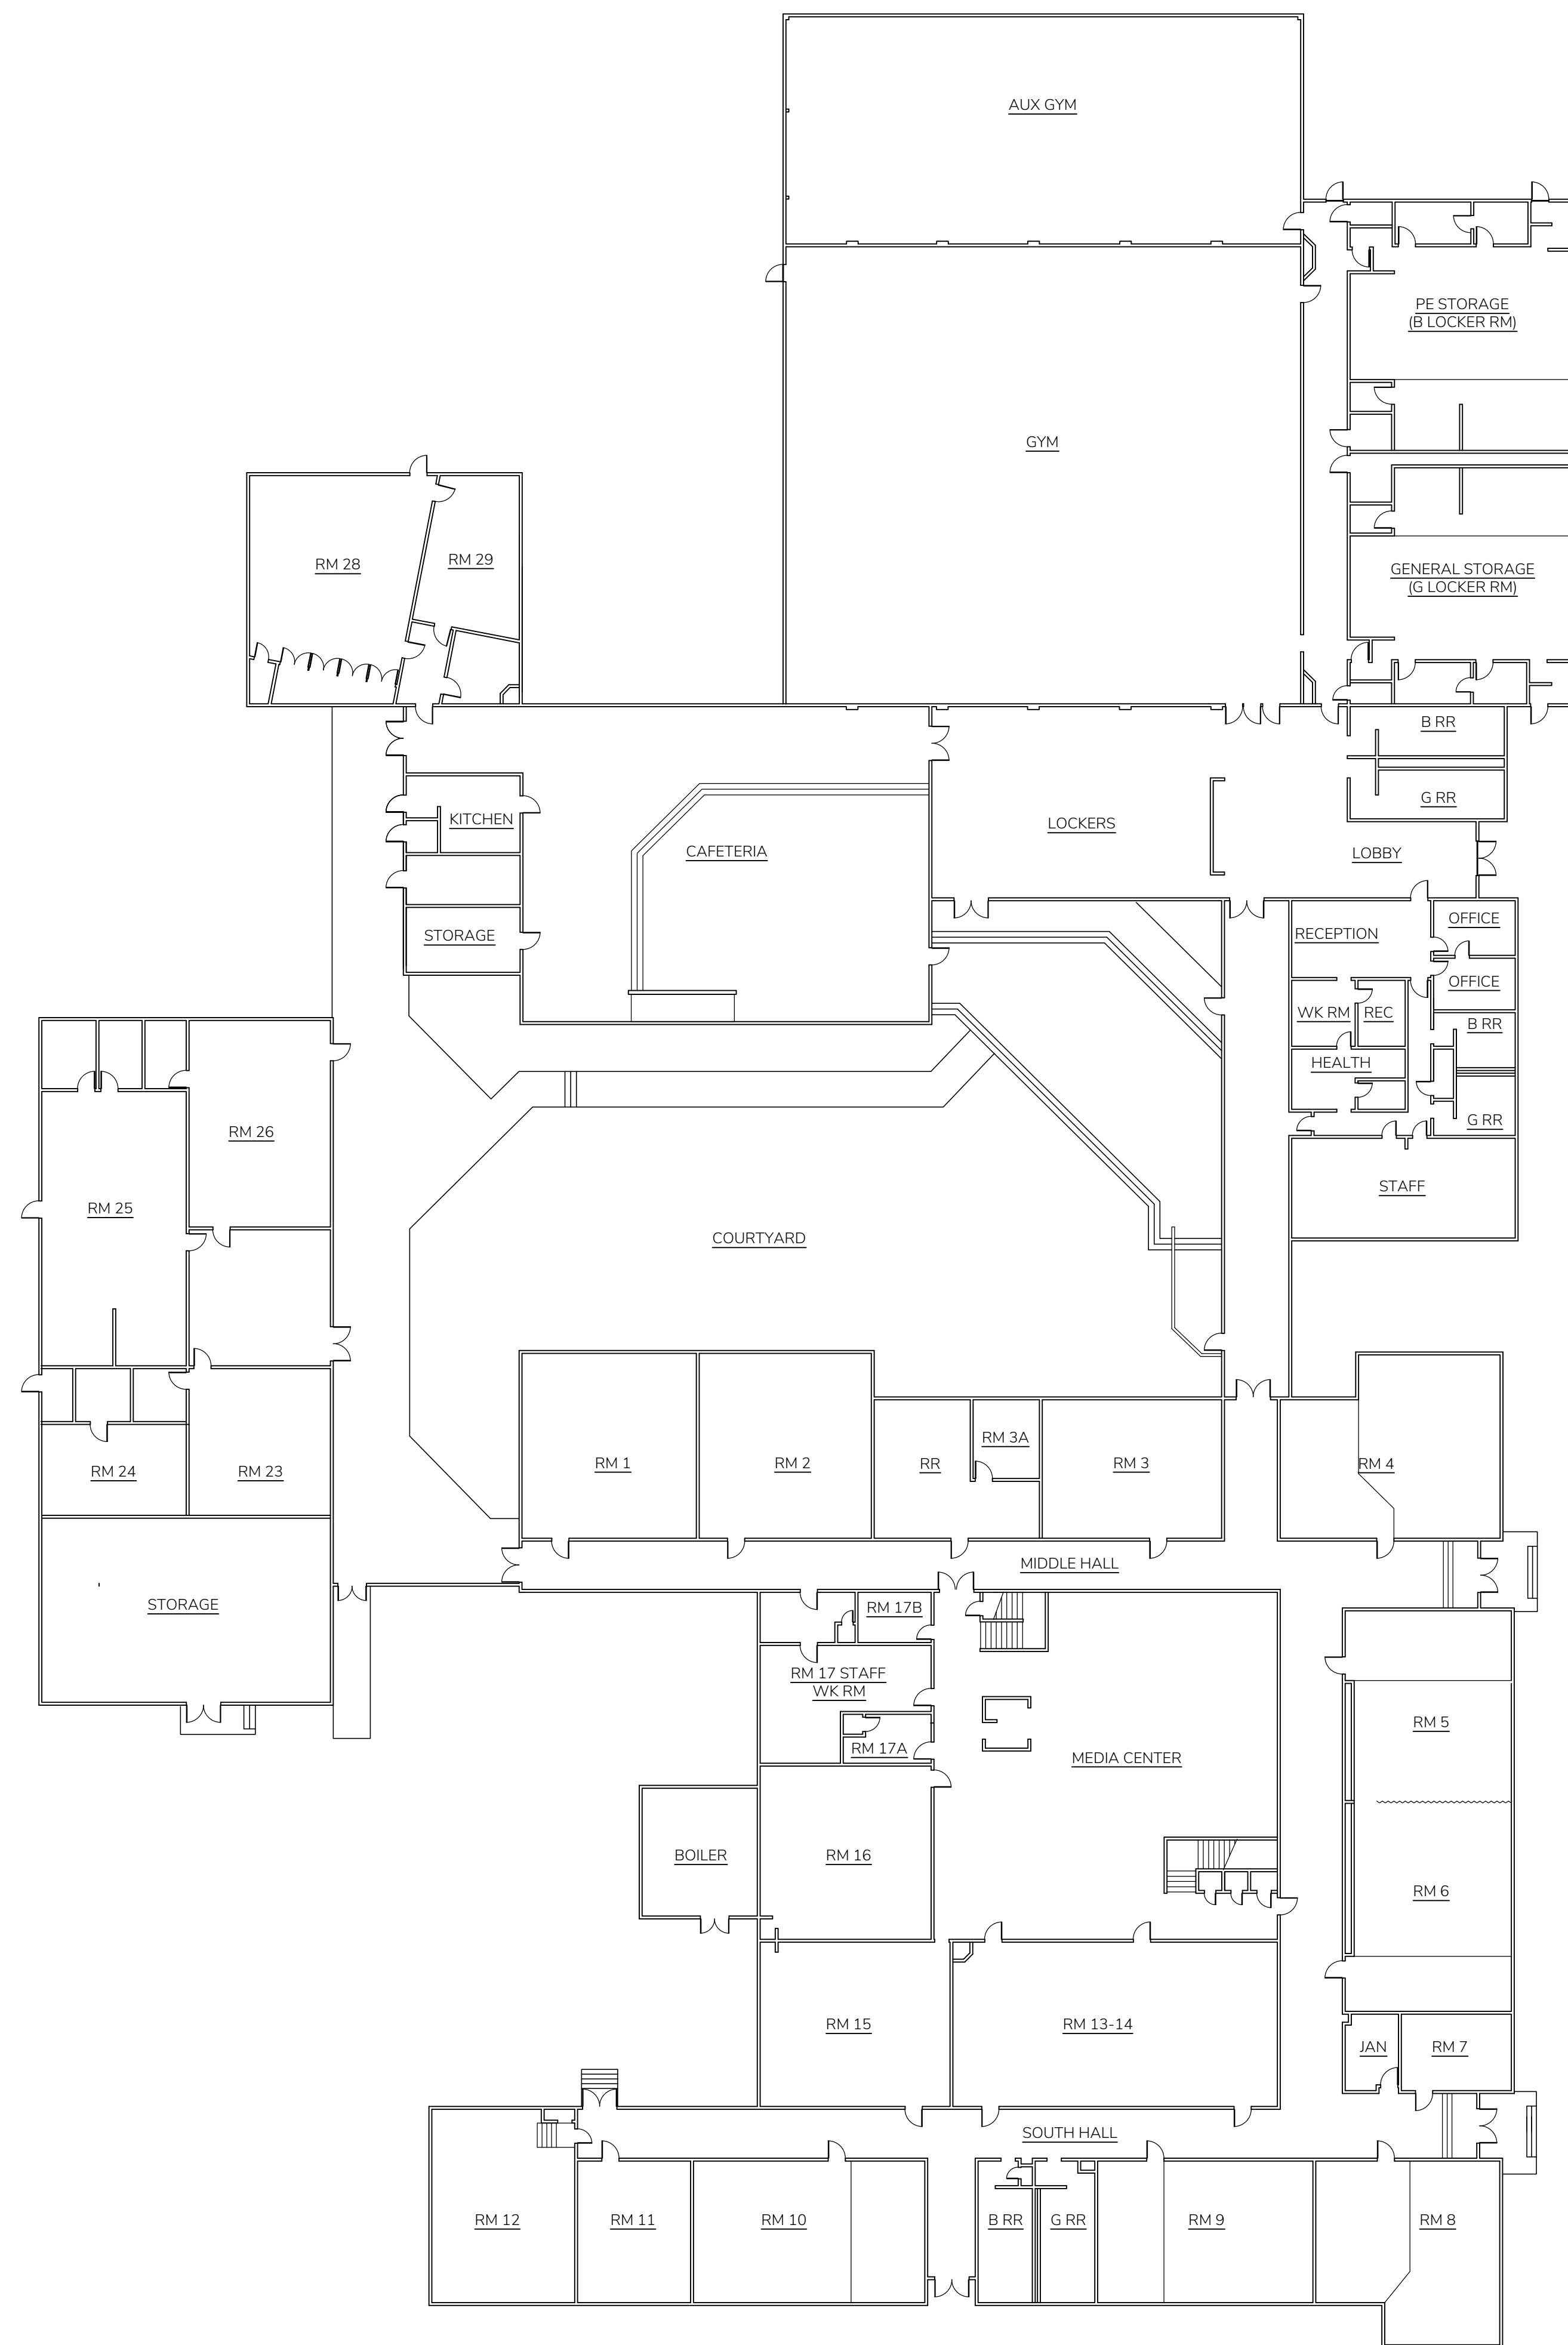
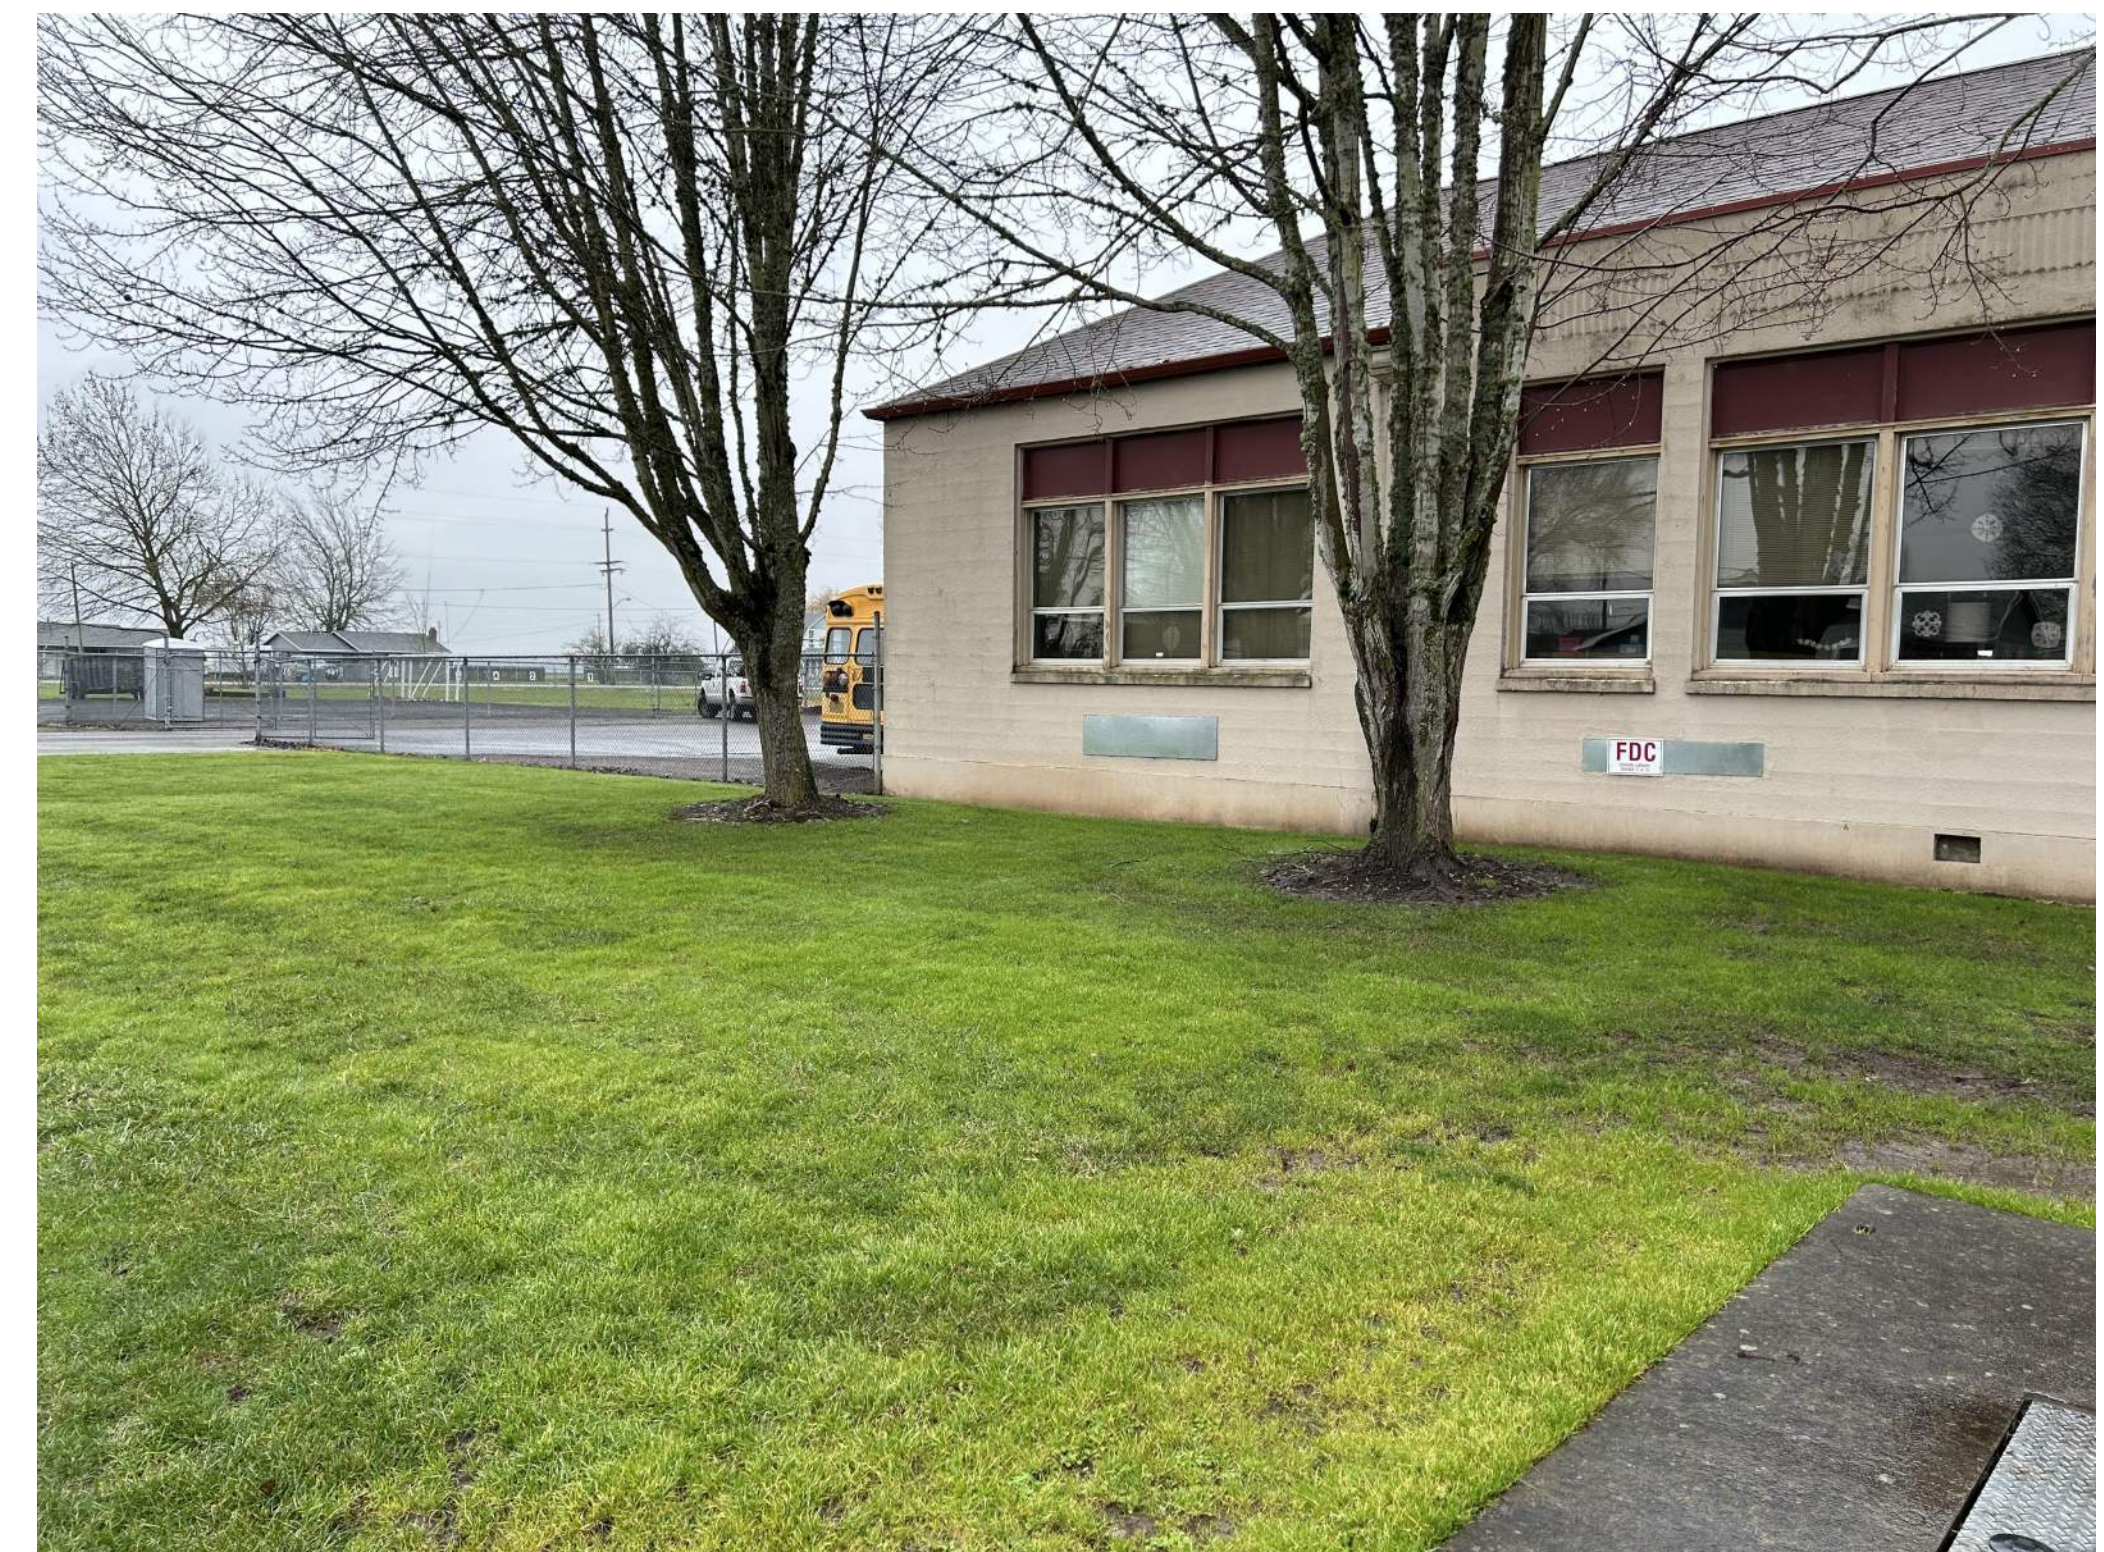
Limited water infiltration, possibly excess water in crawl space.

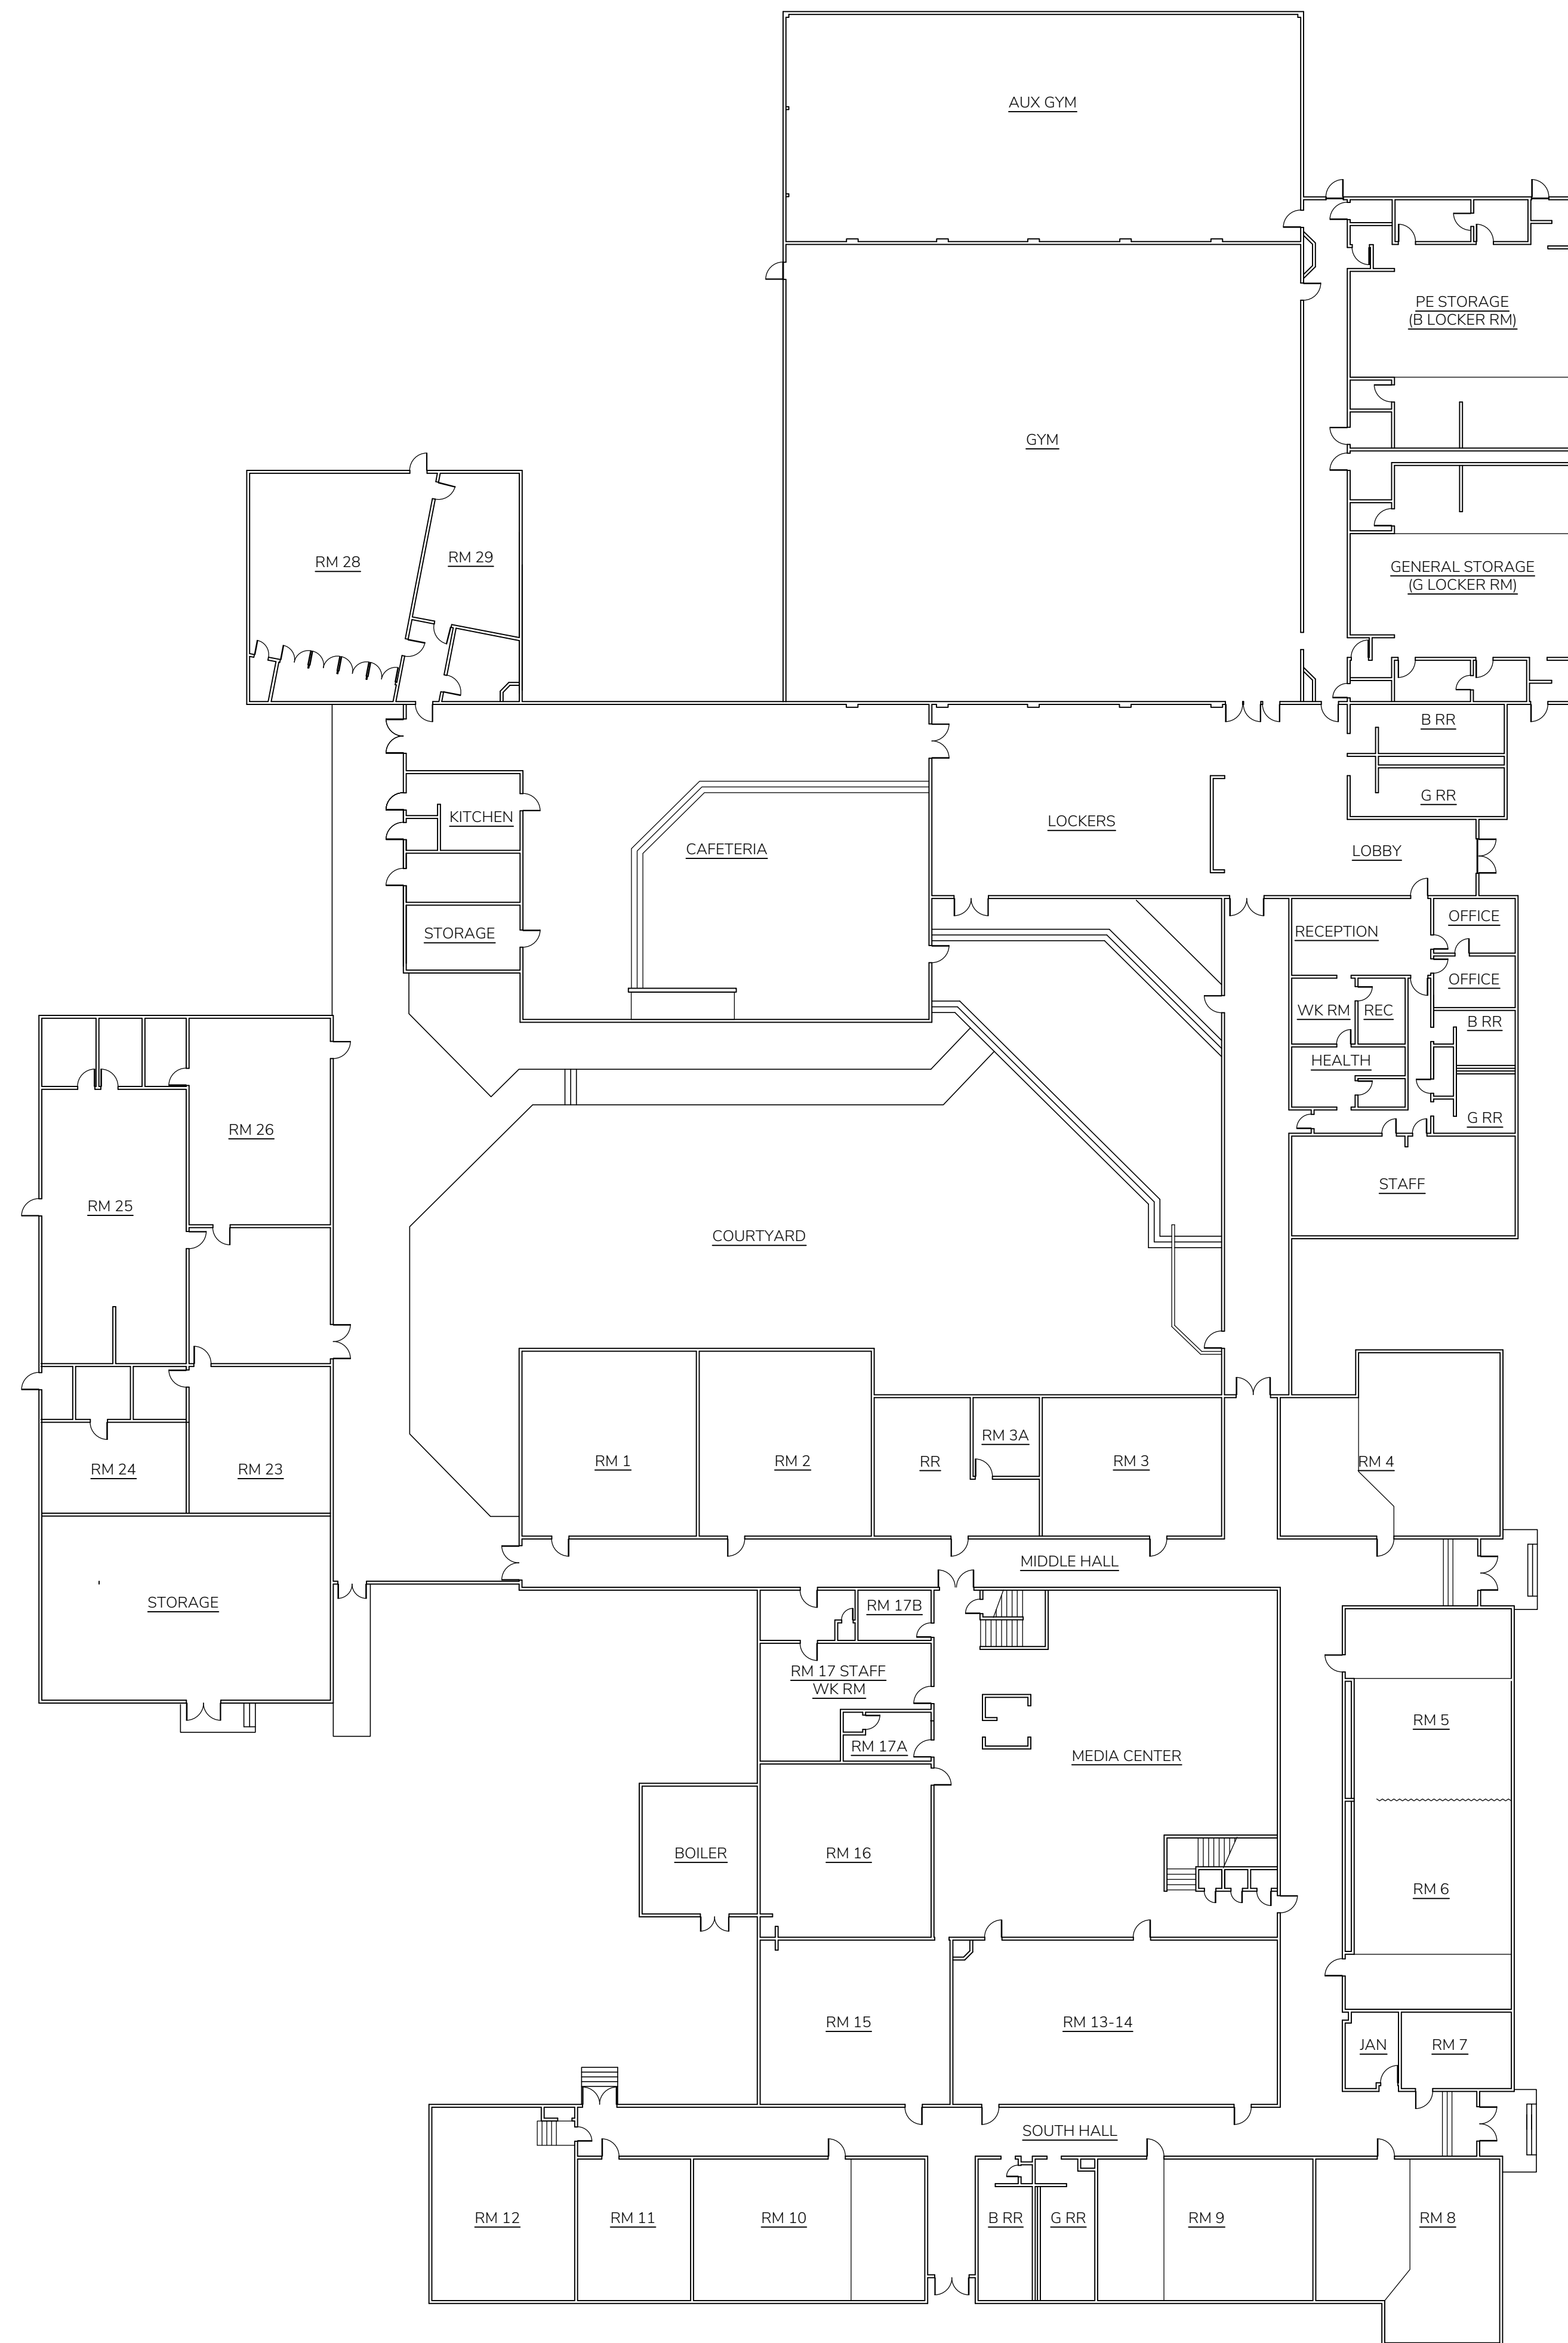
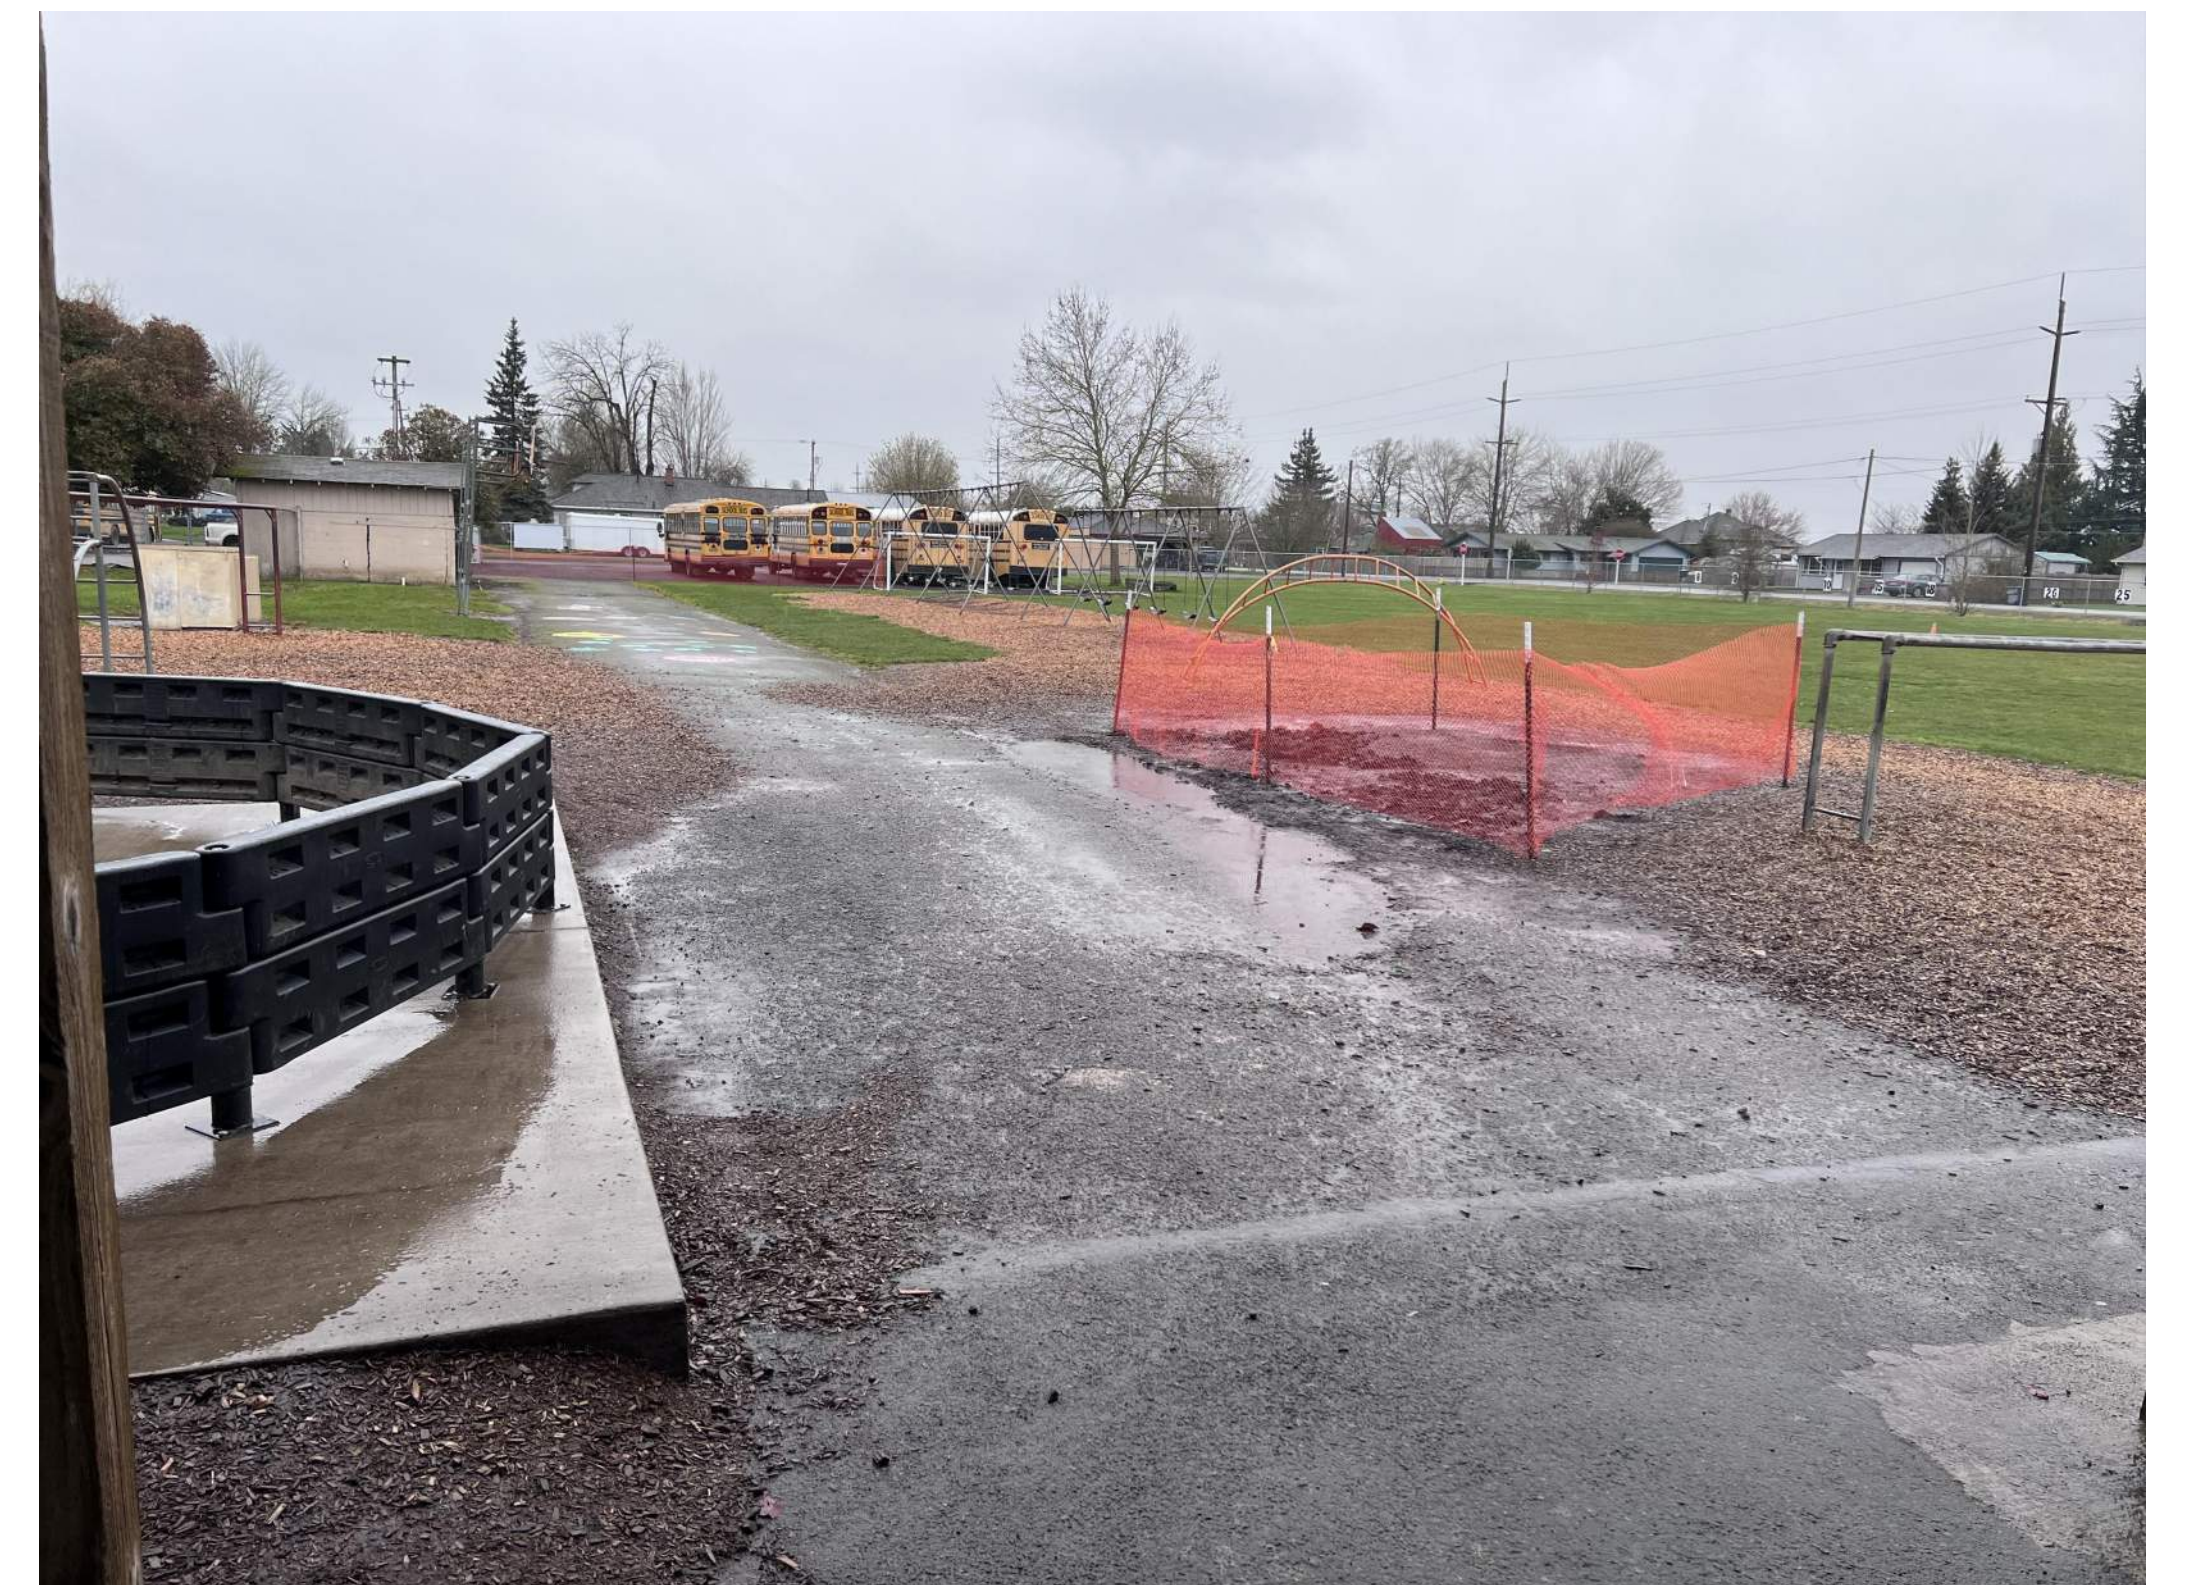
Playground and playfield poor drainage

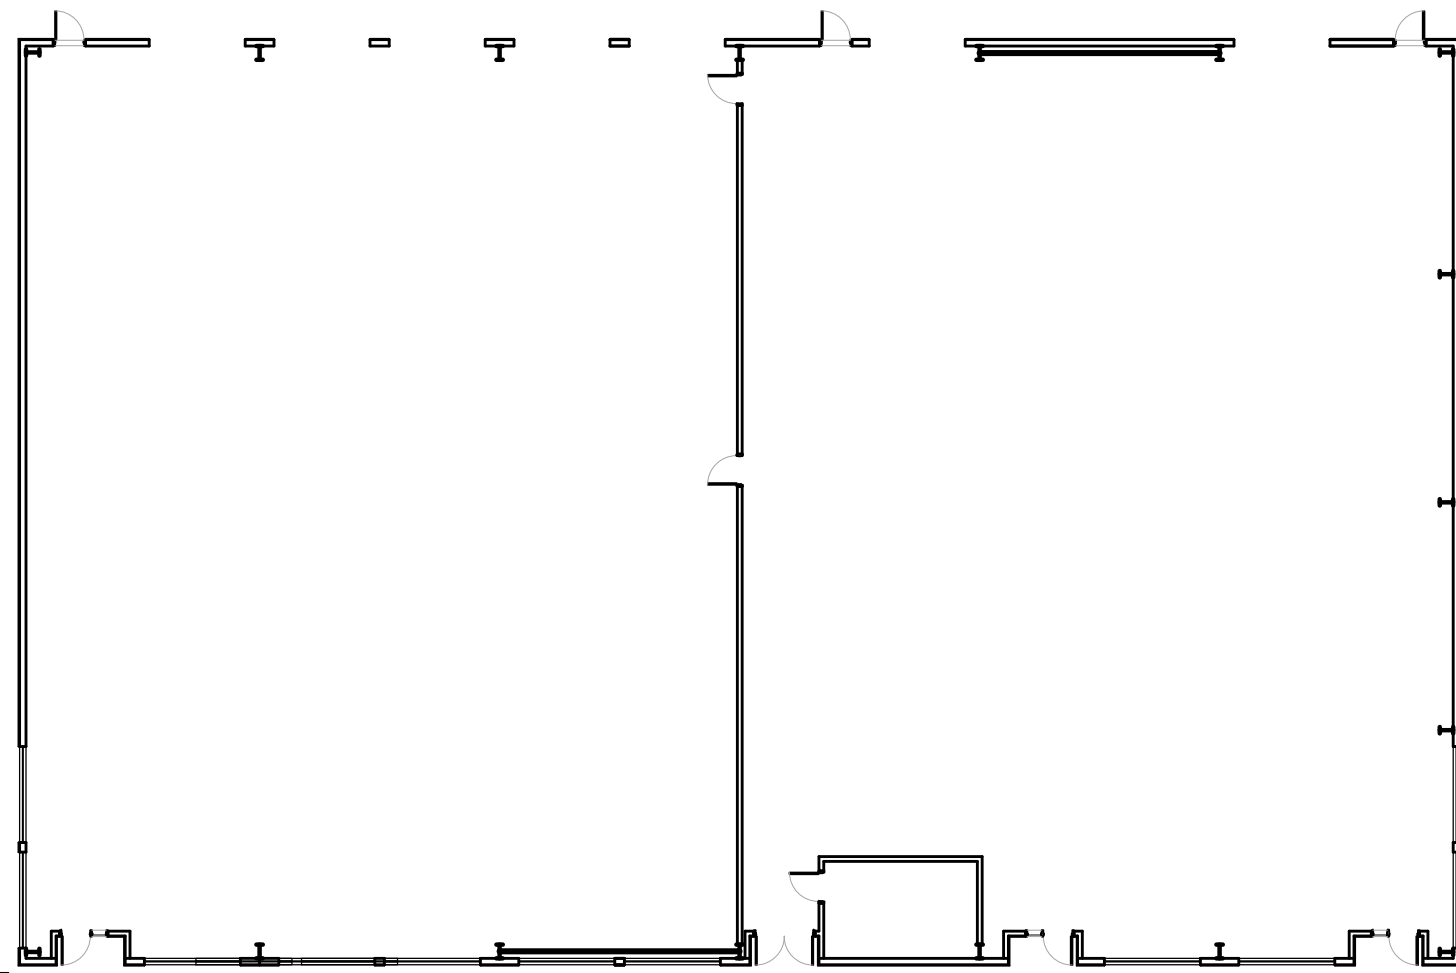
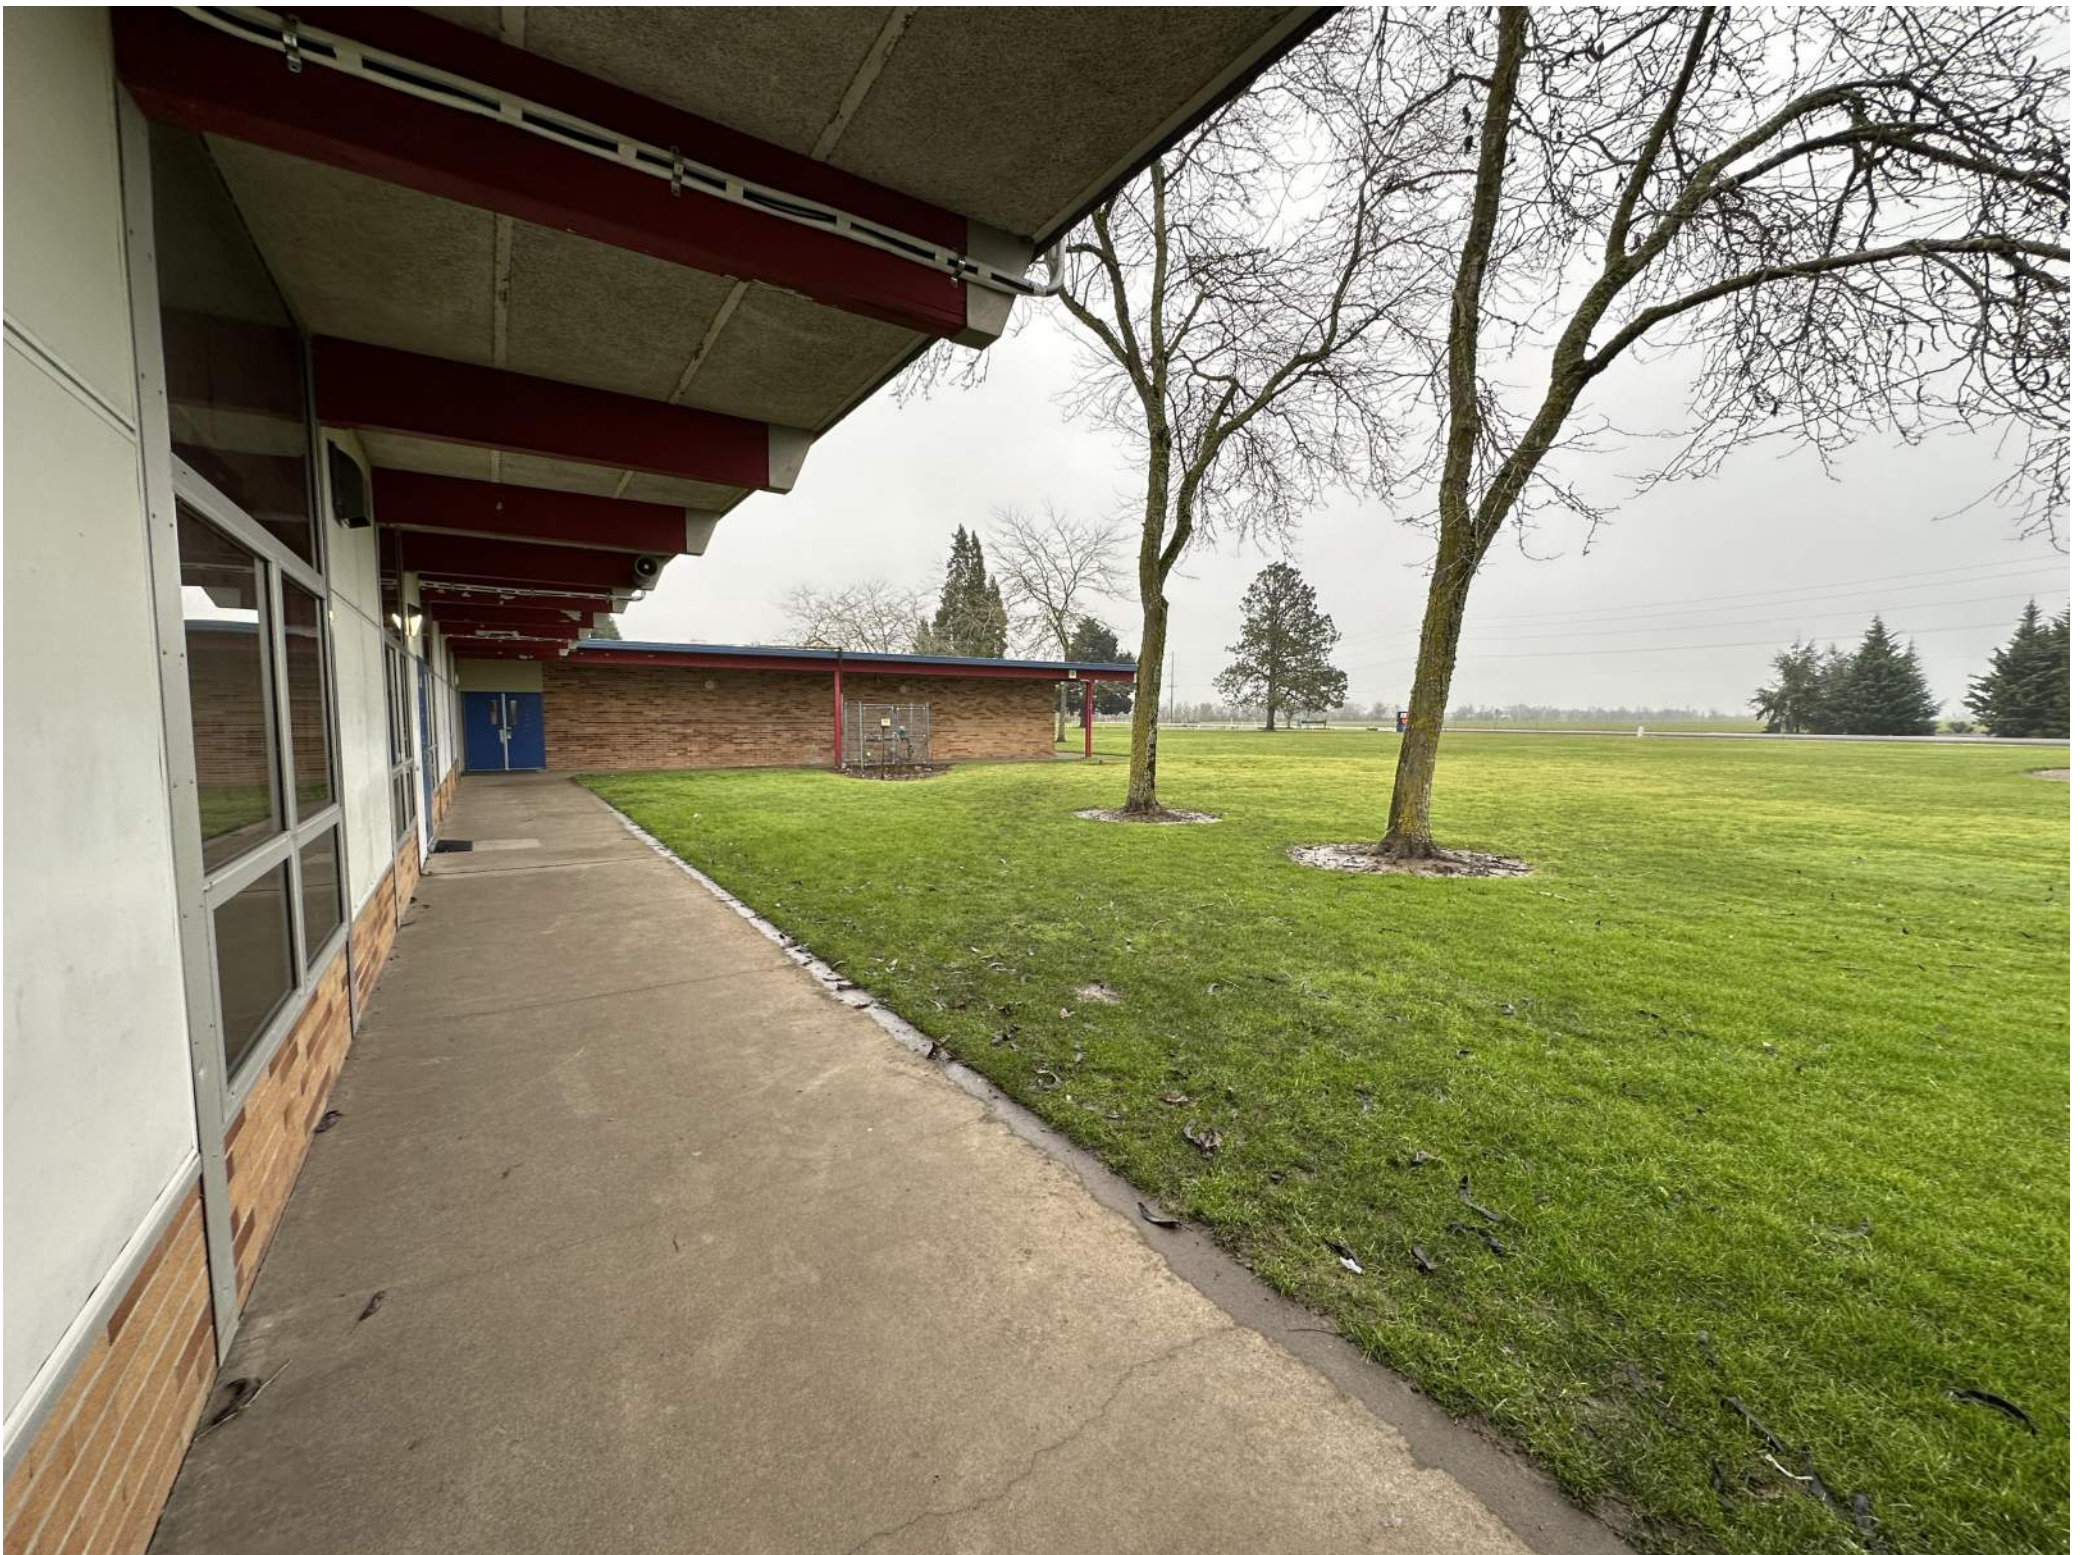
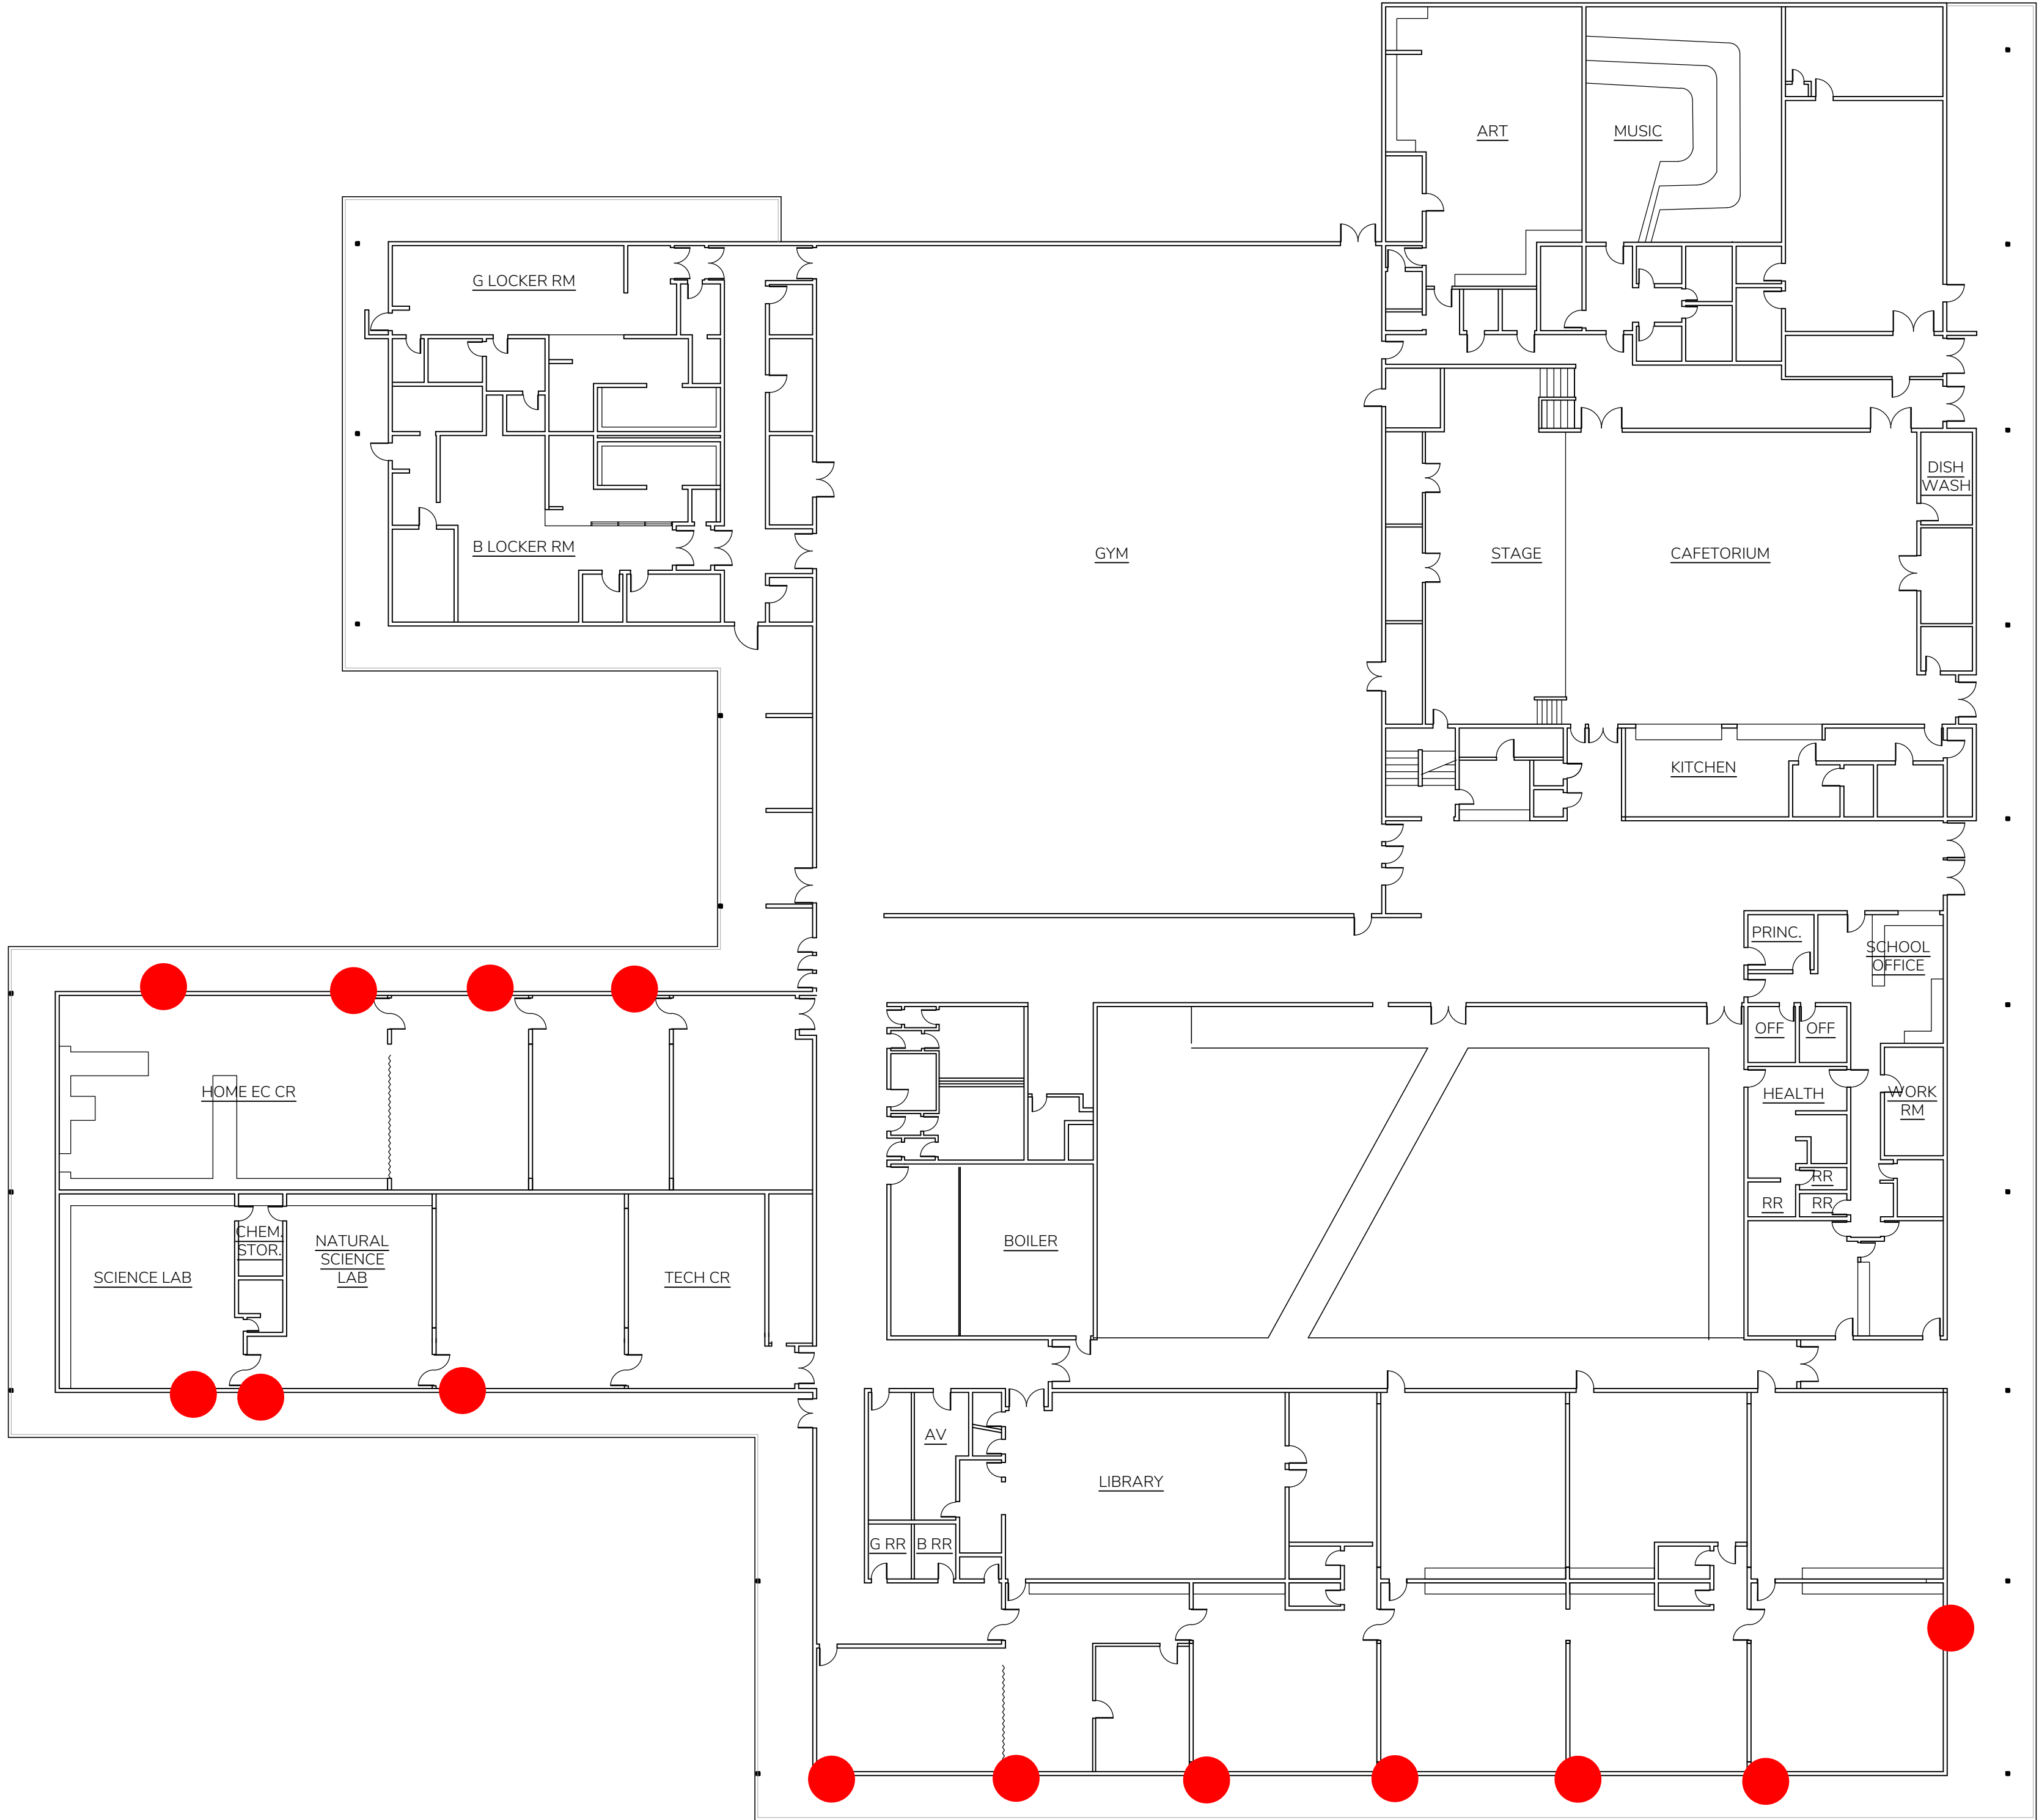
Visual supervision is difficult 1950's "California-style" layout.
