COMMUNITY BOND ADVISORY COMMITTEE MEETING #3

Central Linn School District
March 19, 2024

FACILITY ASSESSMENT EXECUTIVE SUMMARY

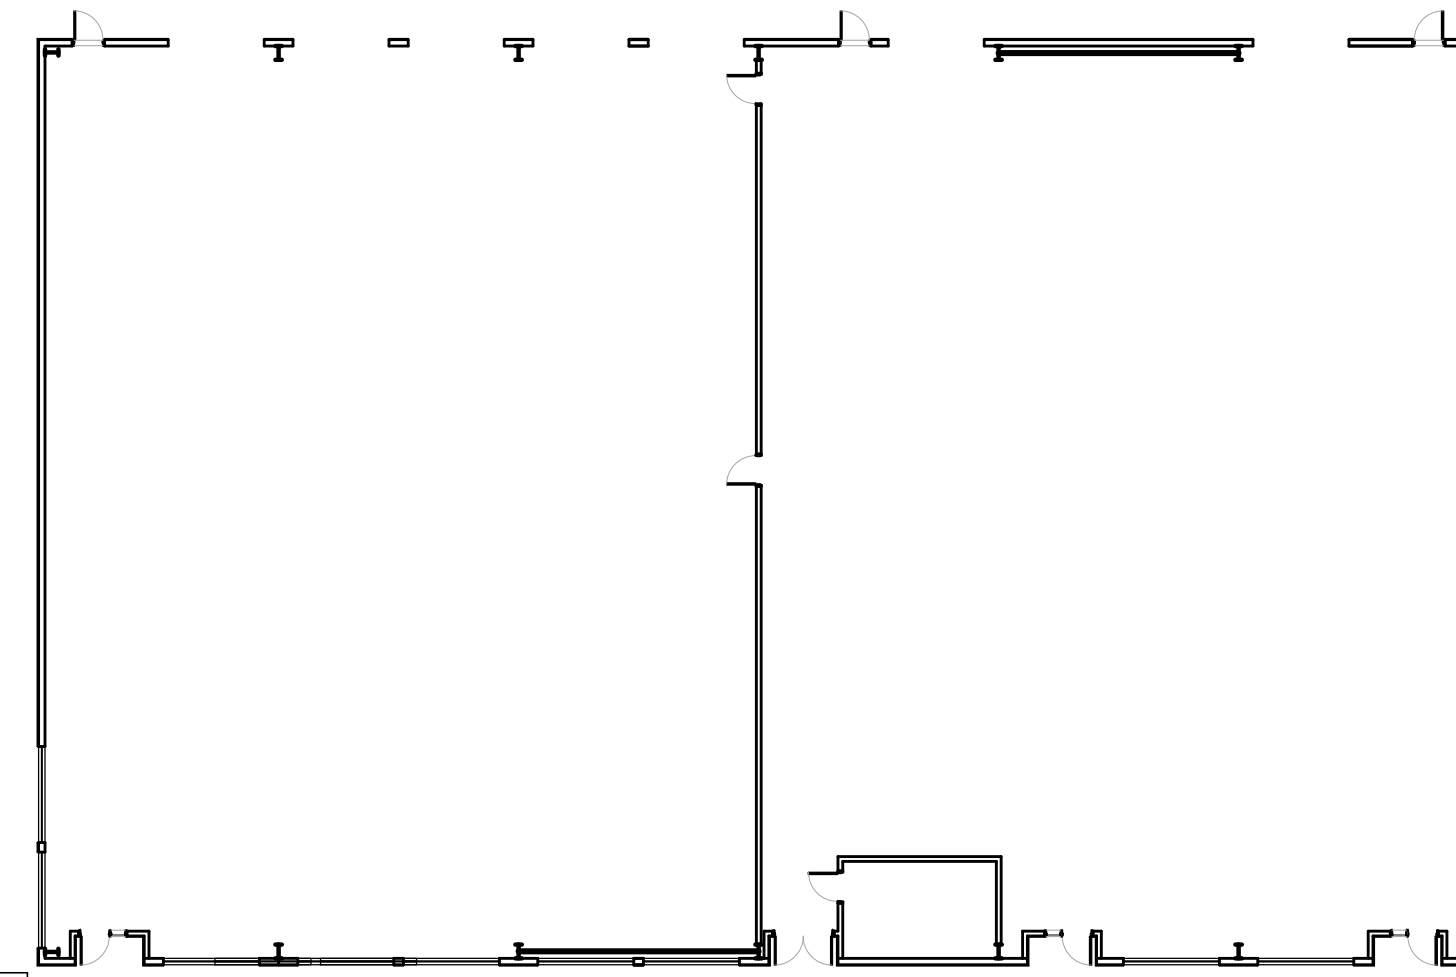
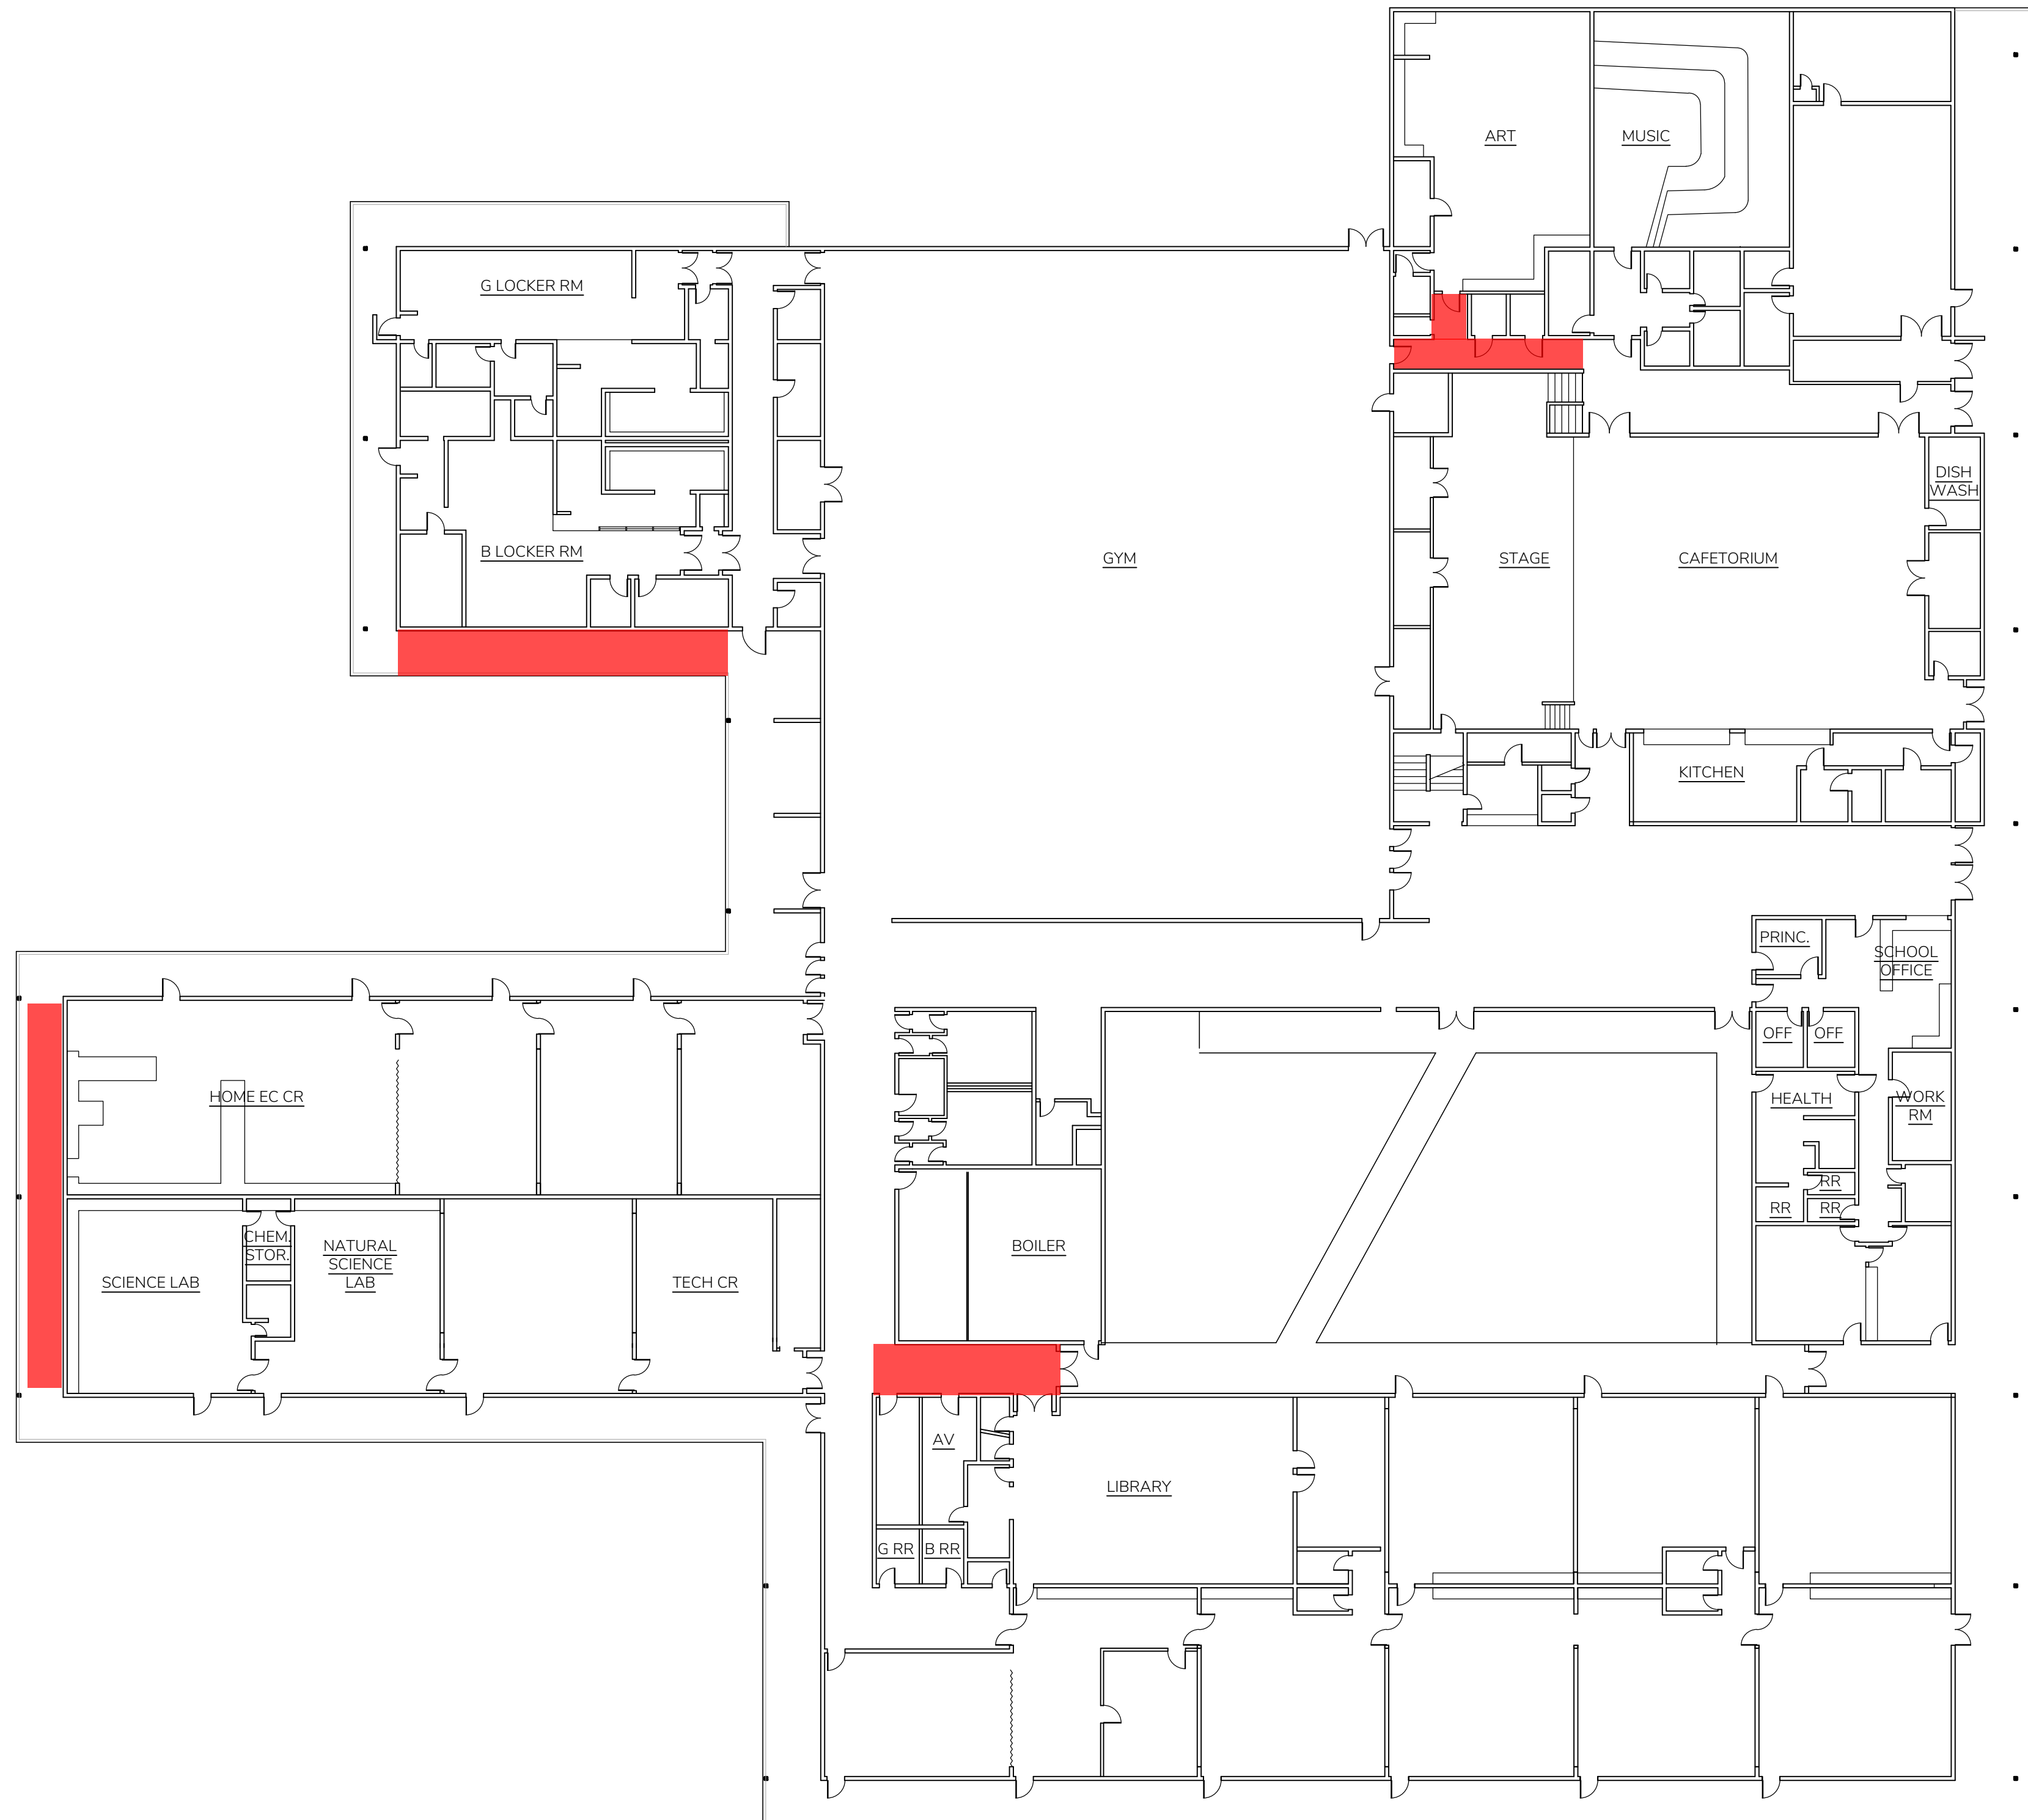
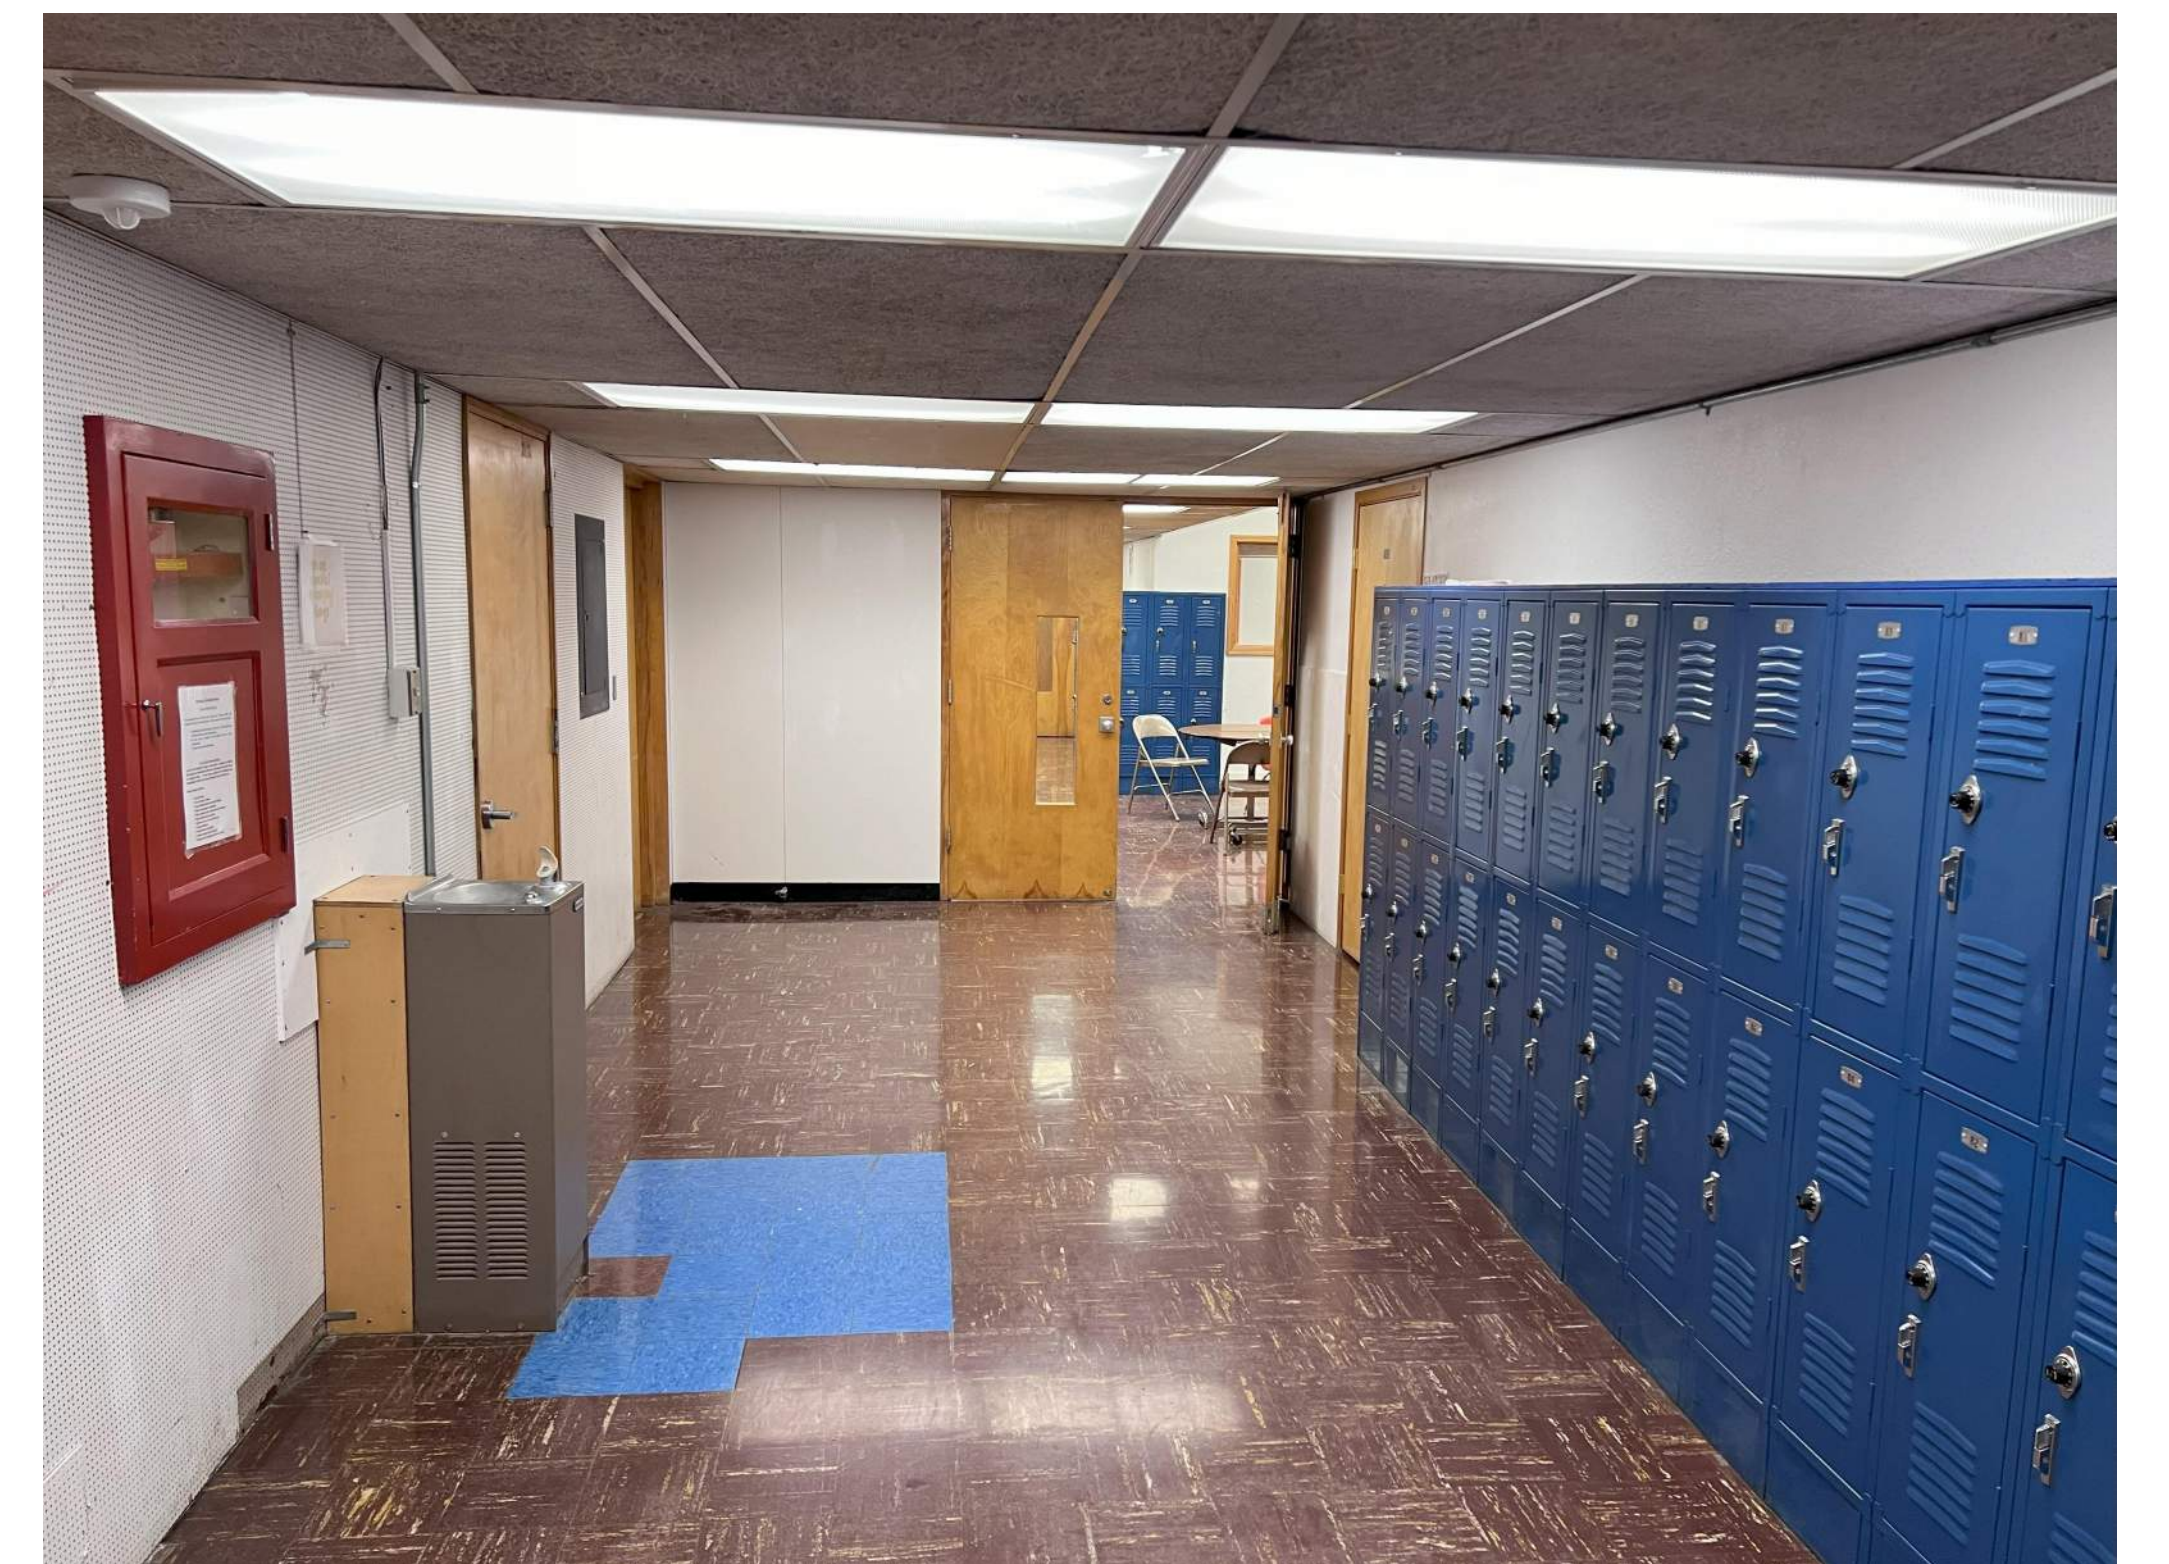
There are many "nooks and crannies" that are difficult to supervise.

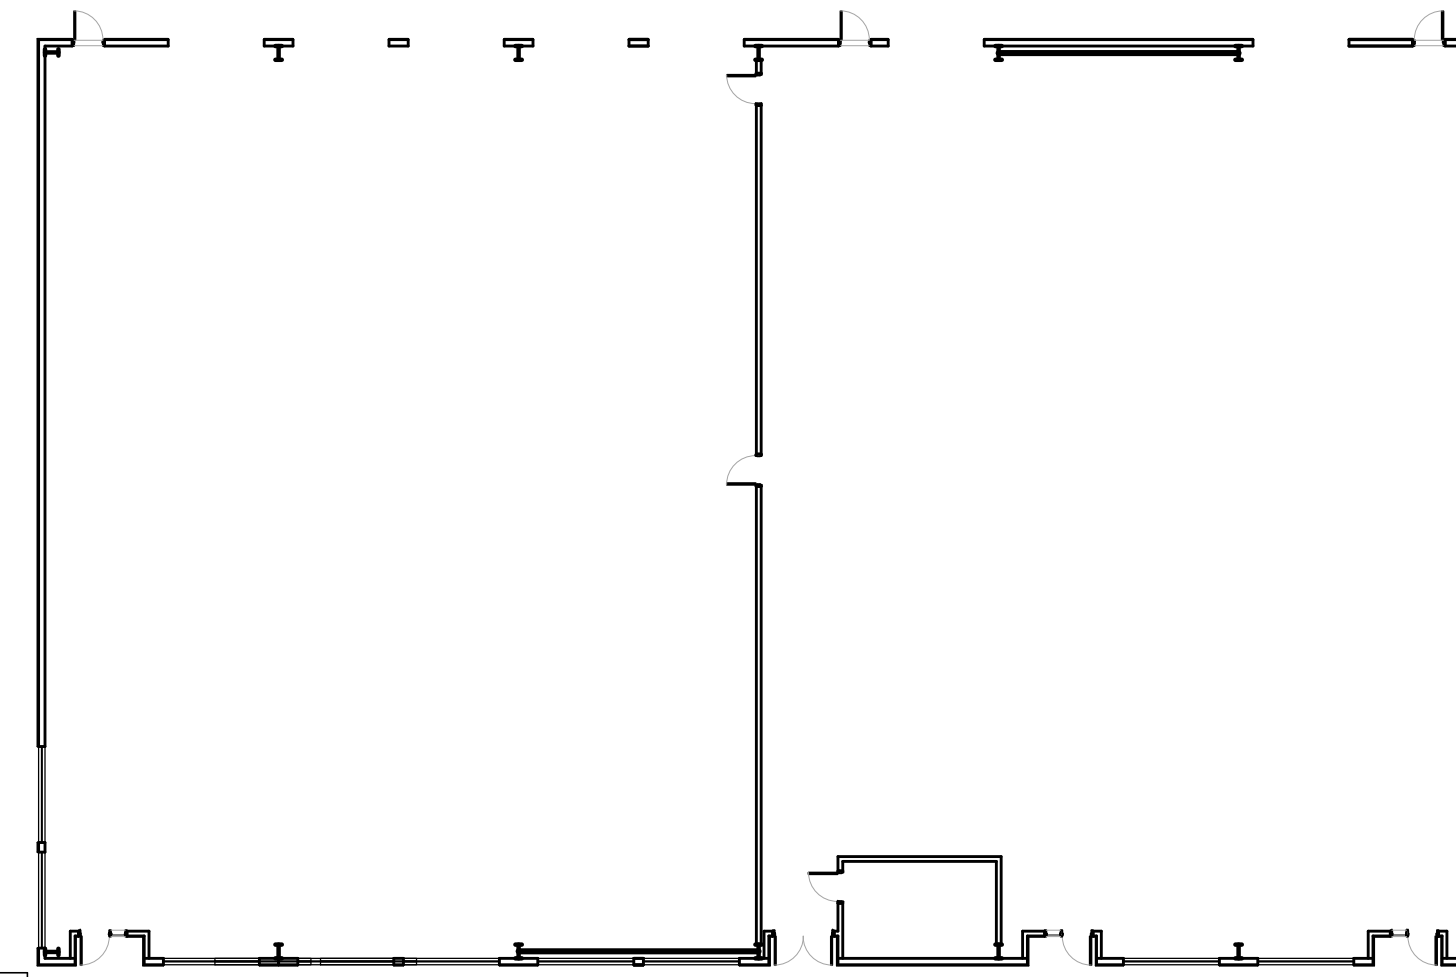
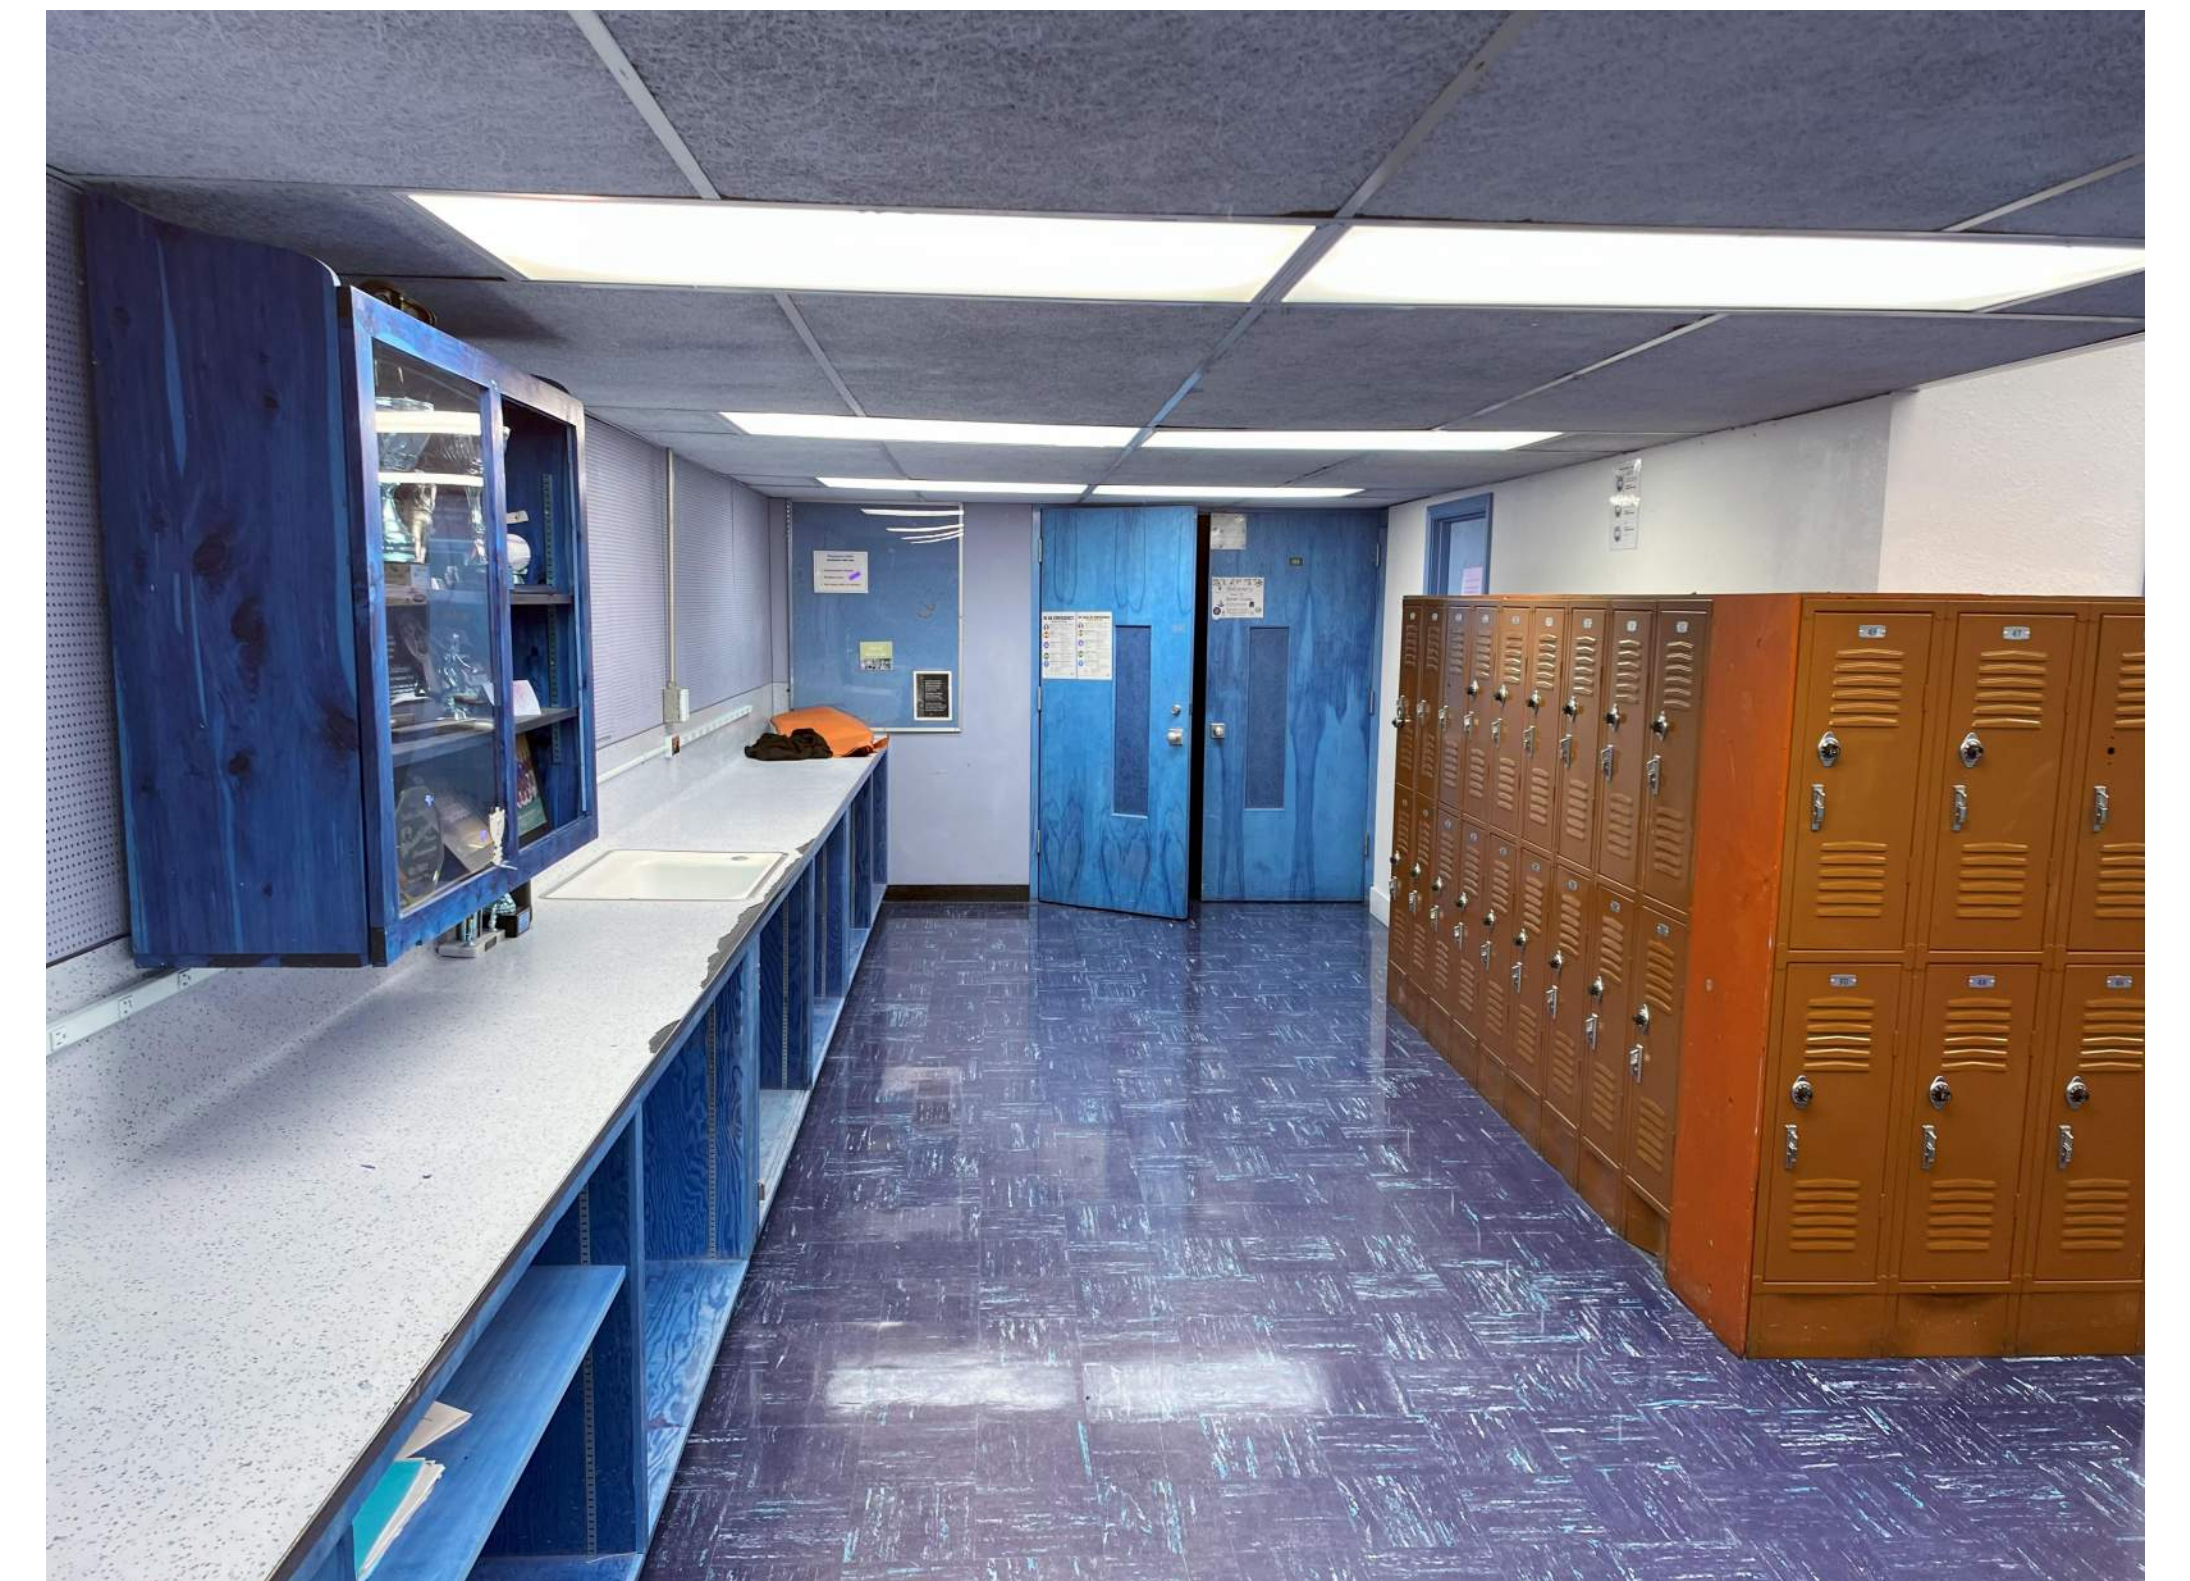
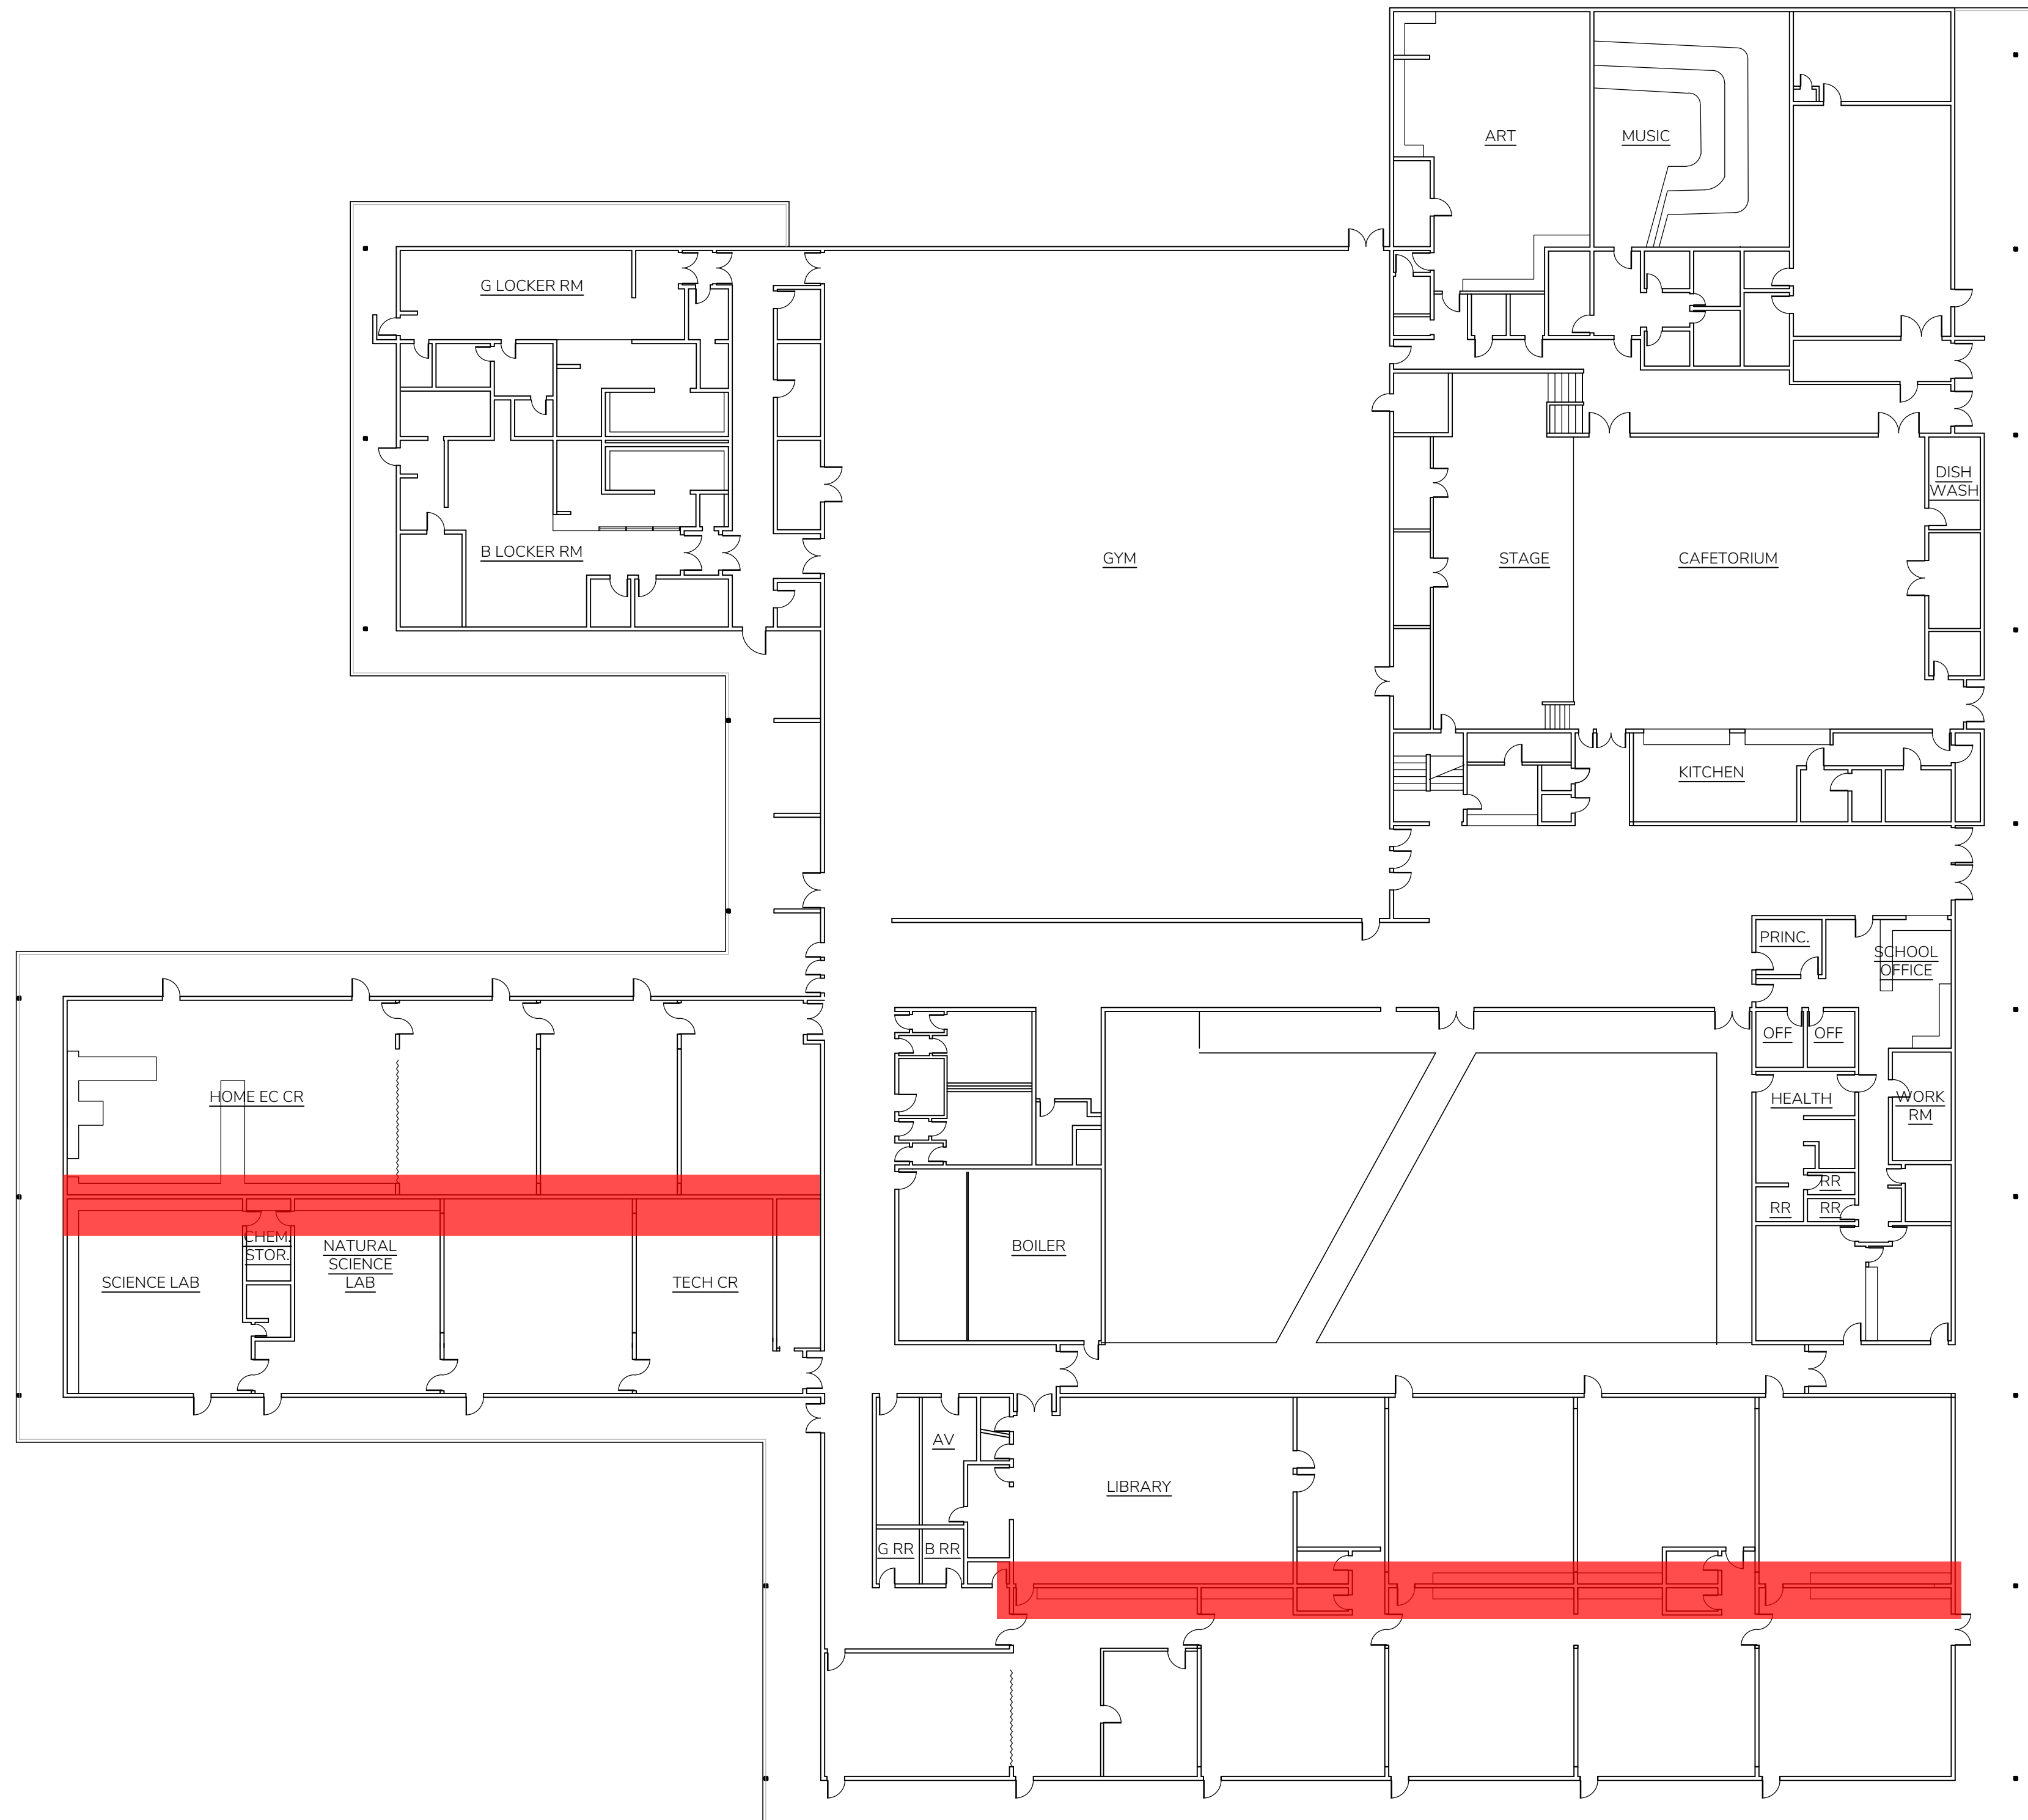
No interior hallway connecting classrooms.
