COMMUNITY BOND ADVISORY COMMITTEE MEETING #3

Central Linn School District
March 19, 2024

FACILITY ASSESSMENT EXECUTIVE SUMMARY

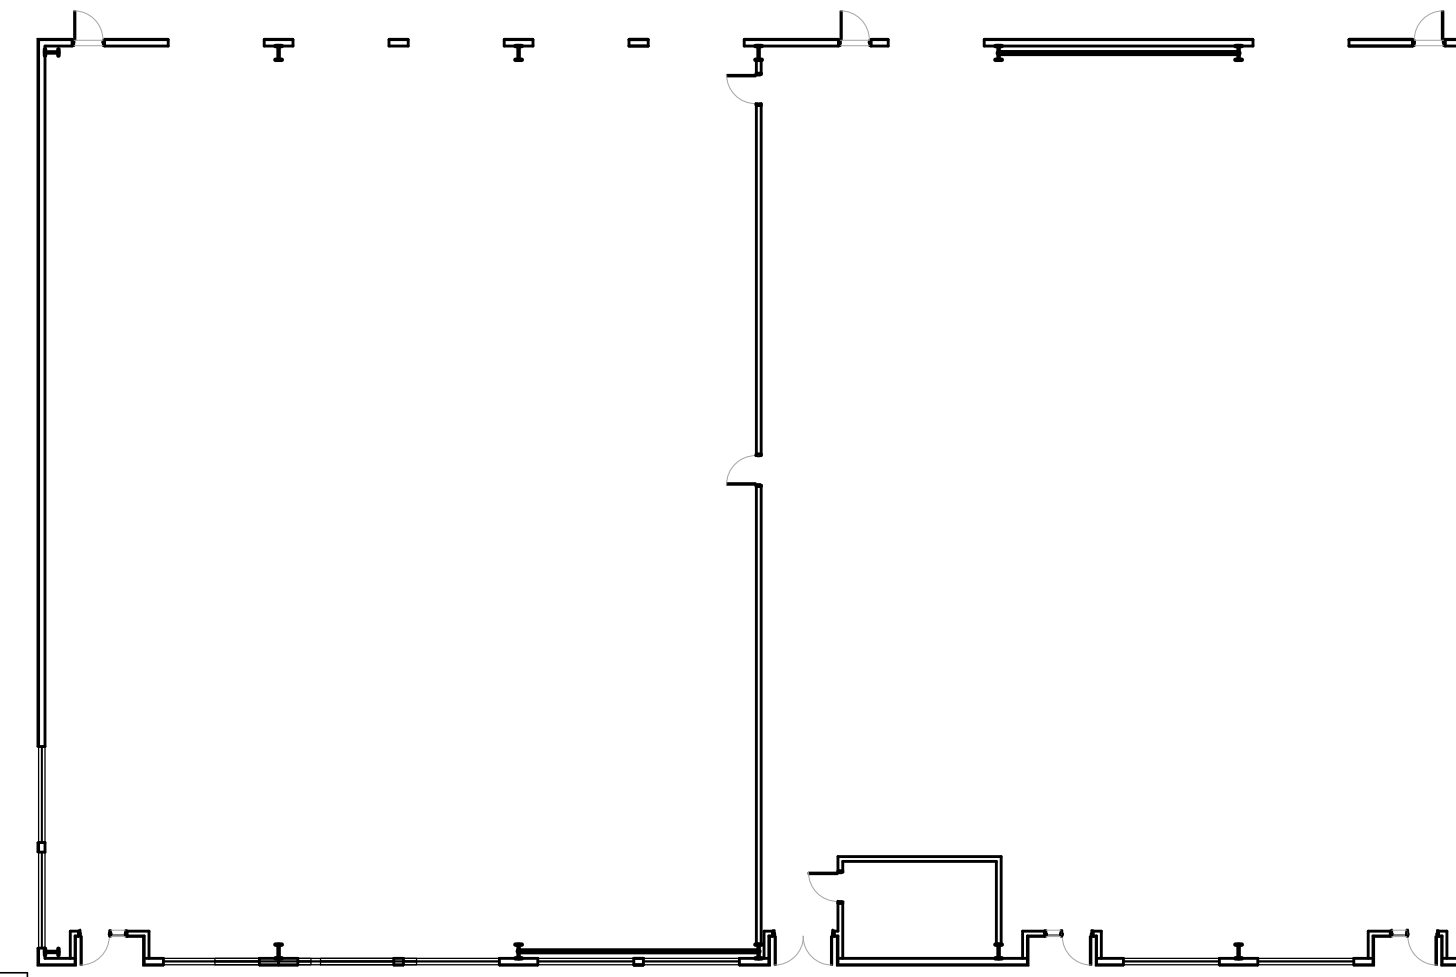
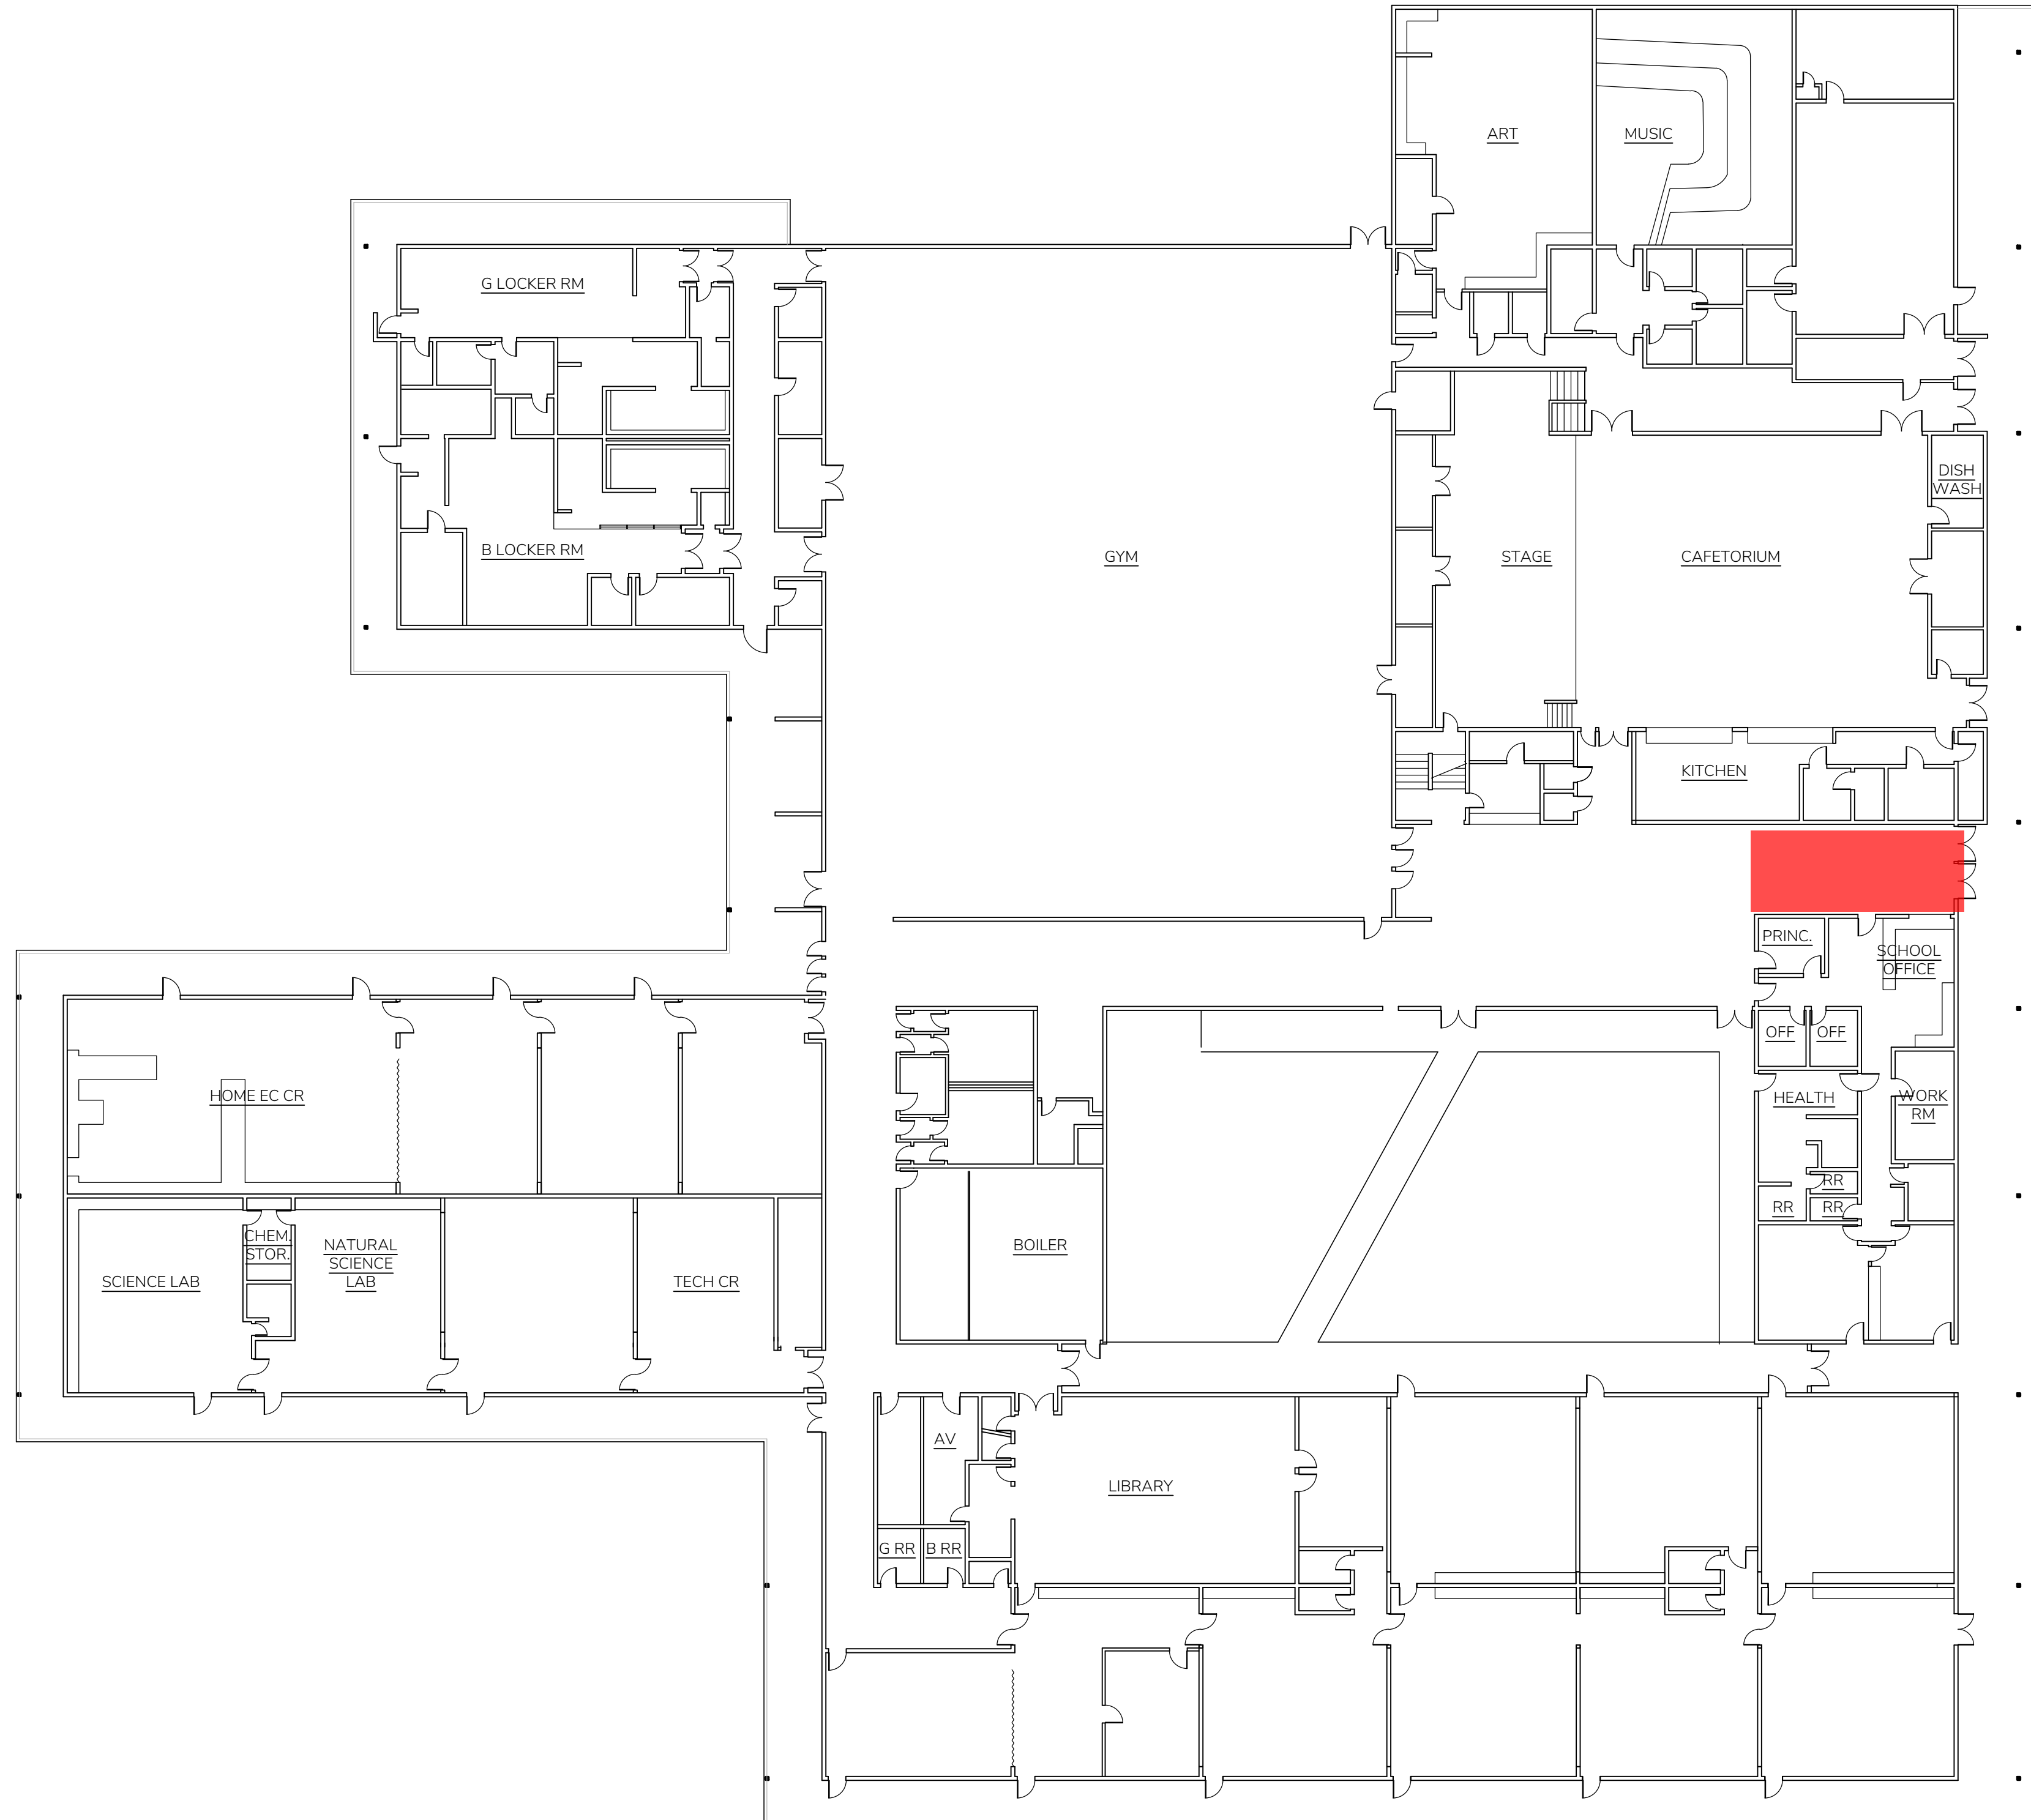
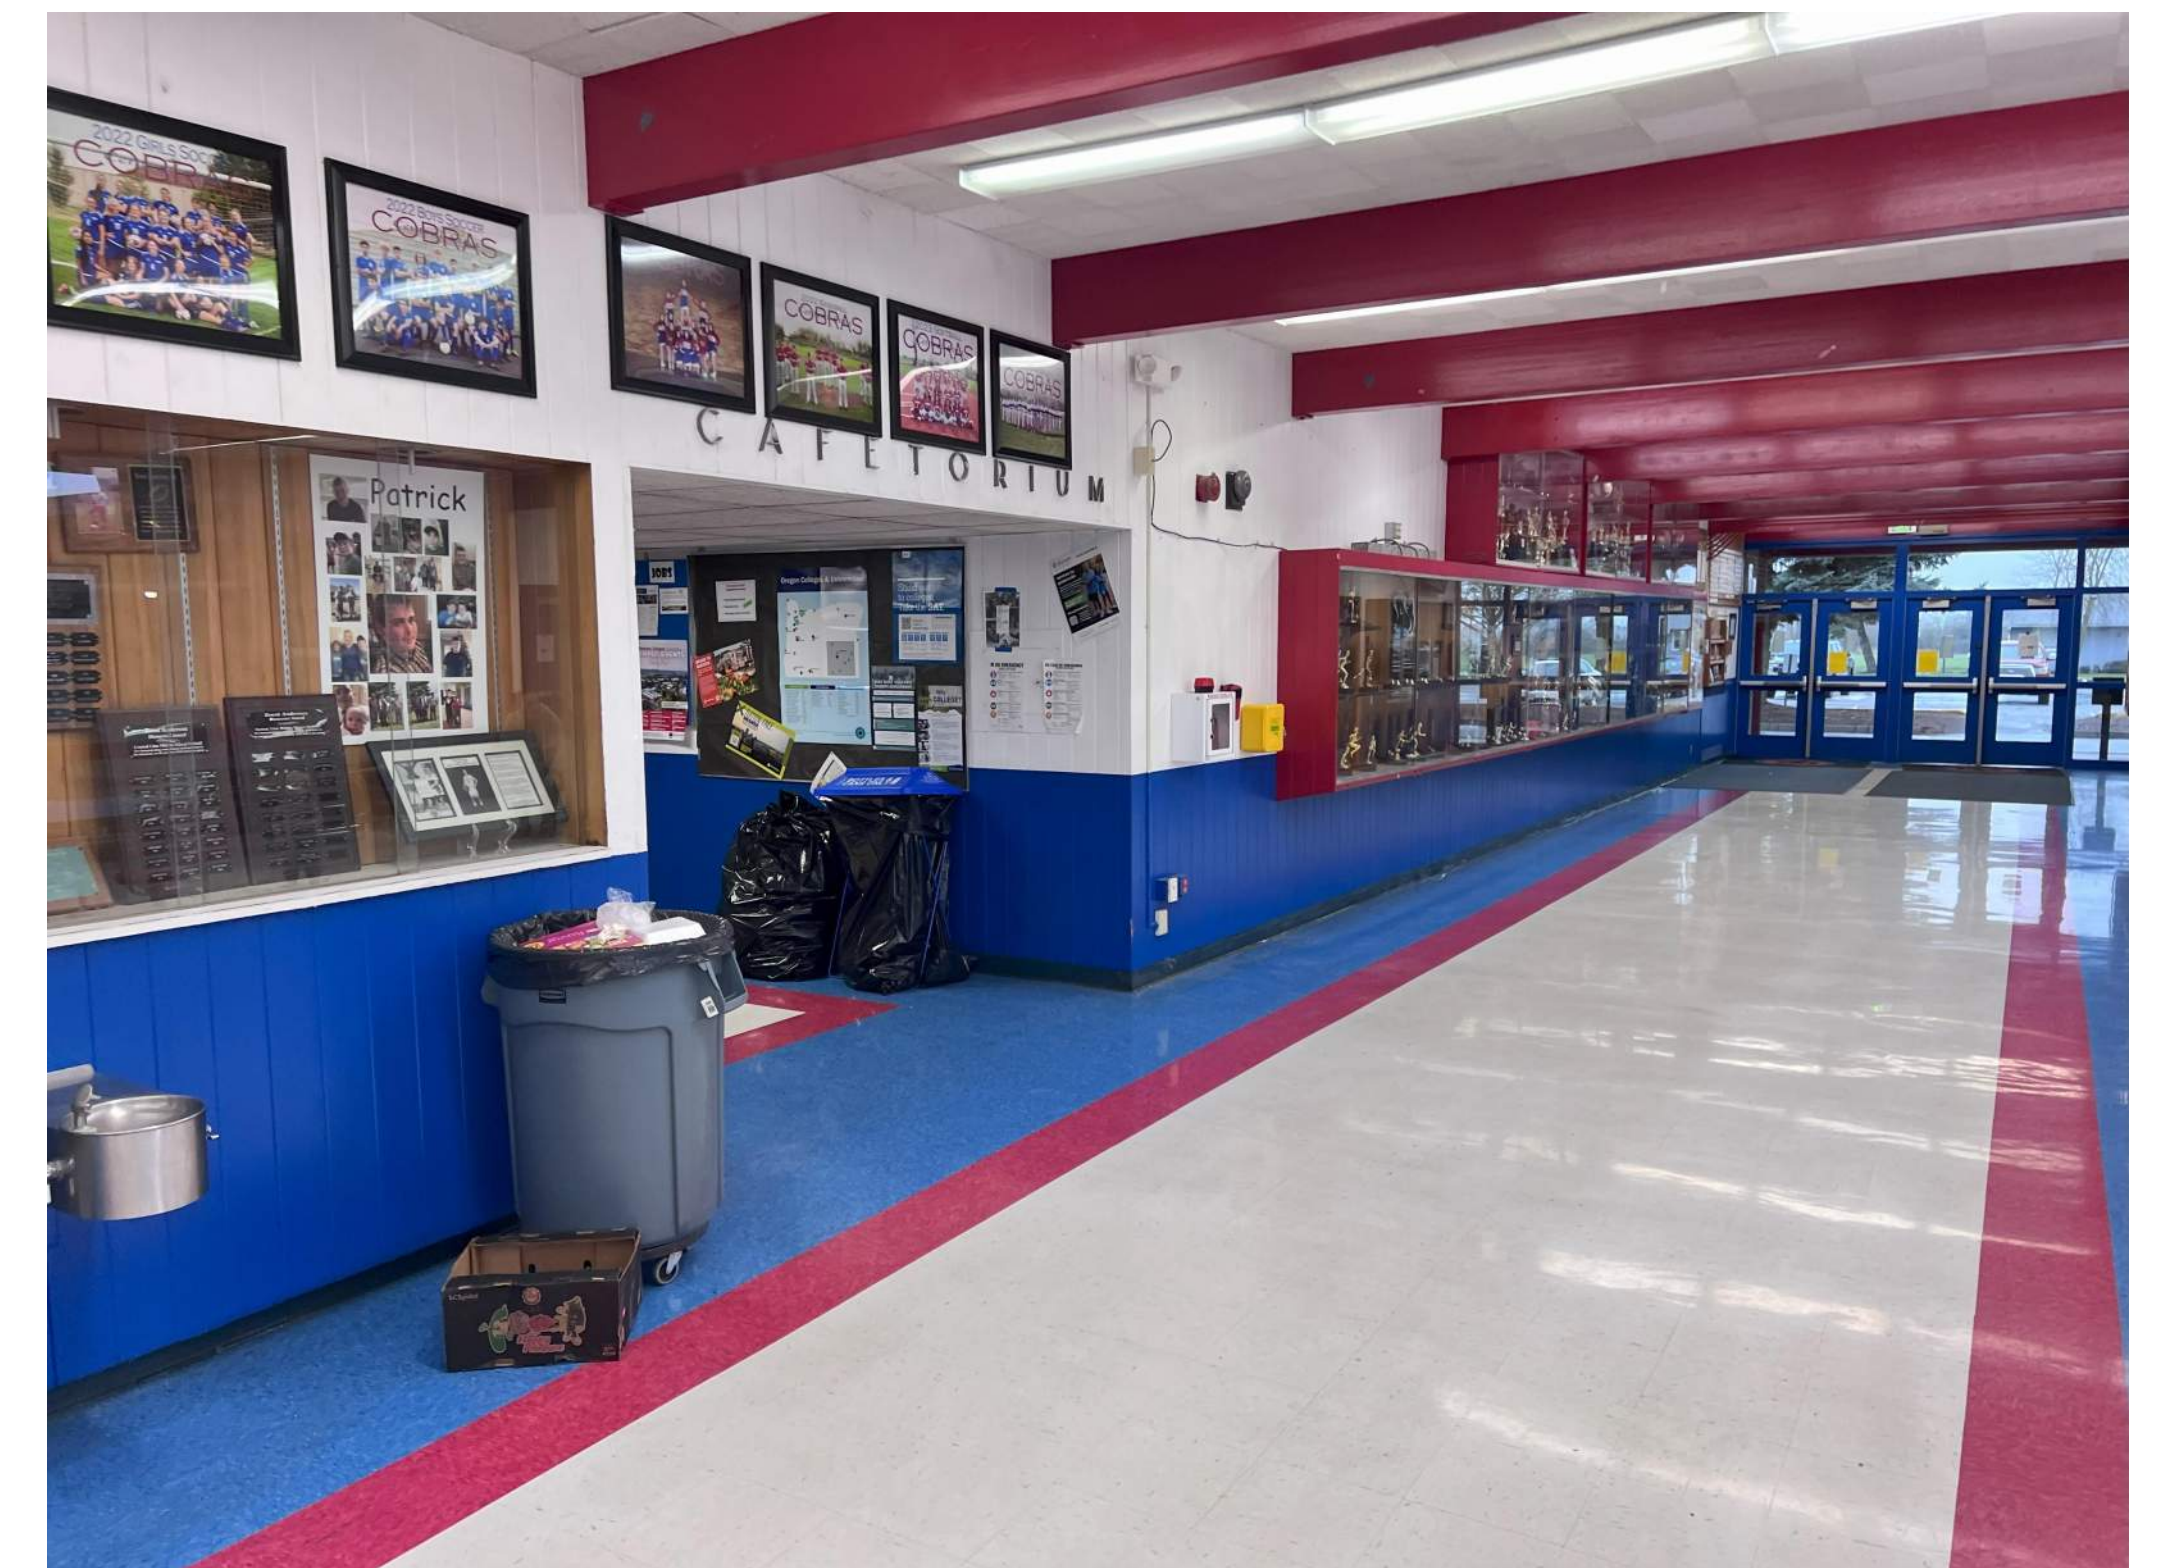
No secure vestibule at lobby.

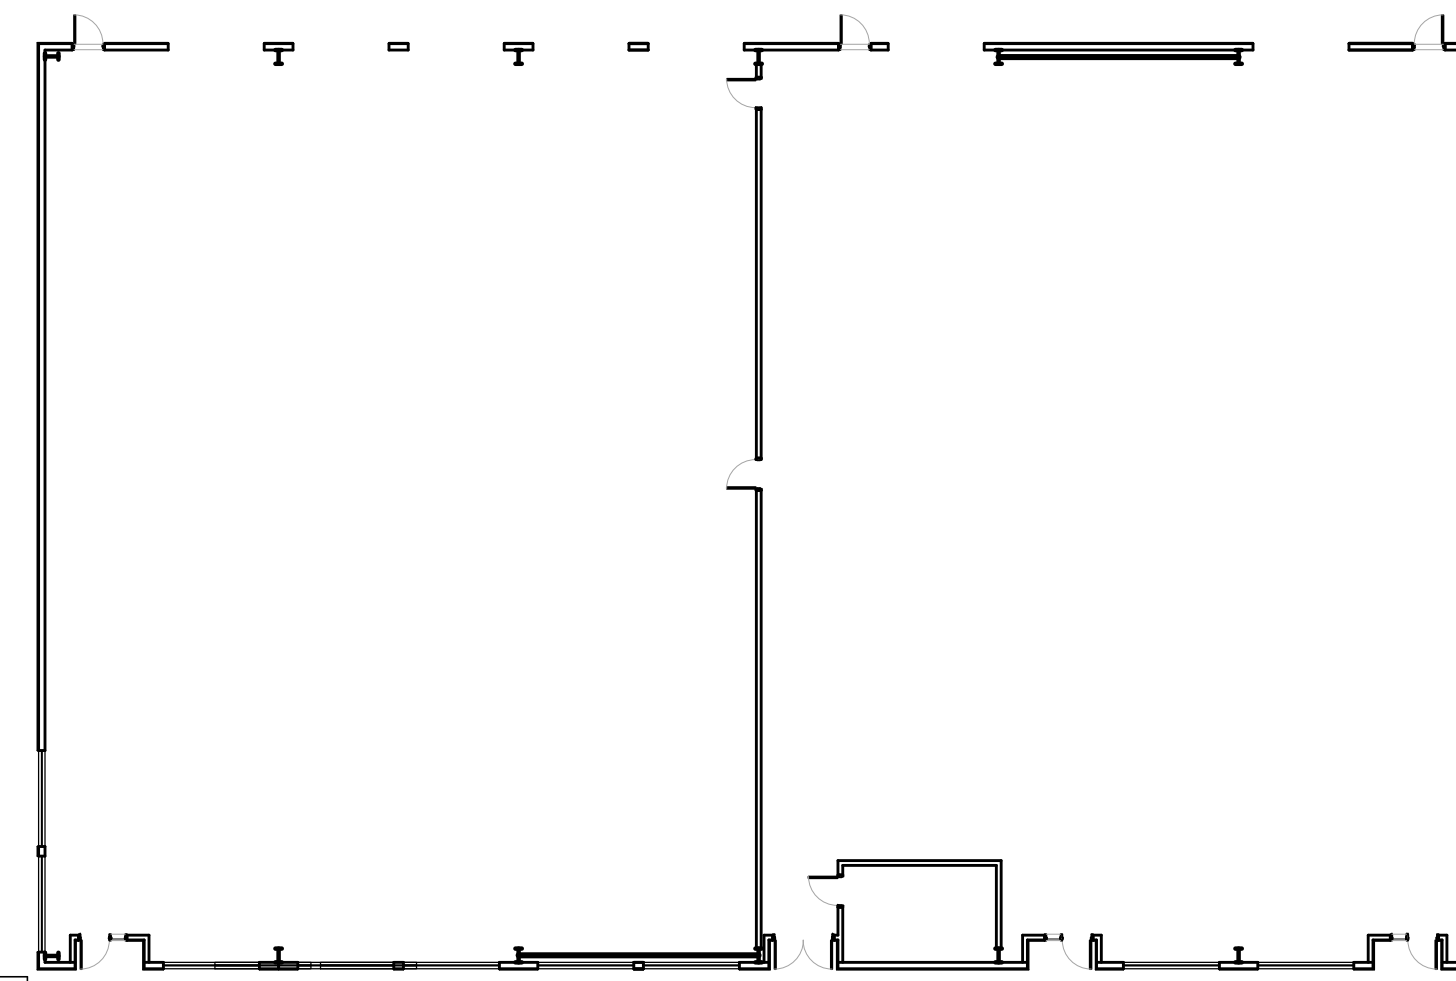
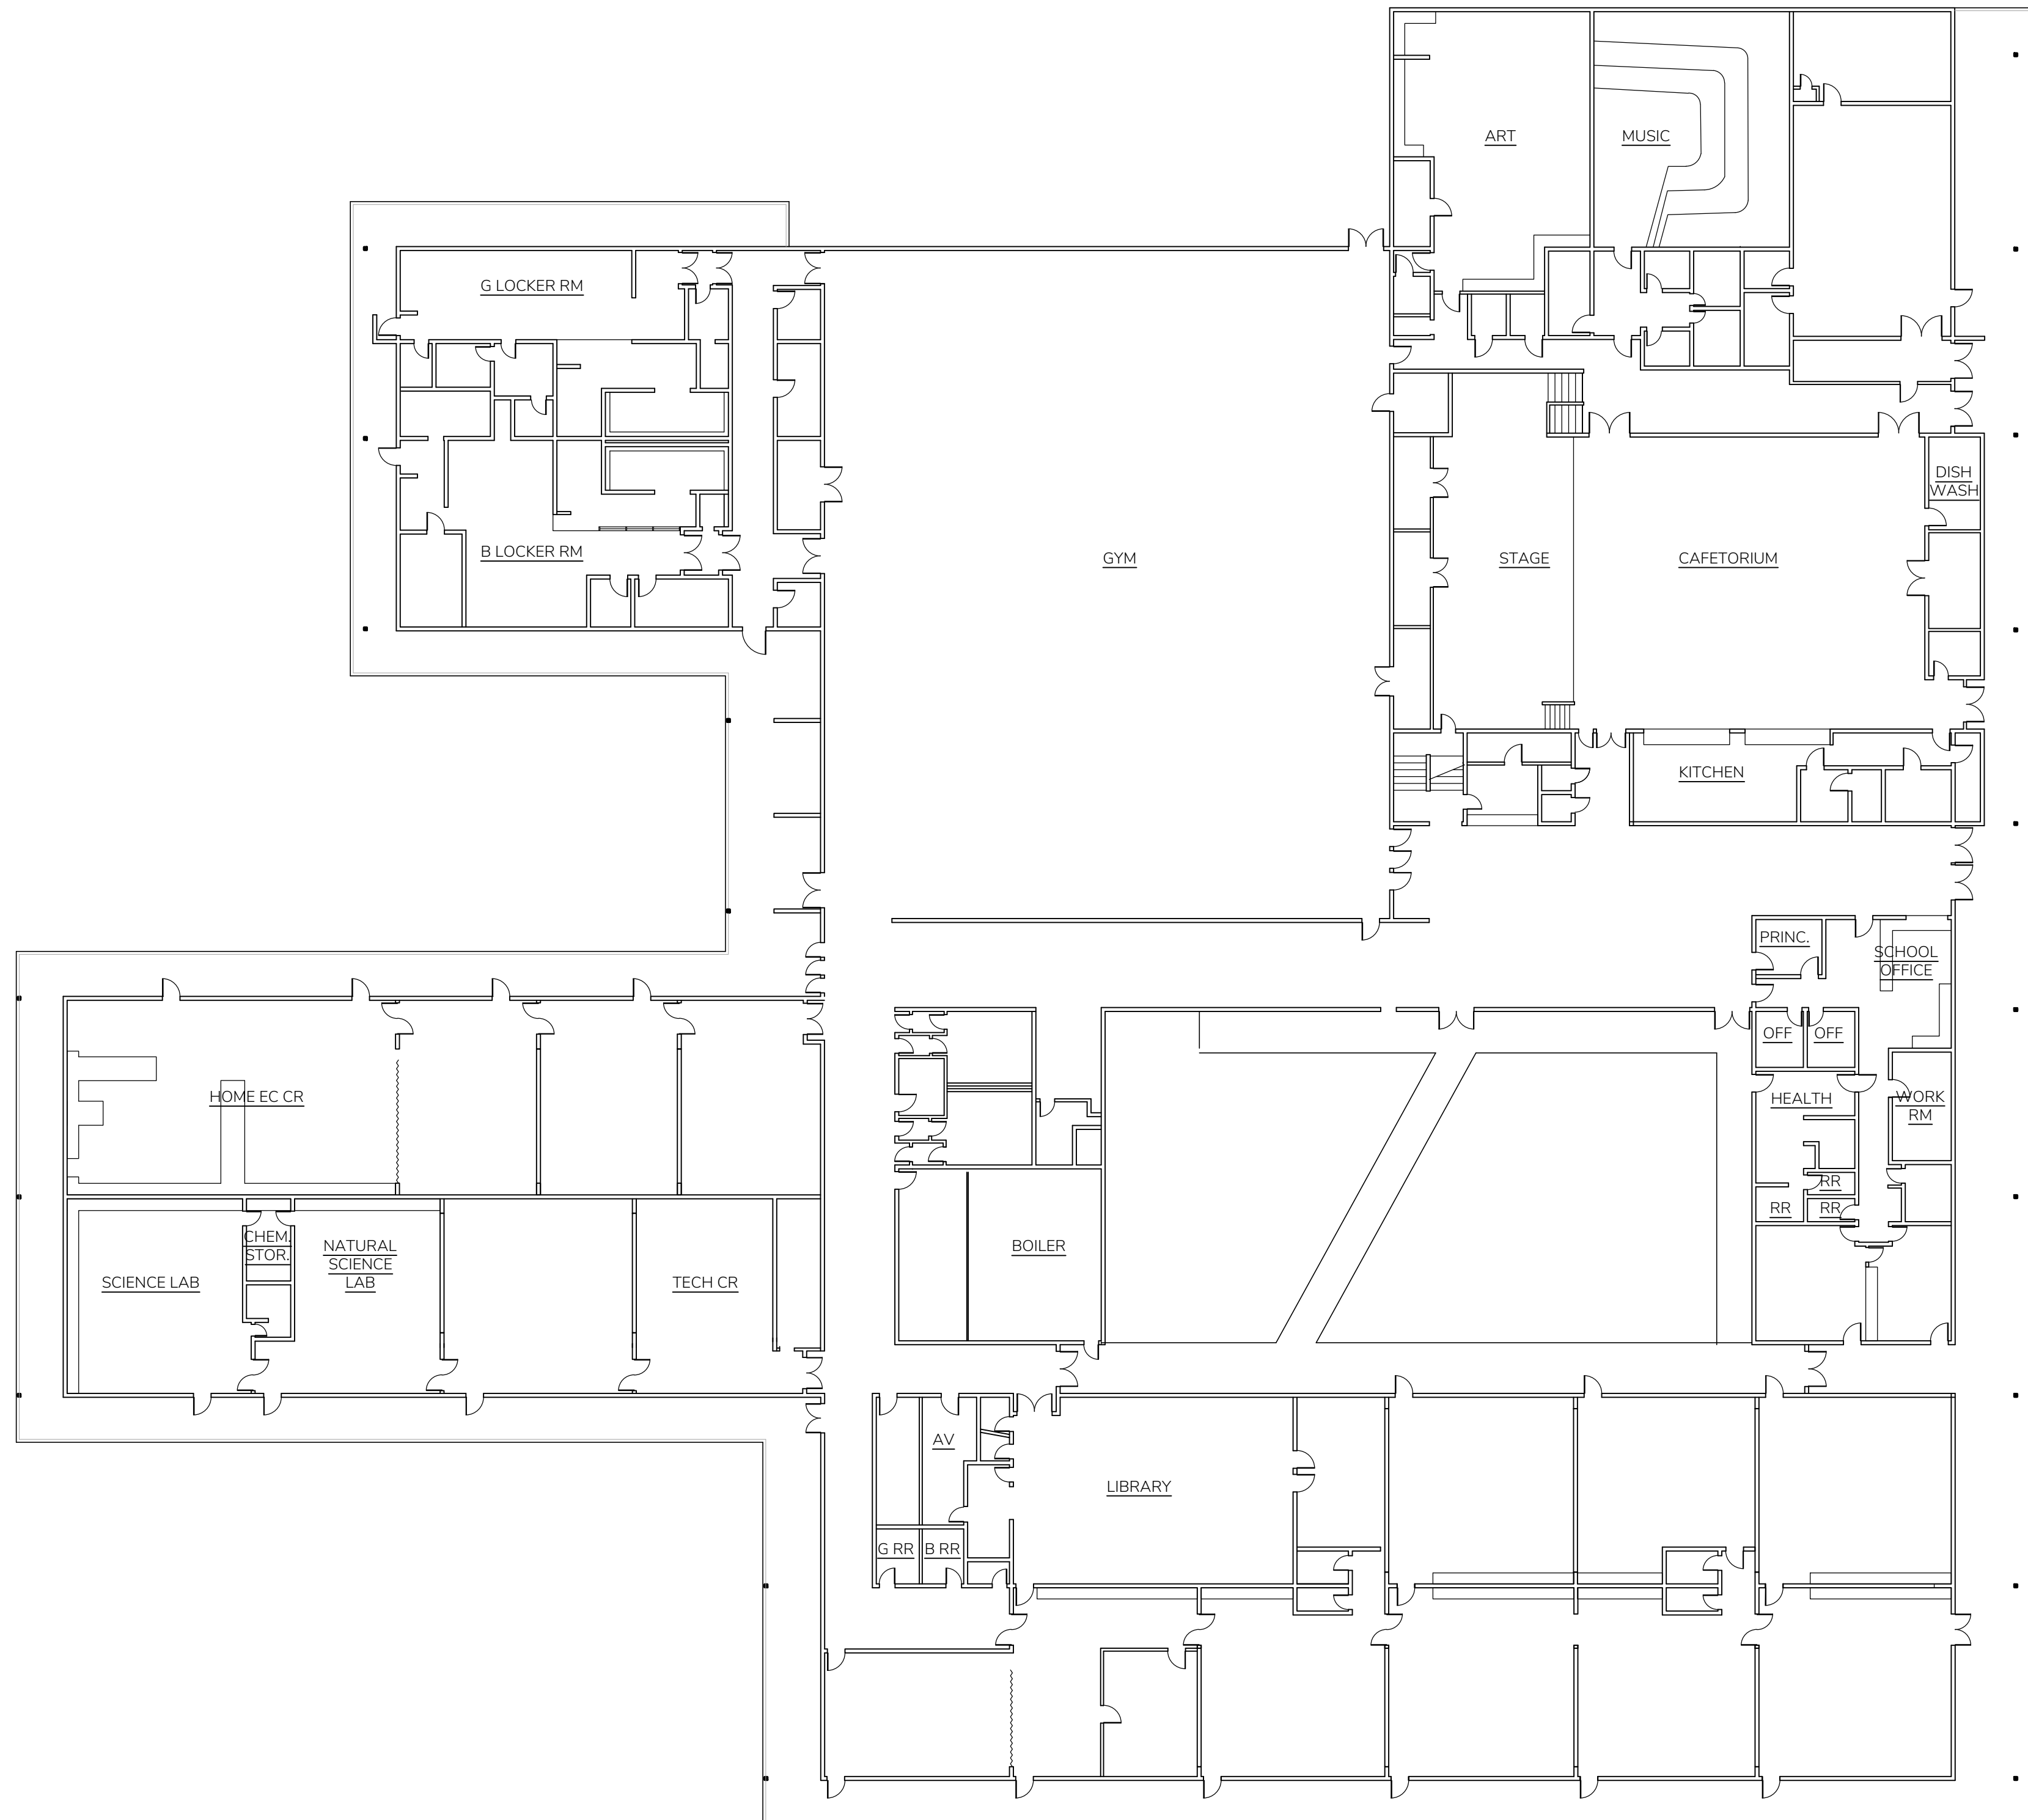
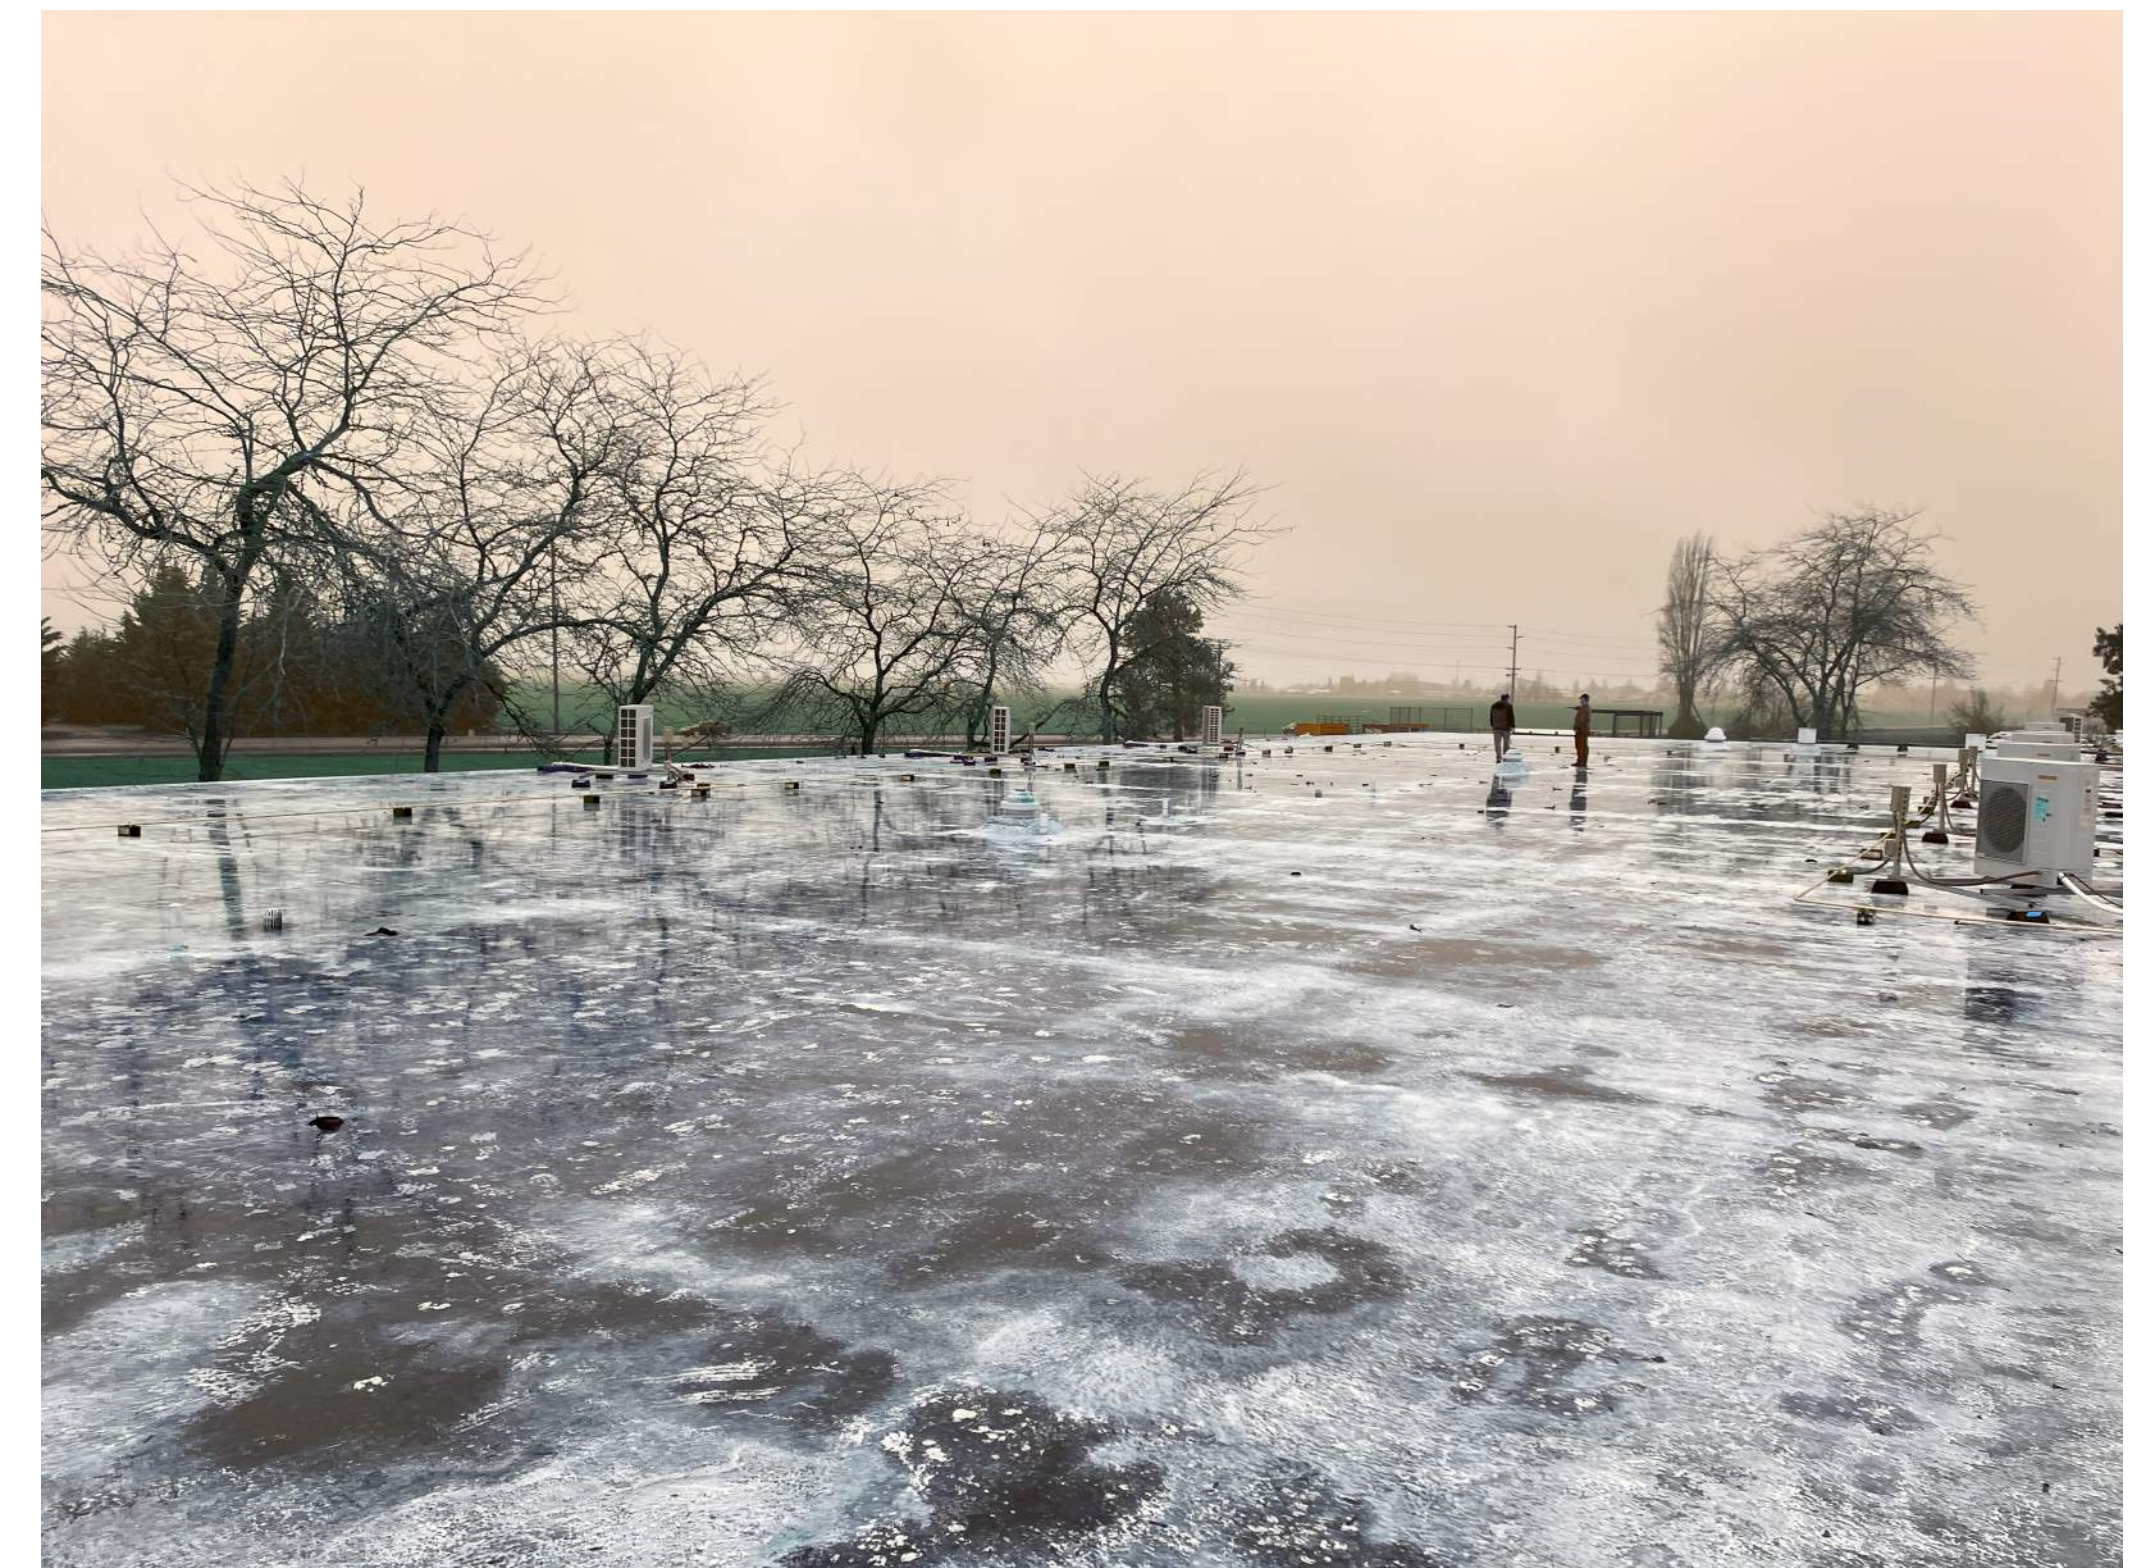
Spray-on roof system is difficult to repair and dangerously slippery.
