COMMUNITY BOND ADVISORY COMMITTEE MEETING #3

Central Linn School District
March 19, 2024

FACILITY ASSESSMENT EXECUTIVE SUMMARY

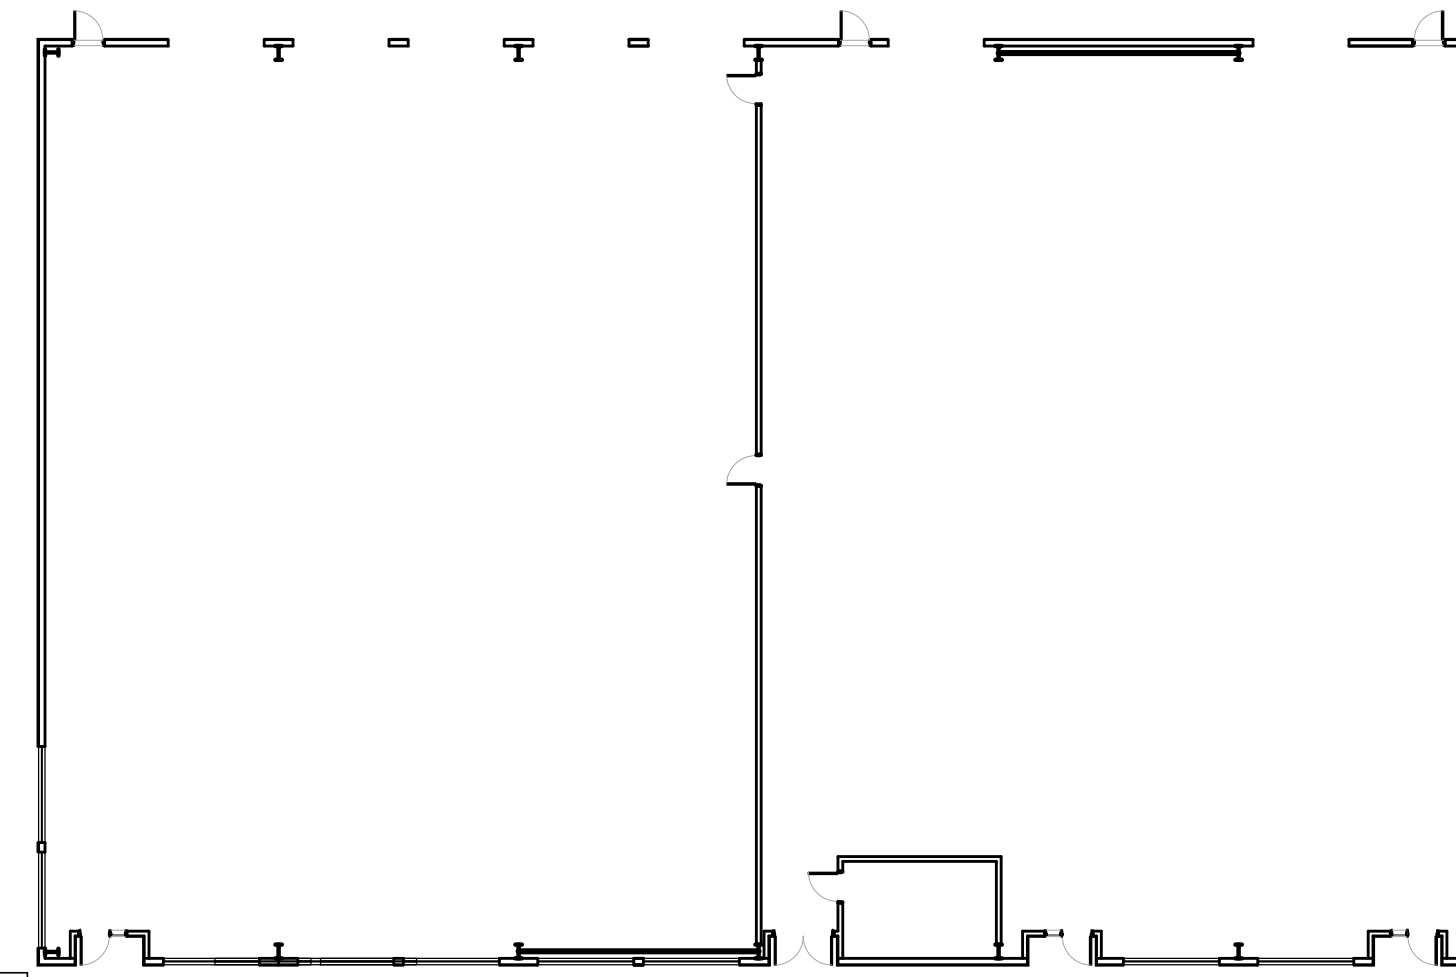
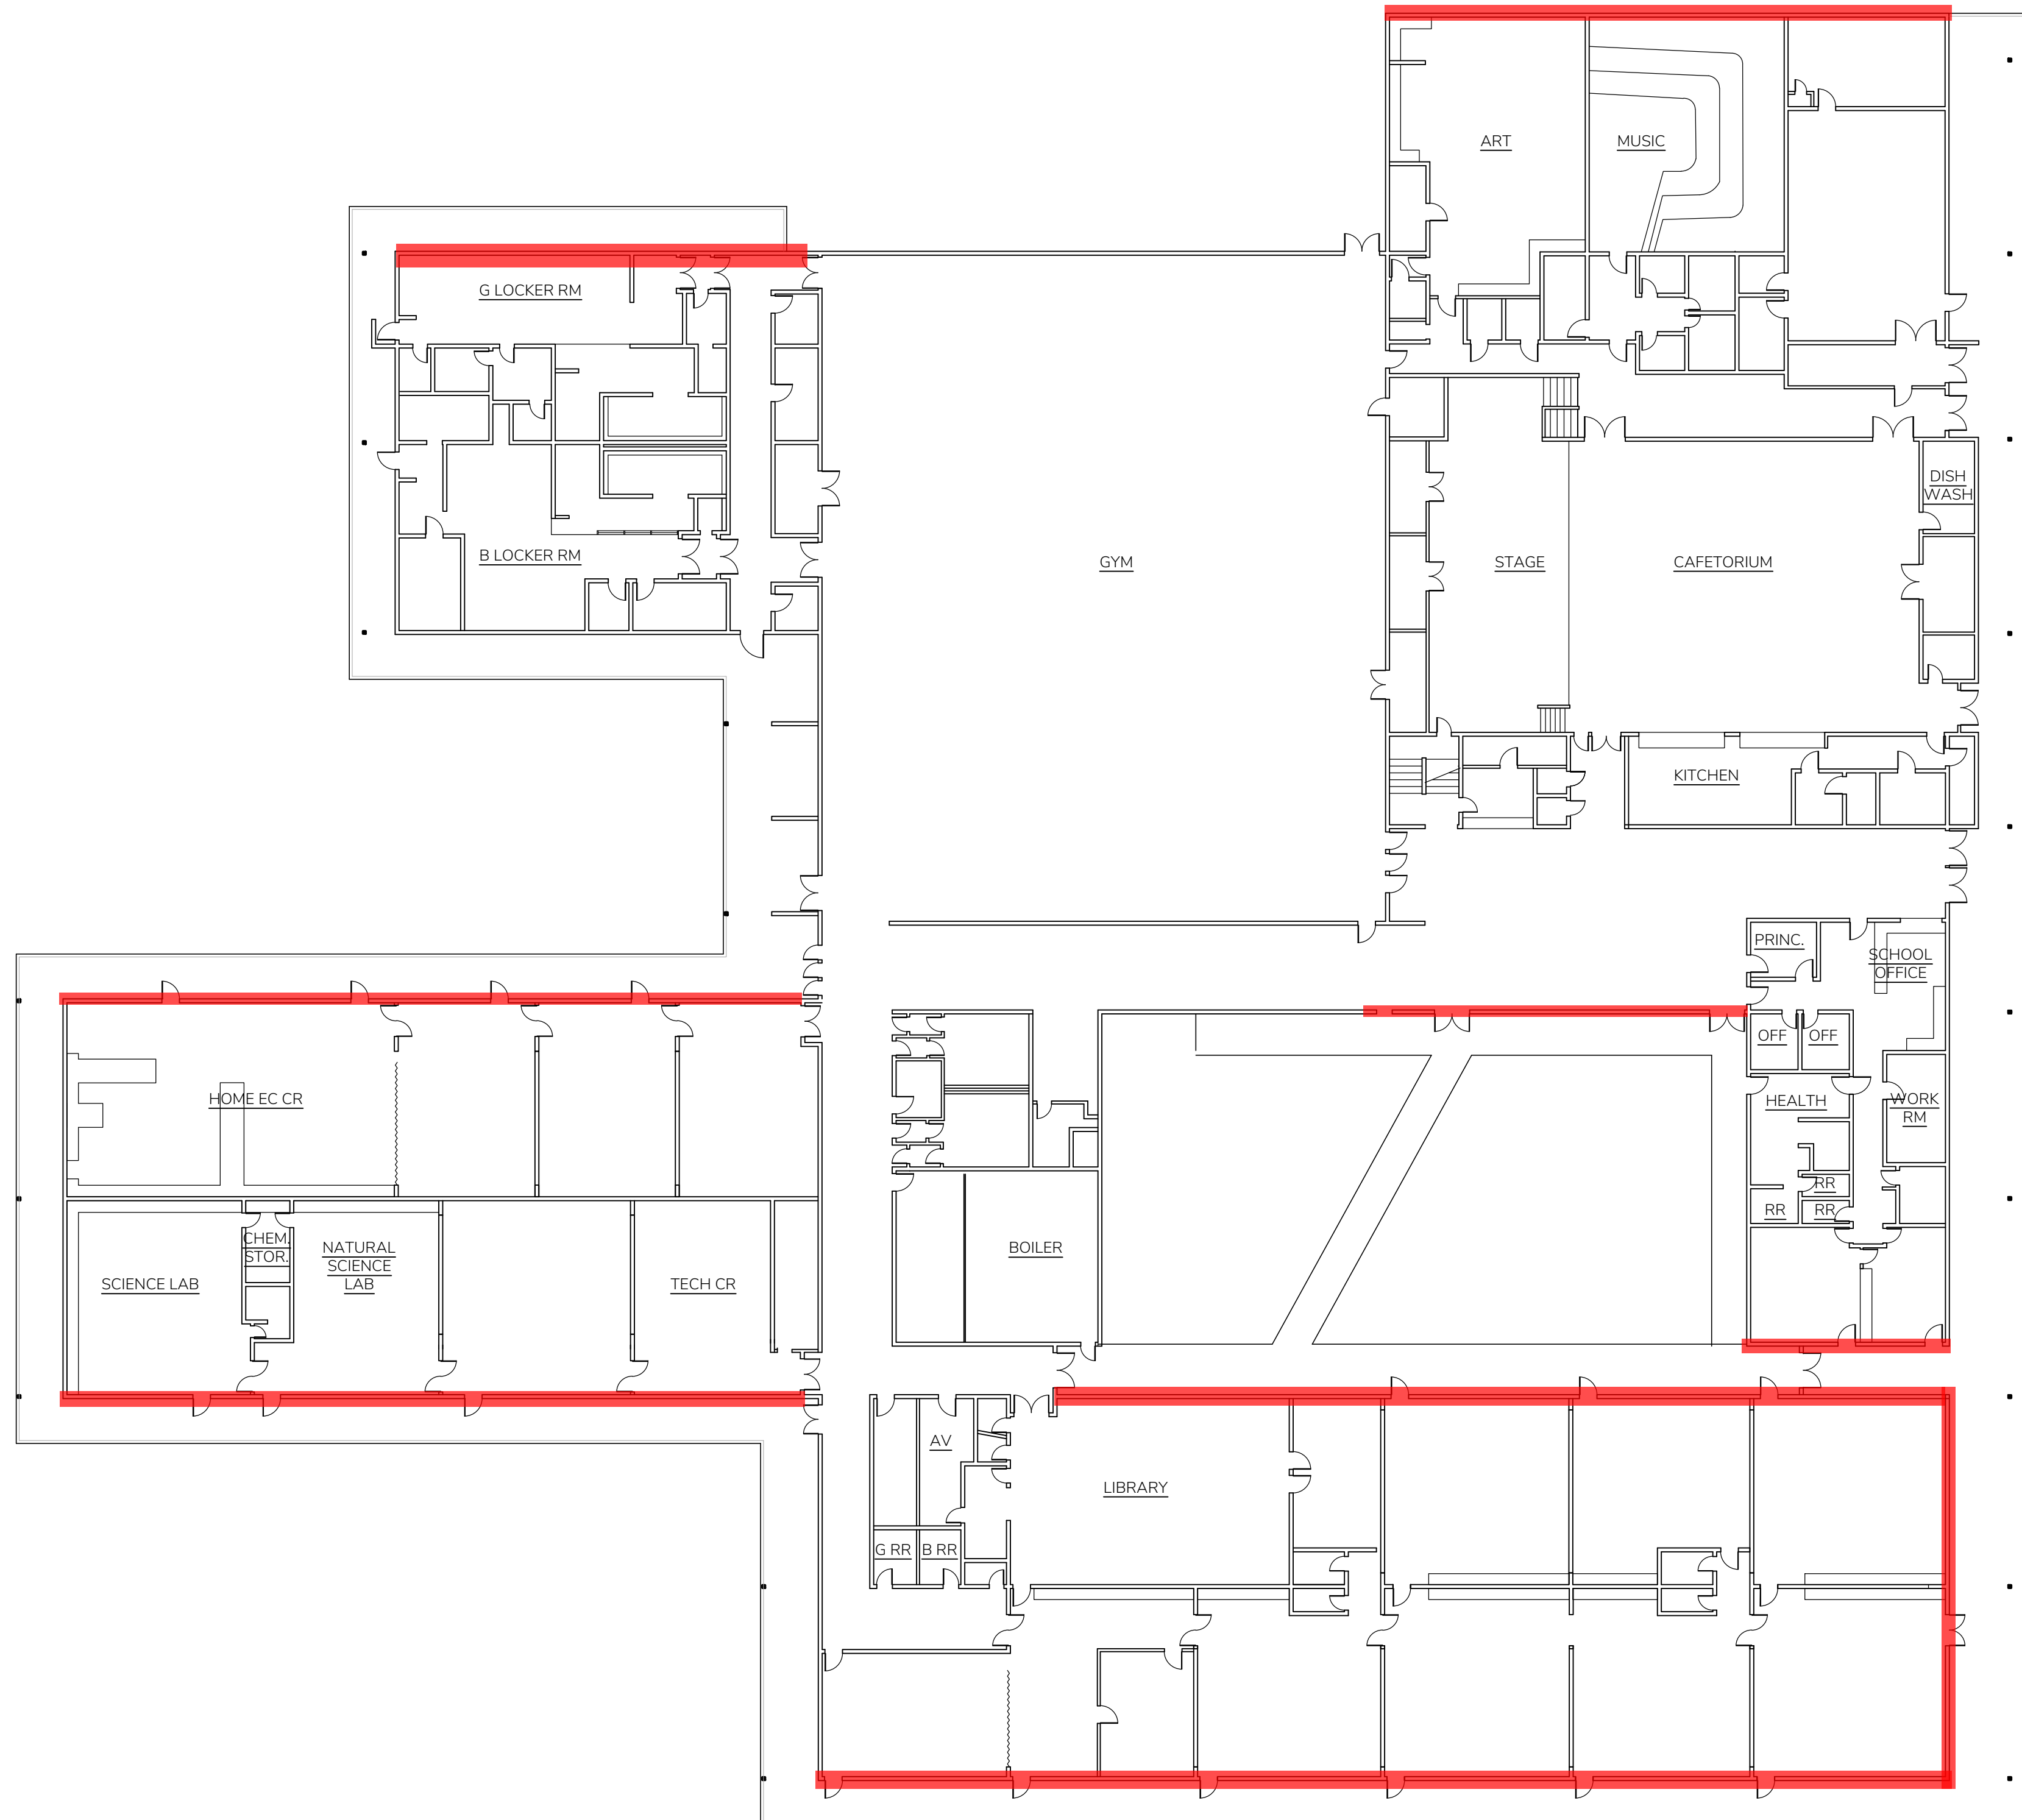
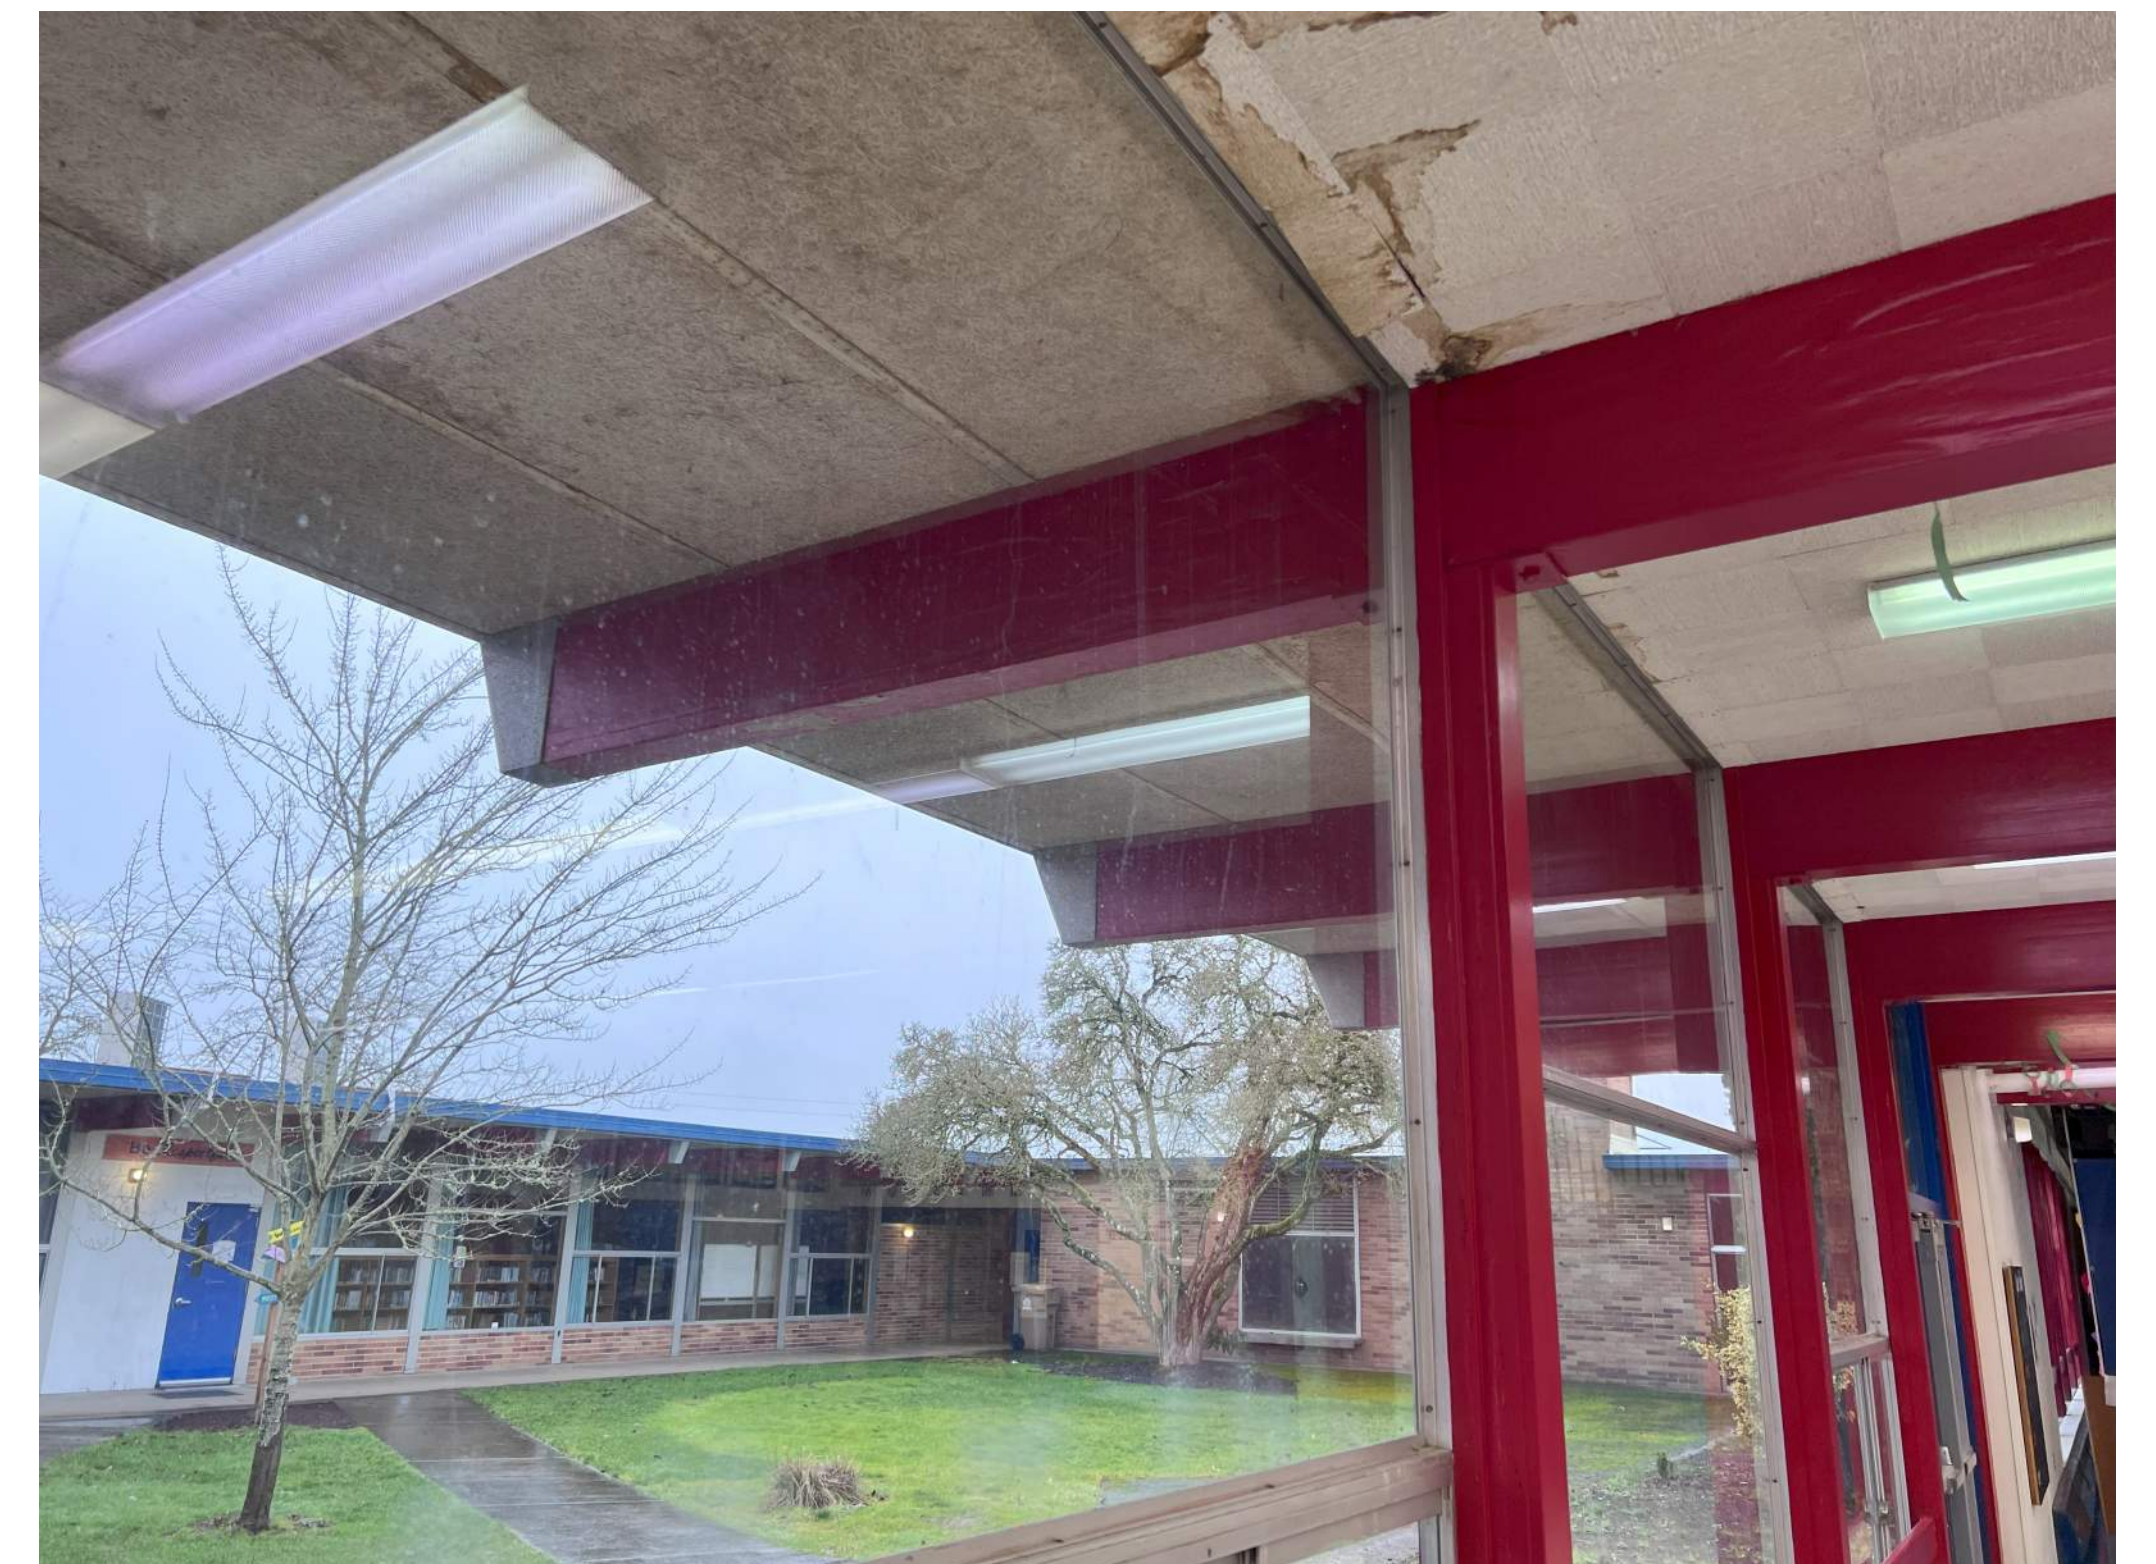
Original windows are single pane, non-thermally broken.

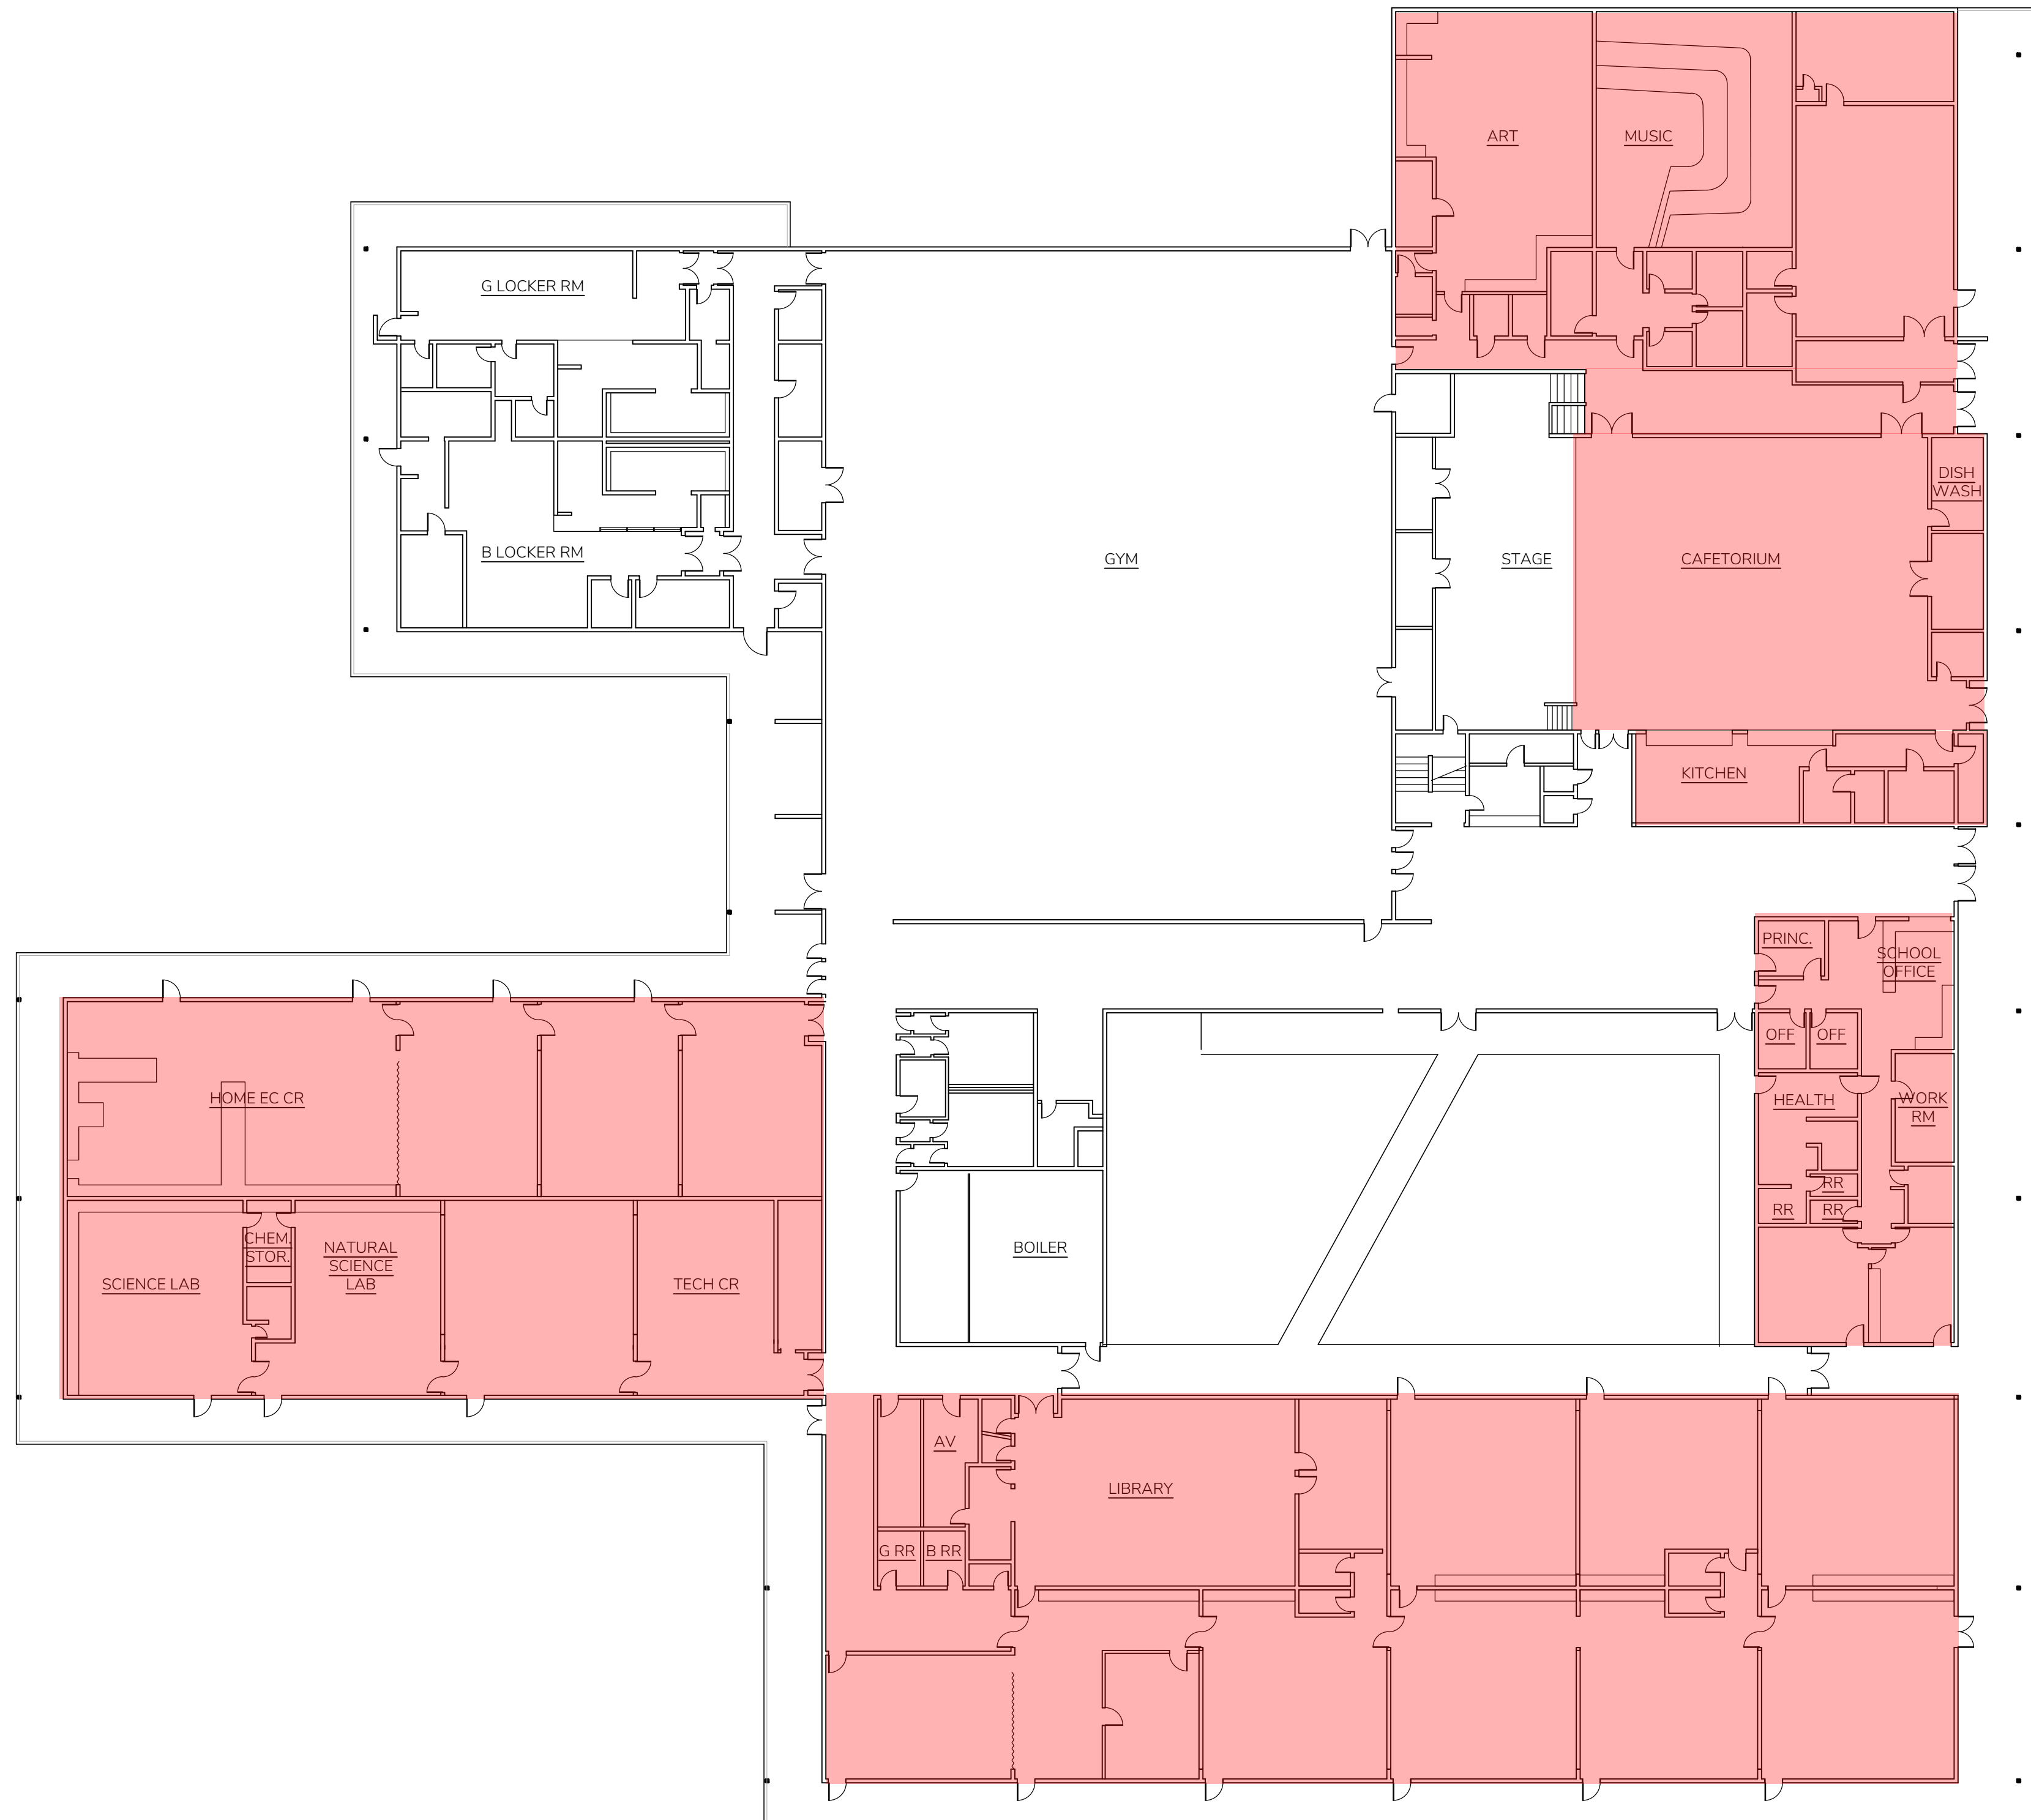
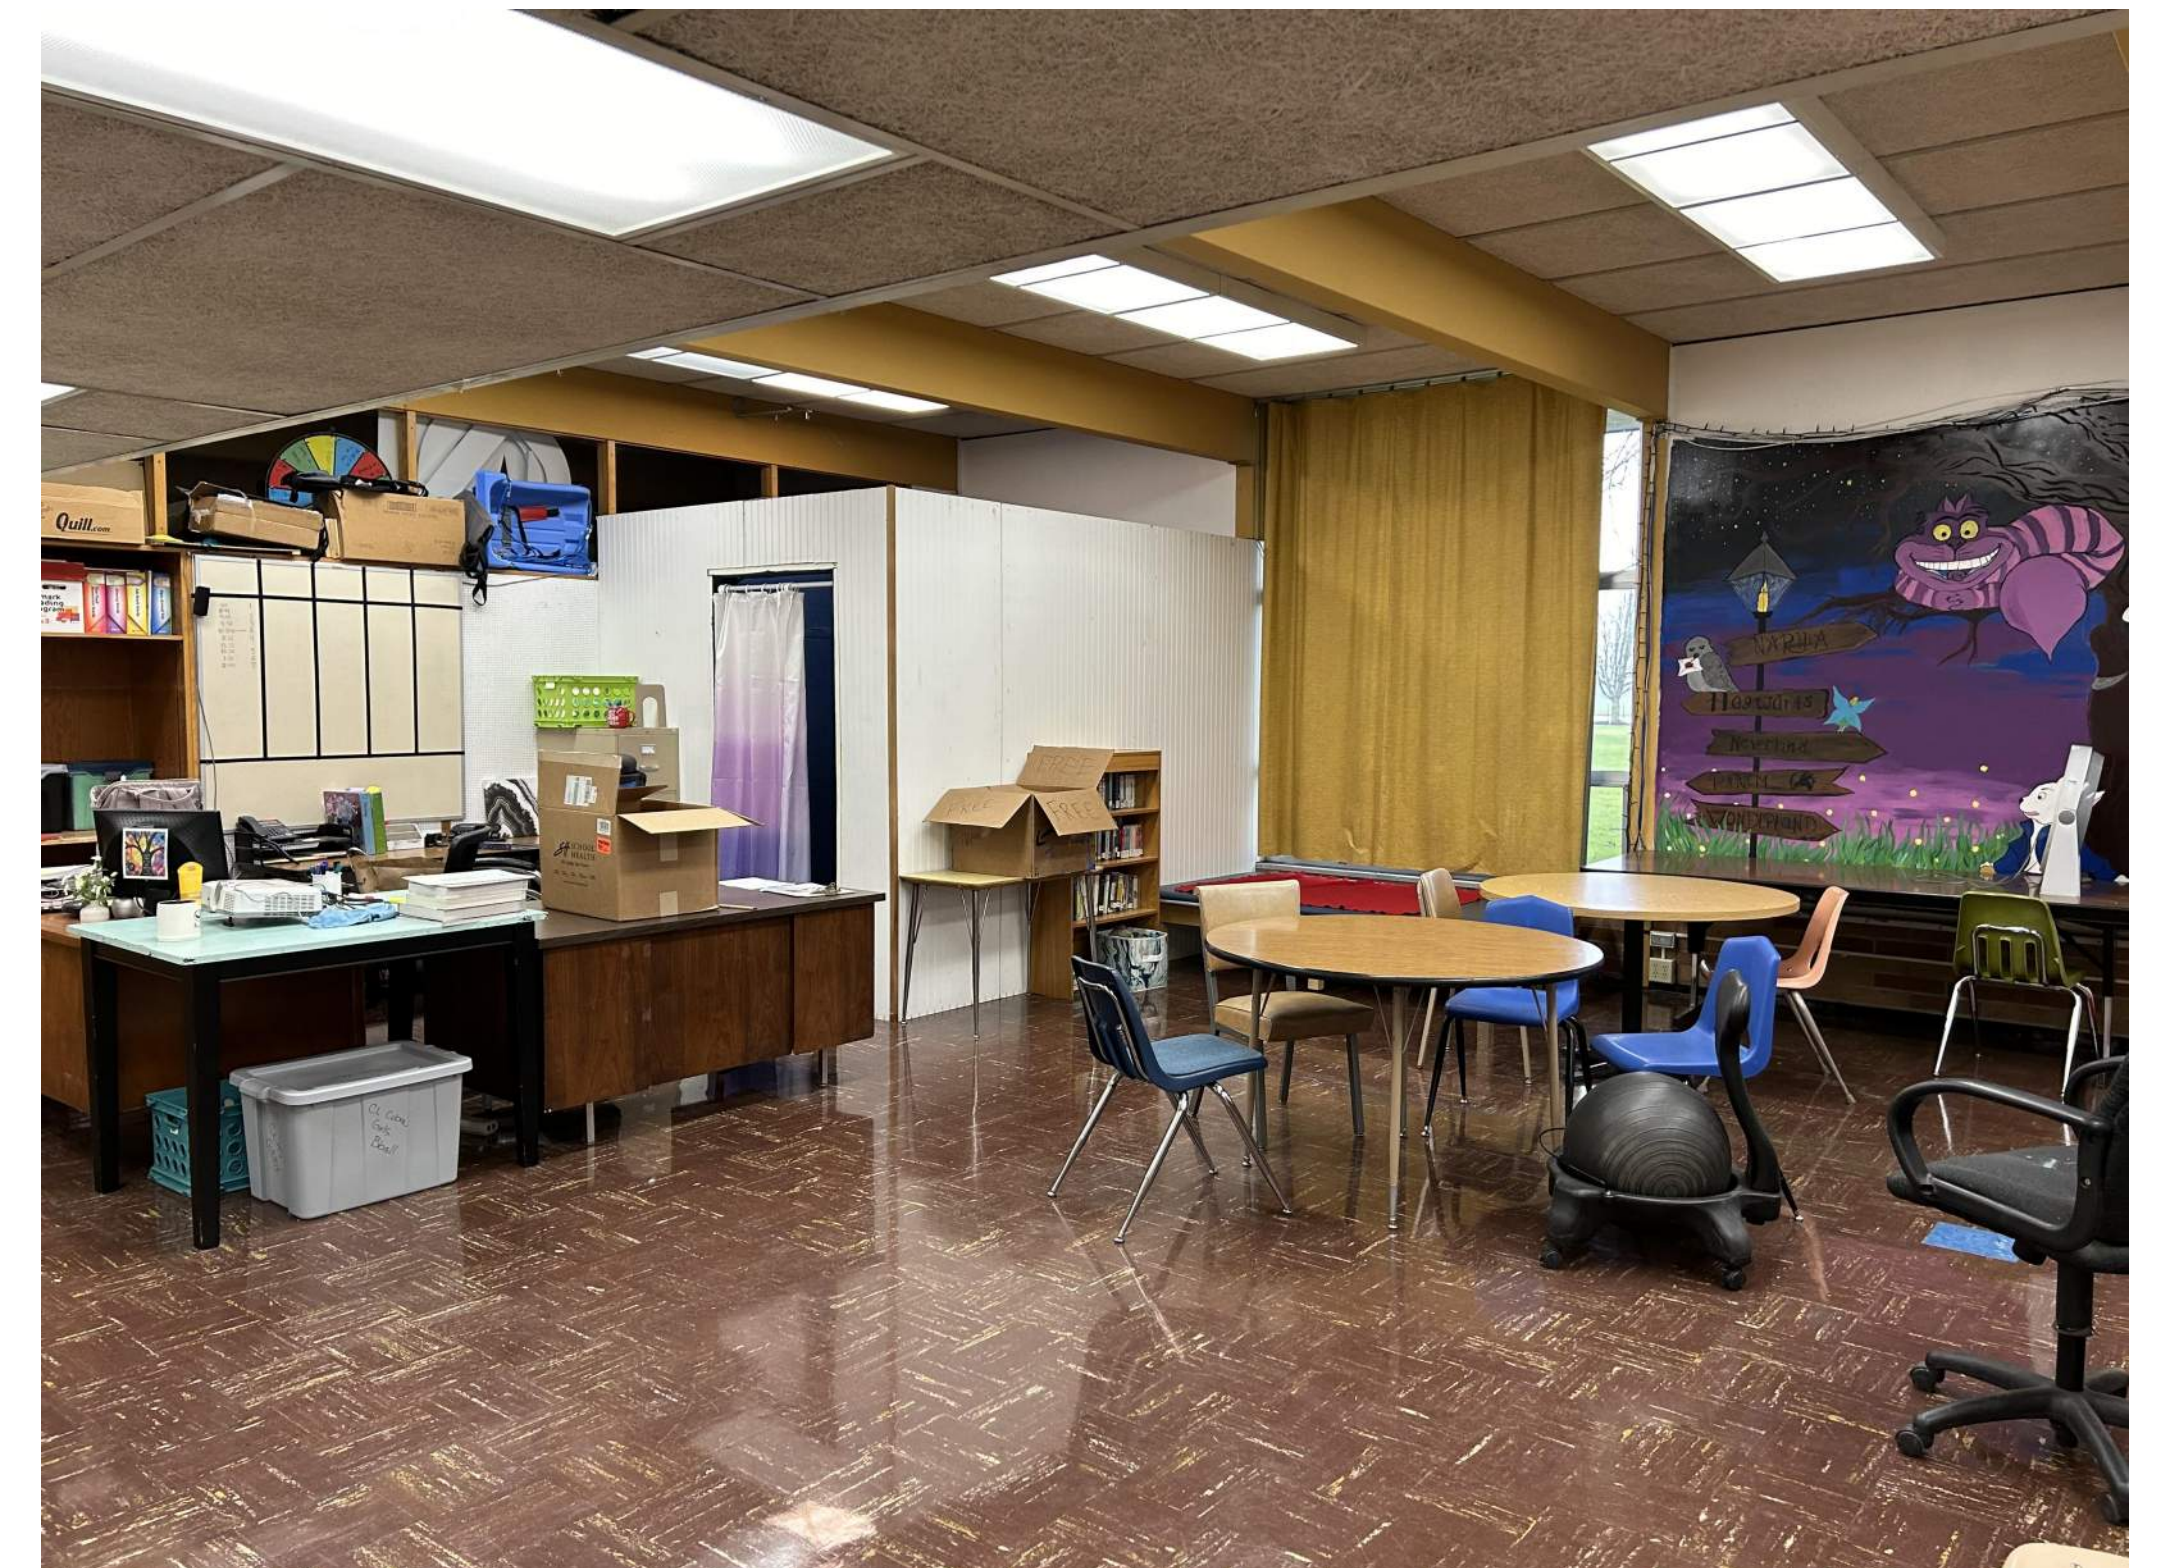
Original flooring through most of the building probably has asbestos.
