COMMUNITY BOND ADVISORY COMMITTEE MEETING #3

Central Linn School District
March 19, 2024

FACILITY ASSESSMENT EXECUTIVE SUMMARY

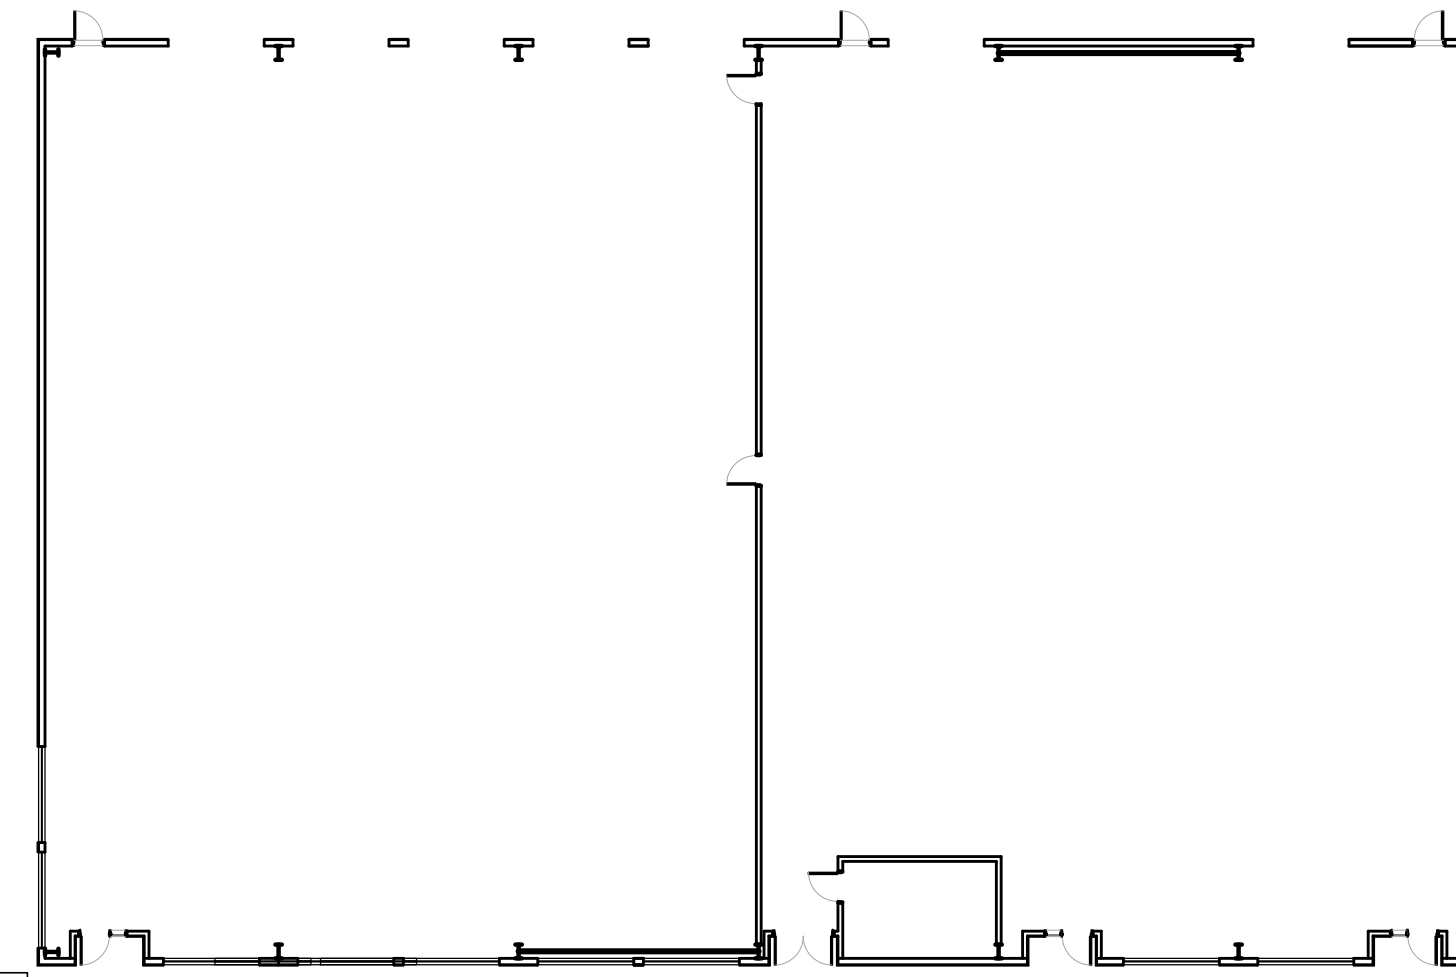
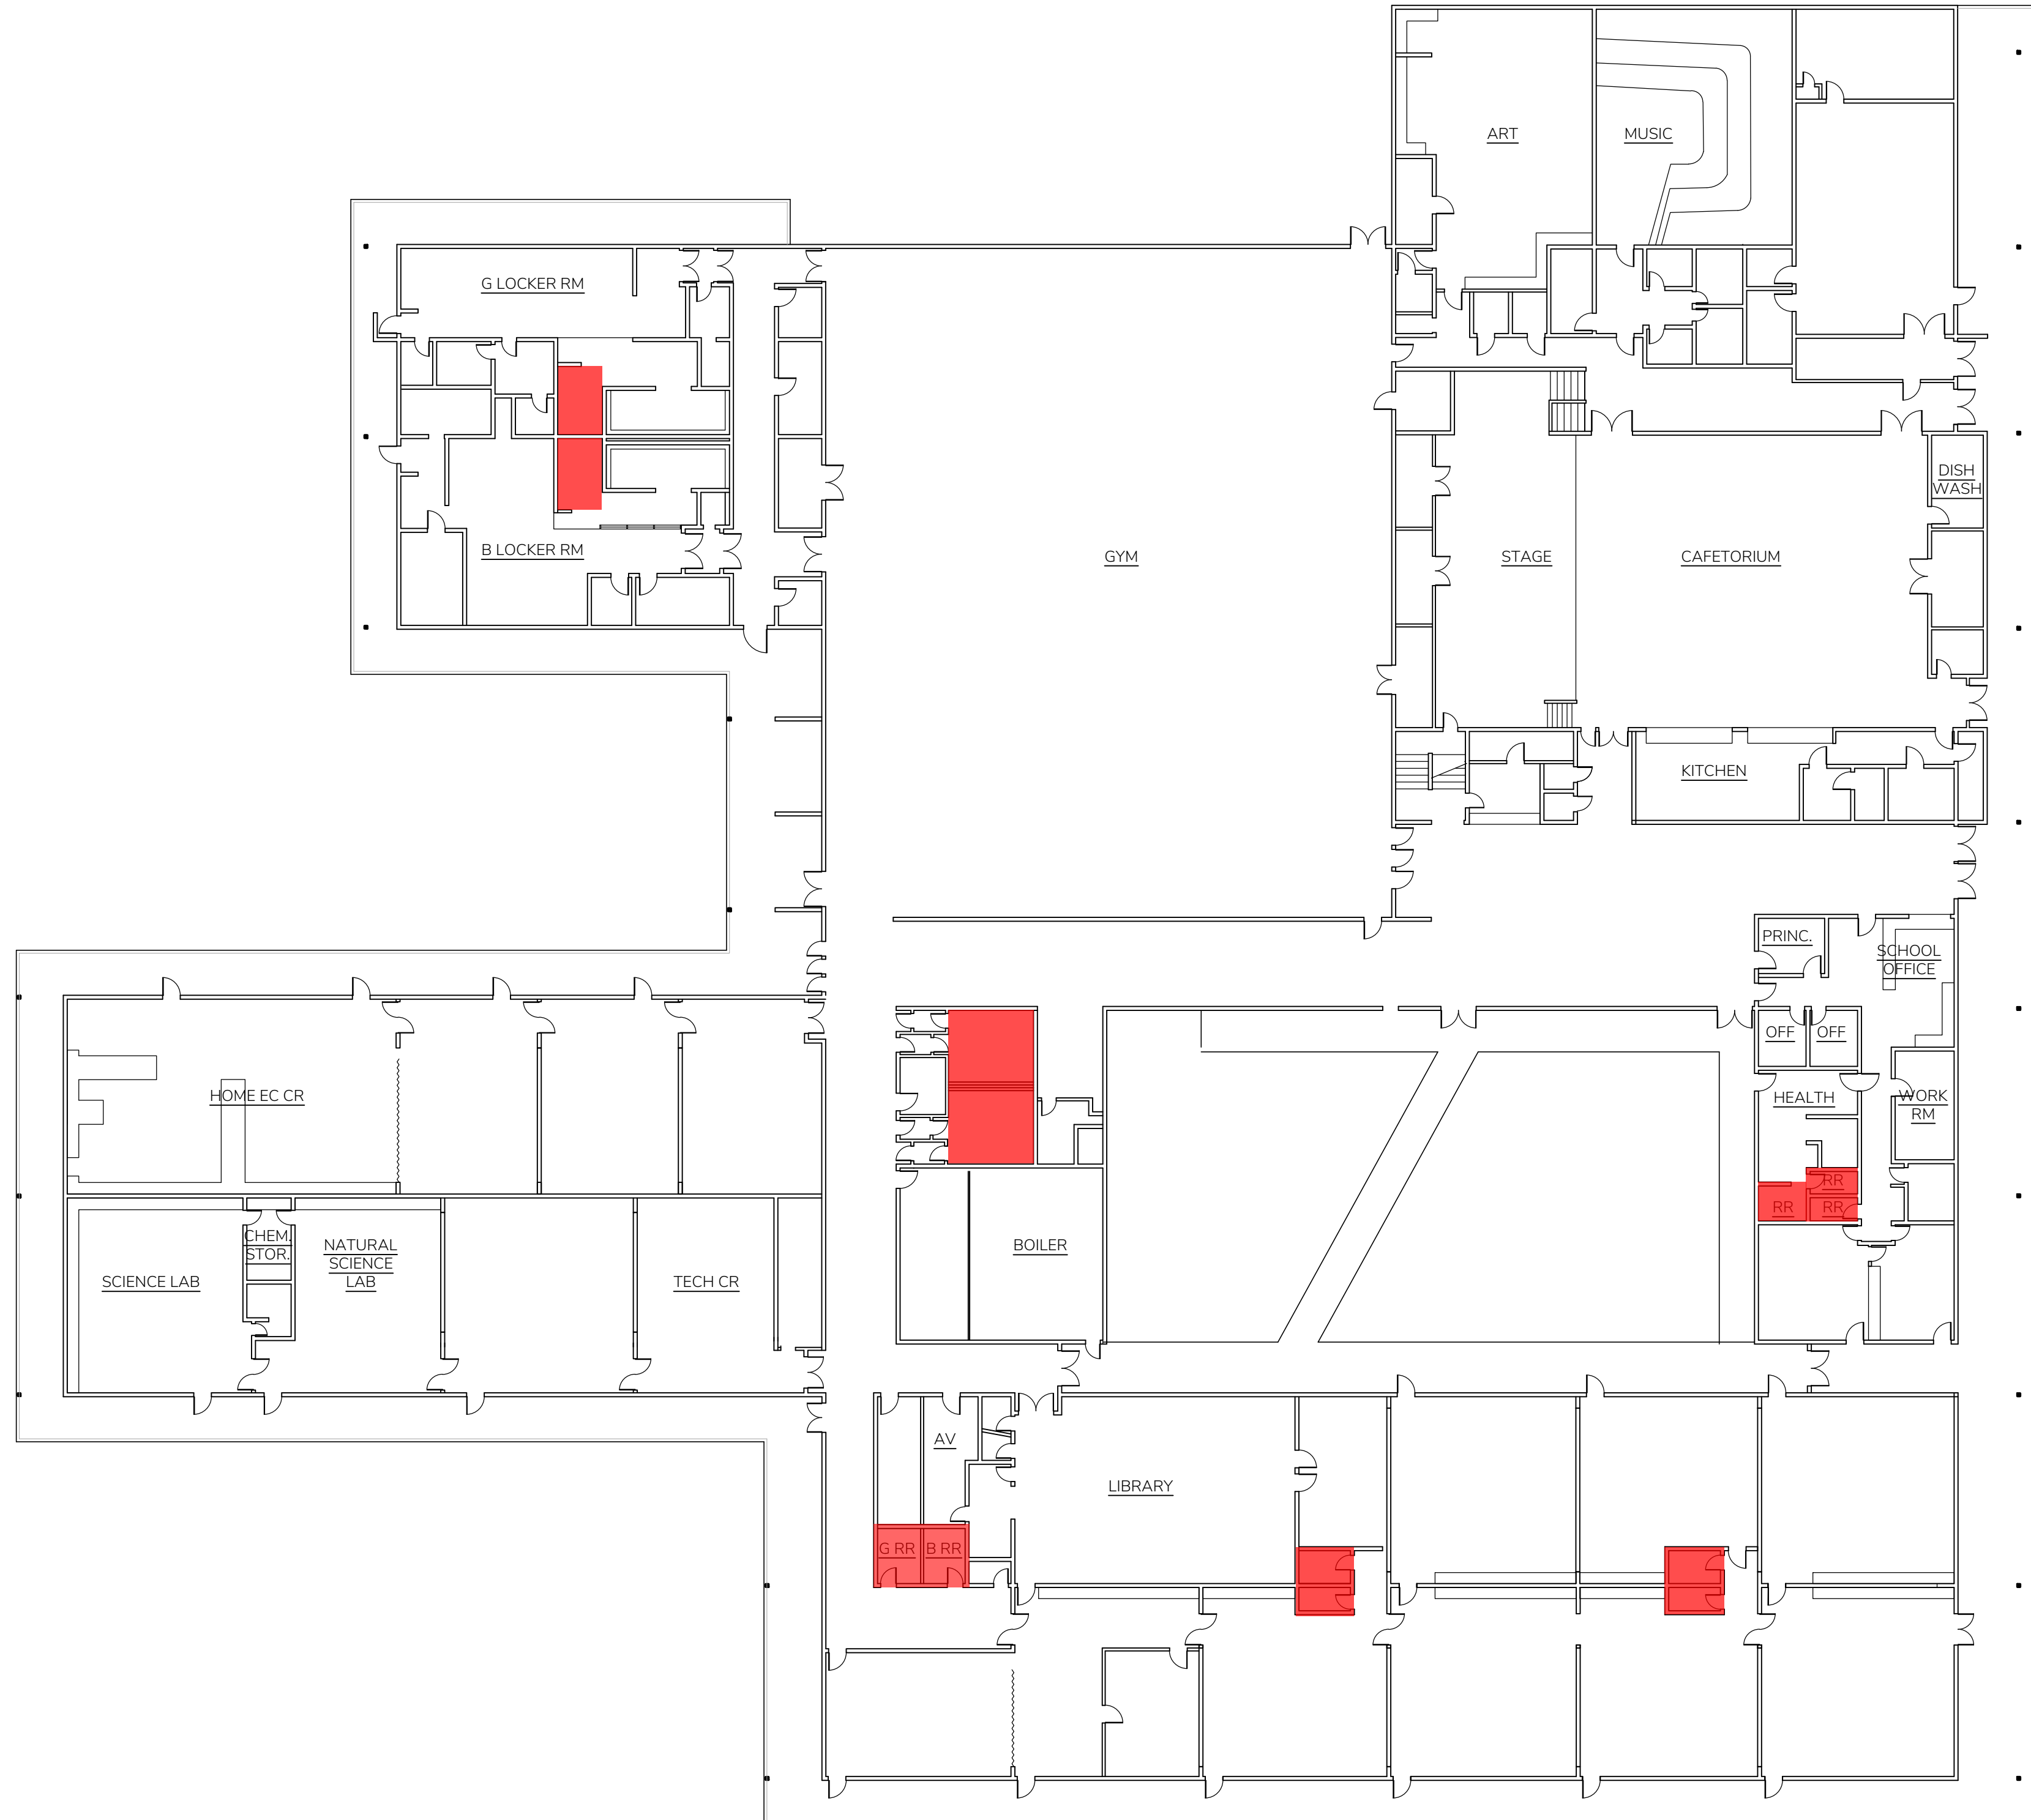
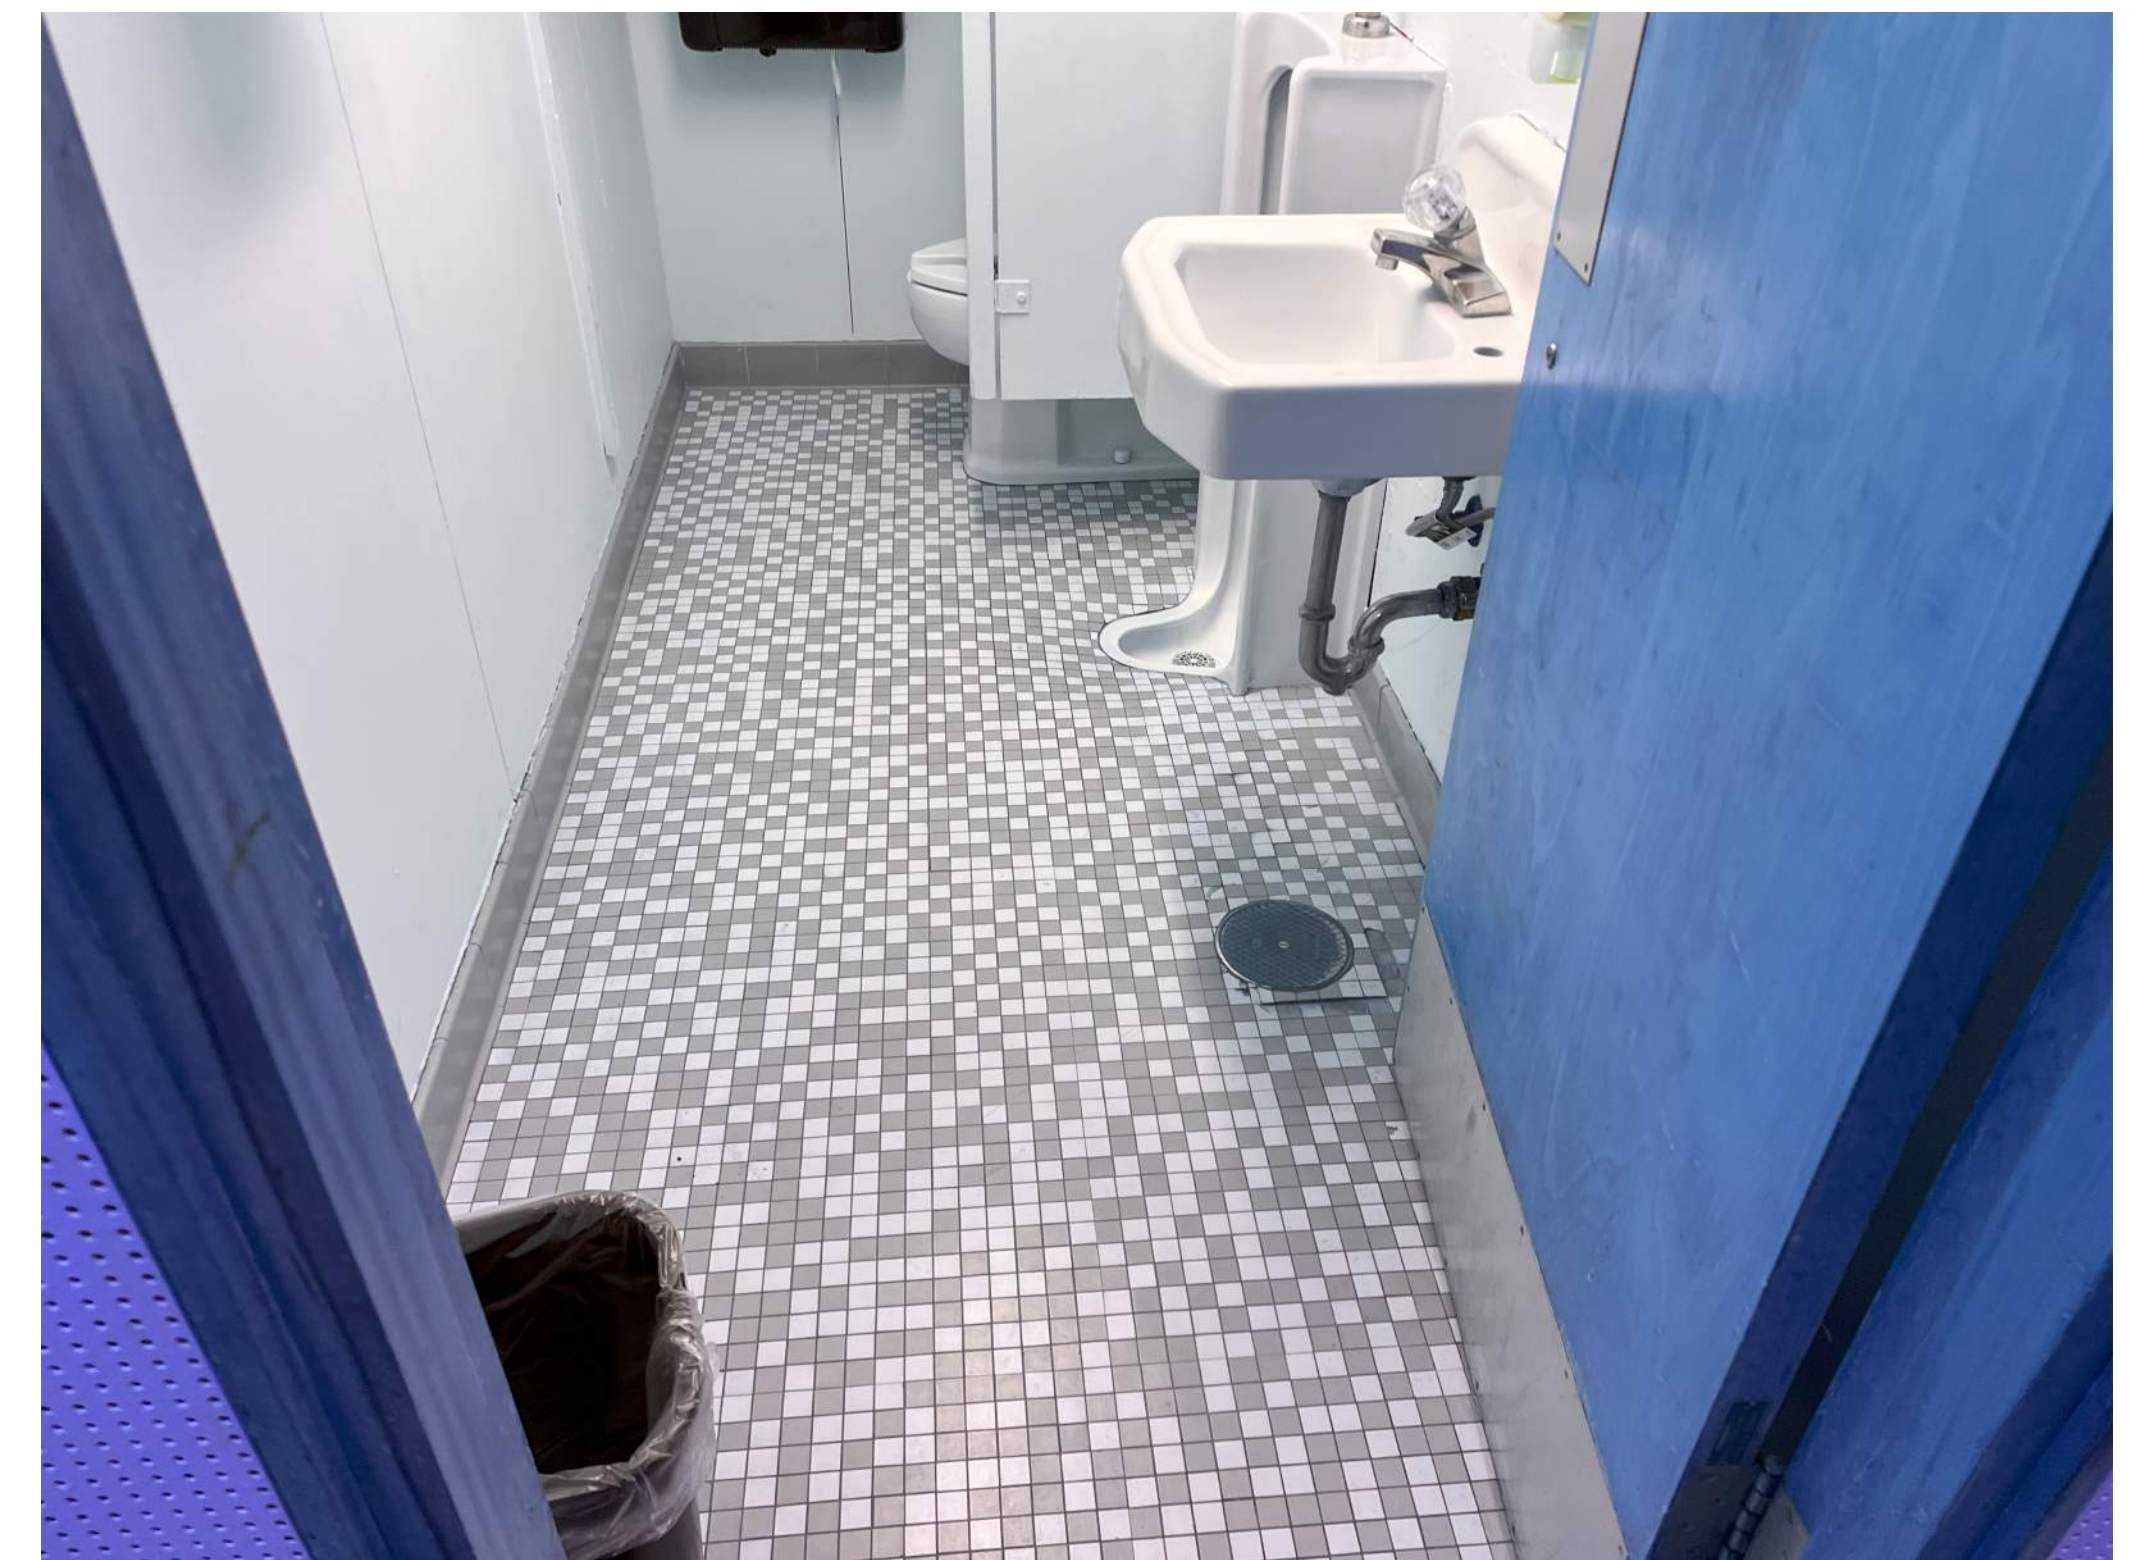
Accessibility upgrades are restrooms are needed

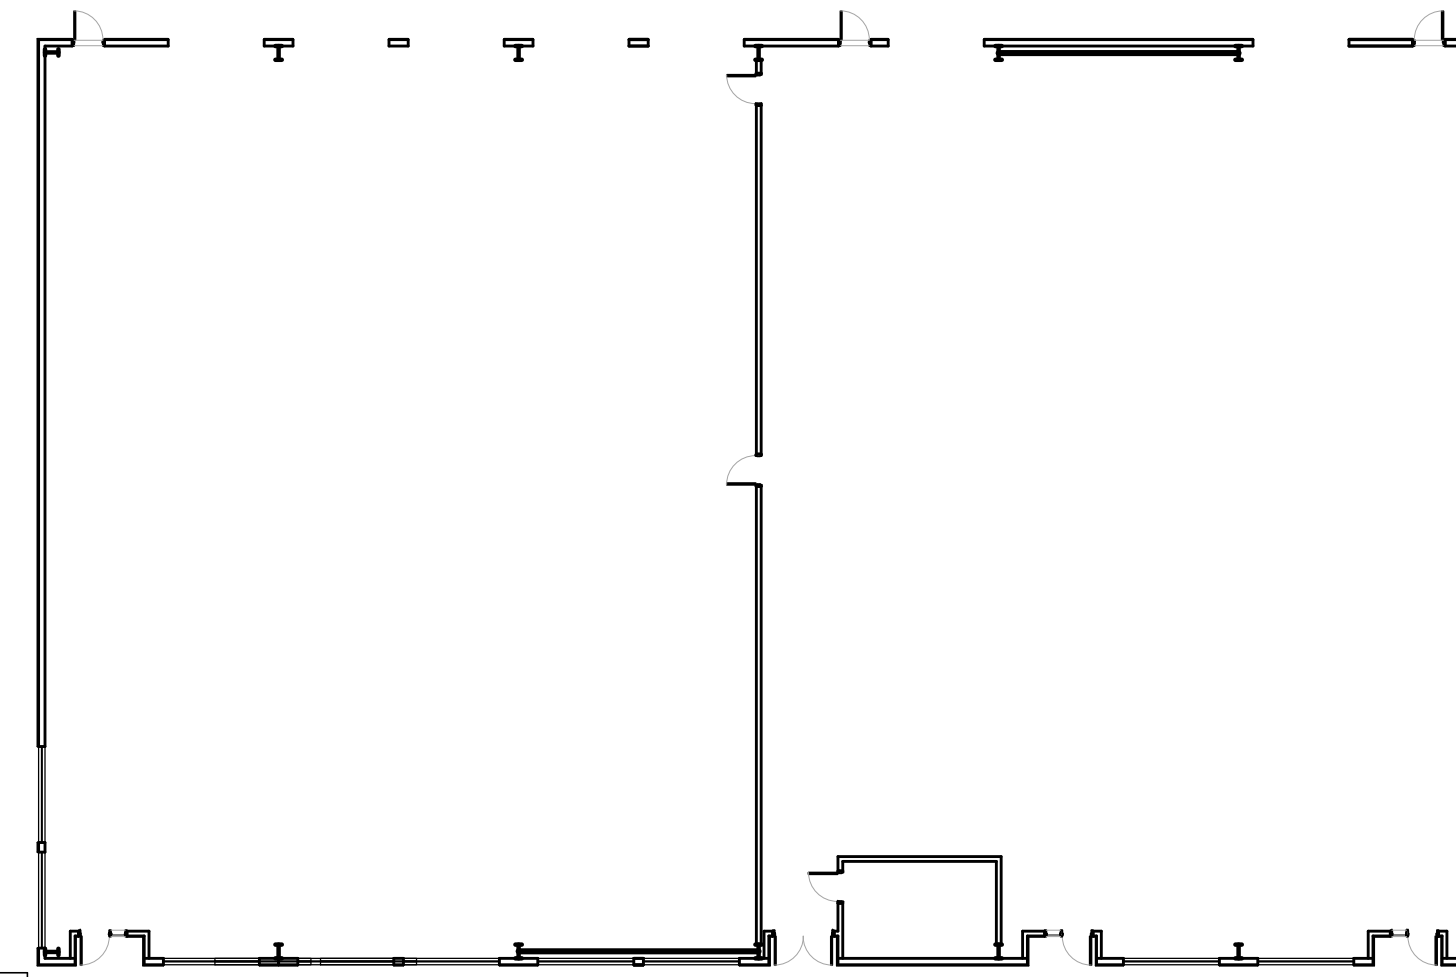
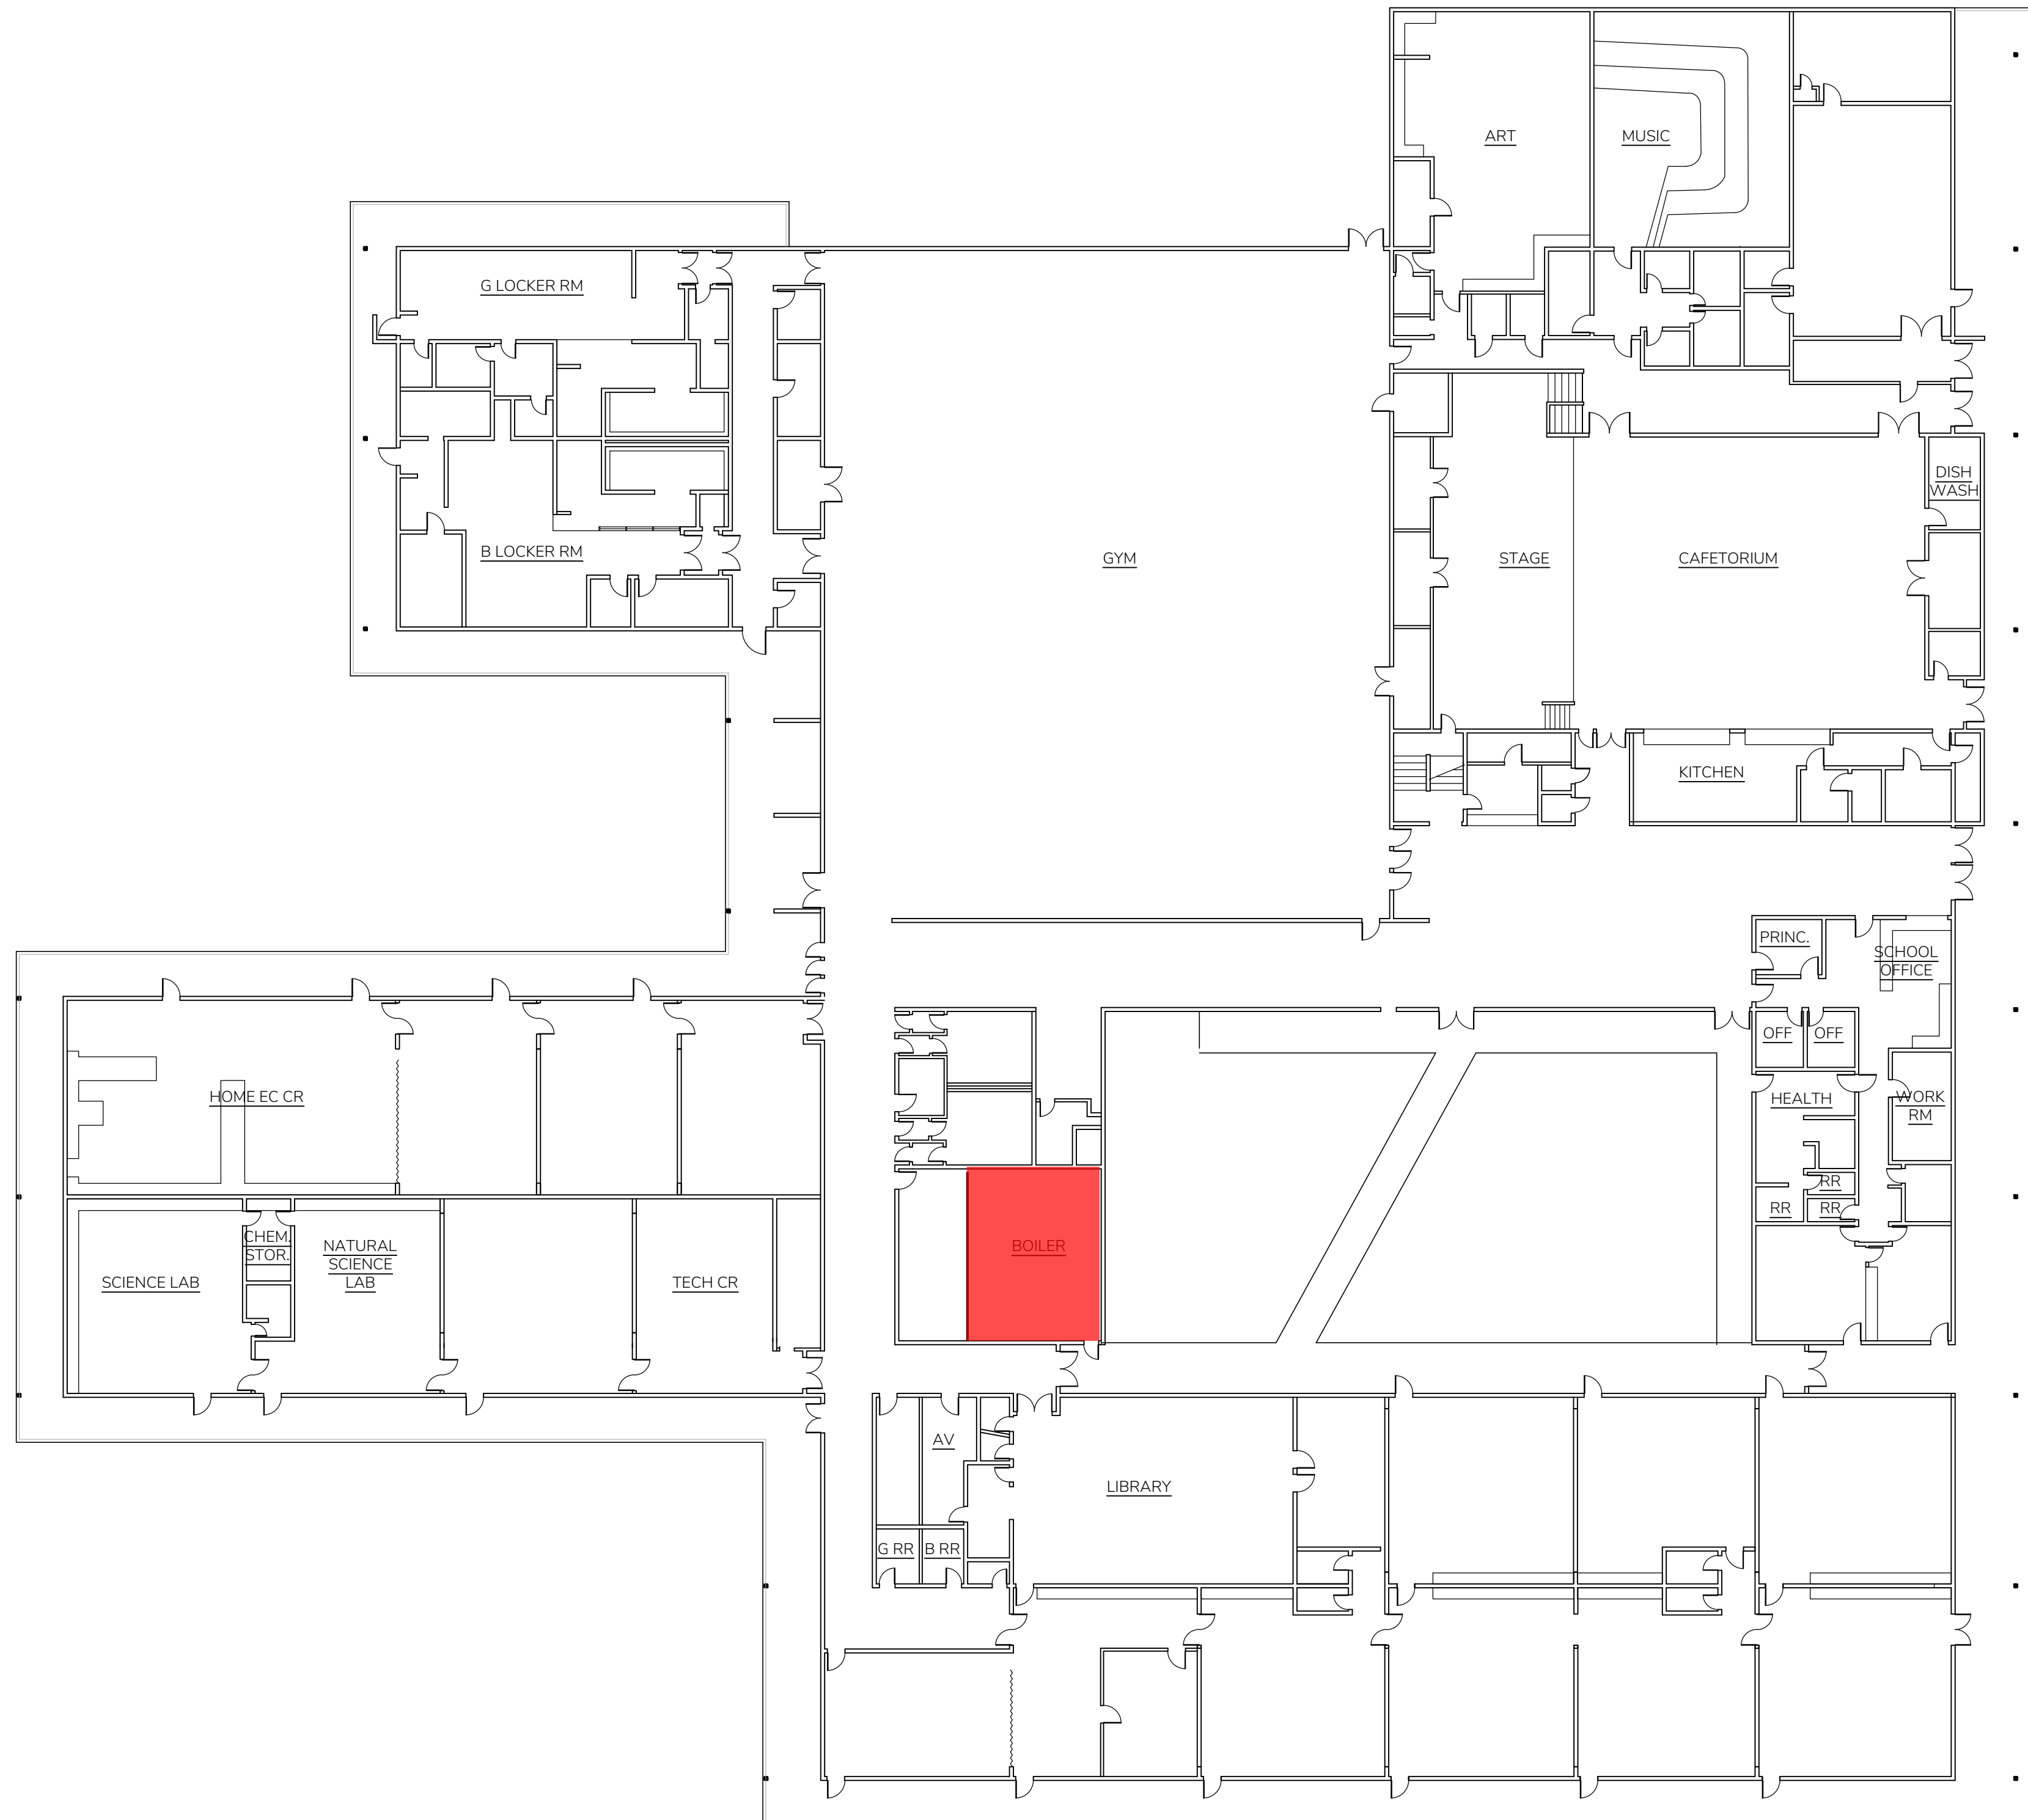
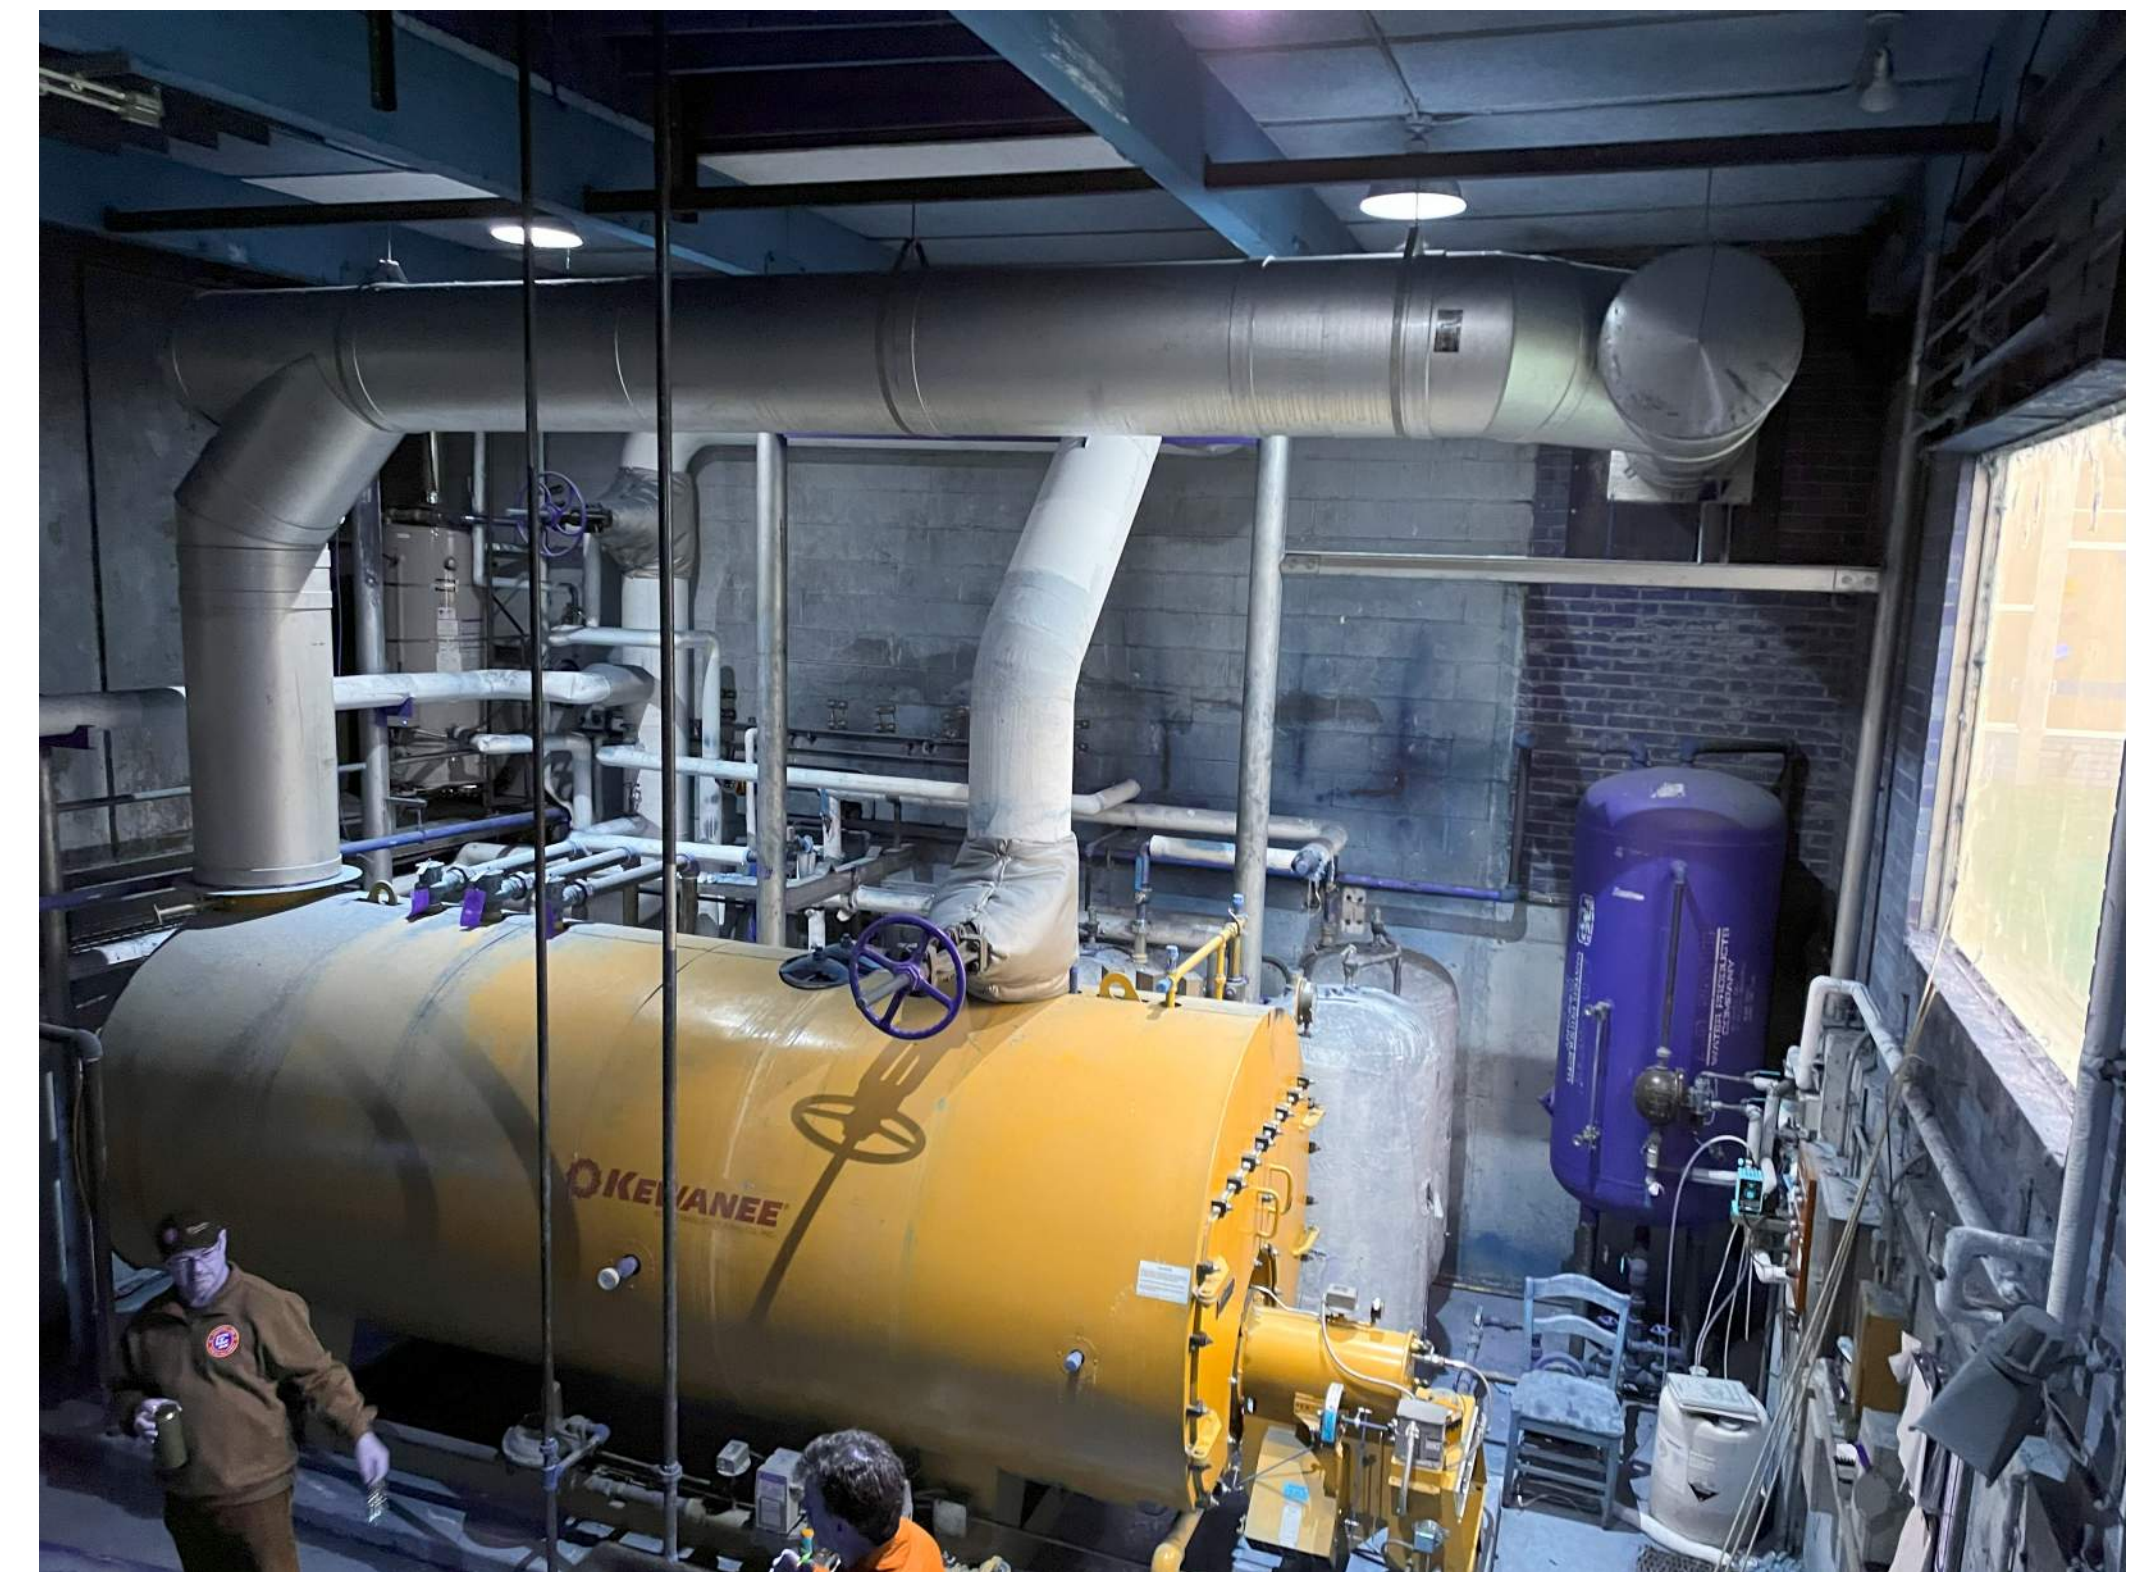
Mechanical equipment and distribution has exceed useful life.
