COMMUNITY BOND ADVISORY COMMITTEE MEETING #3

Central Linn School District
March 19, 2024

FACILITY ASSESSMENT EXECUTIVE SUMMARY

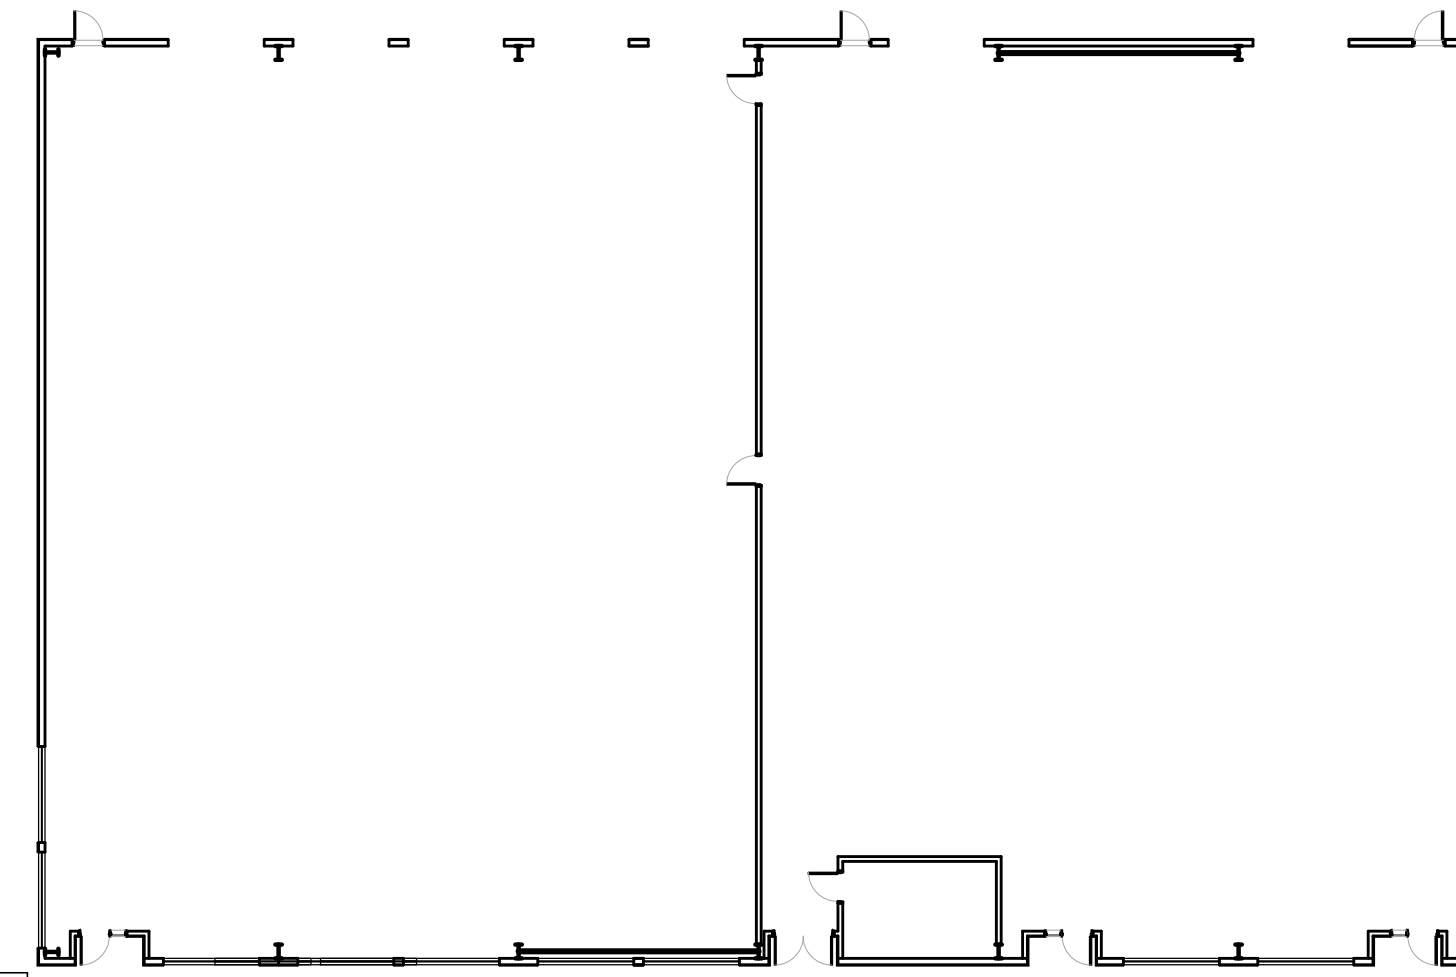
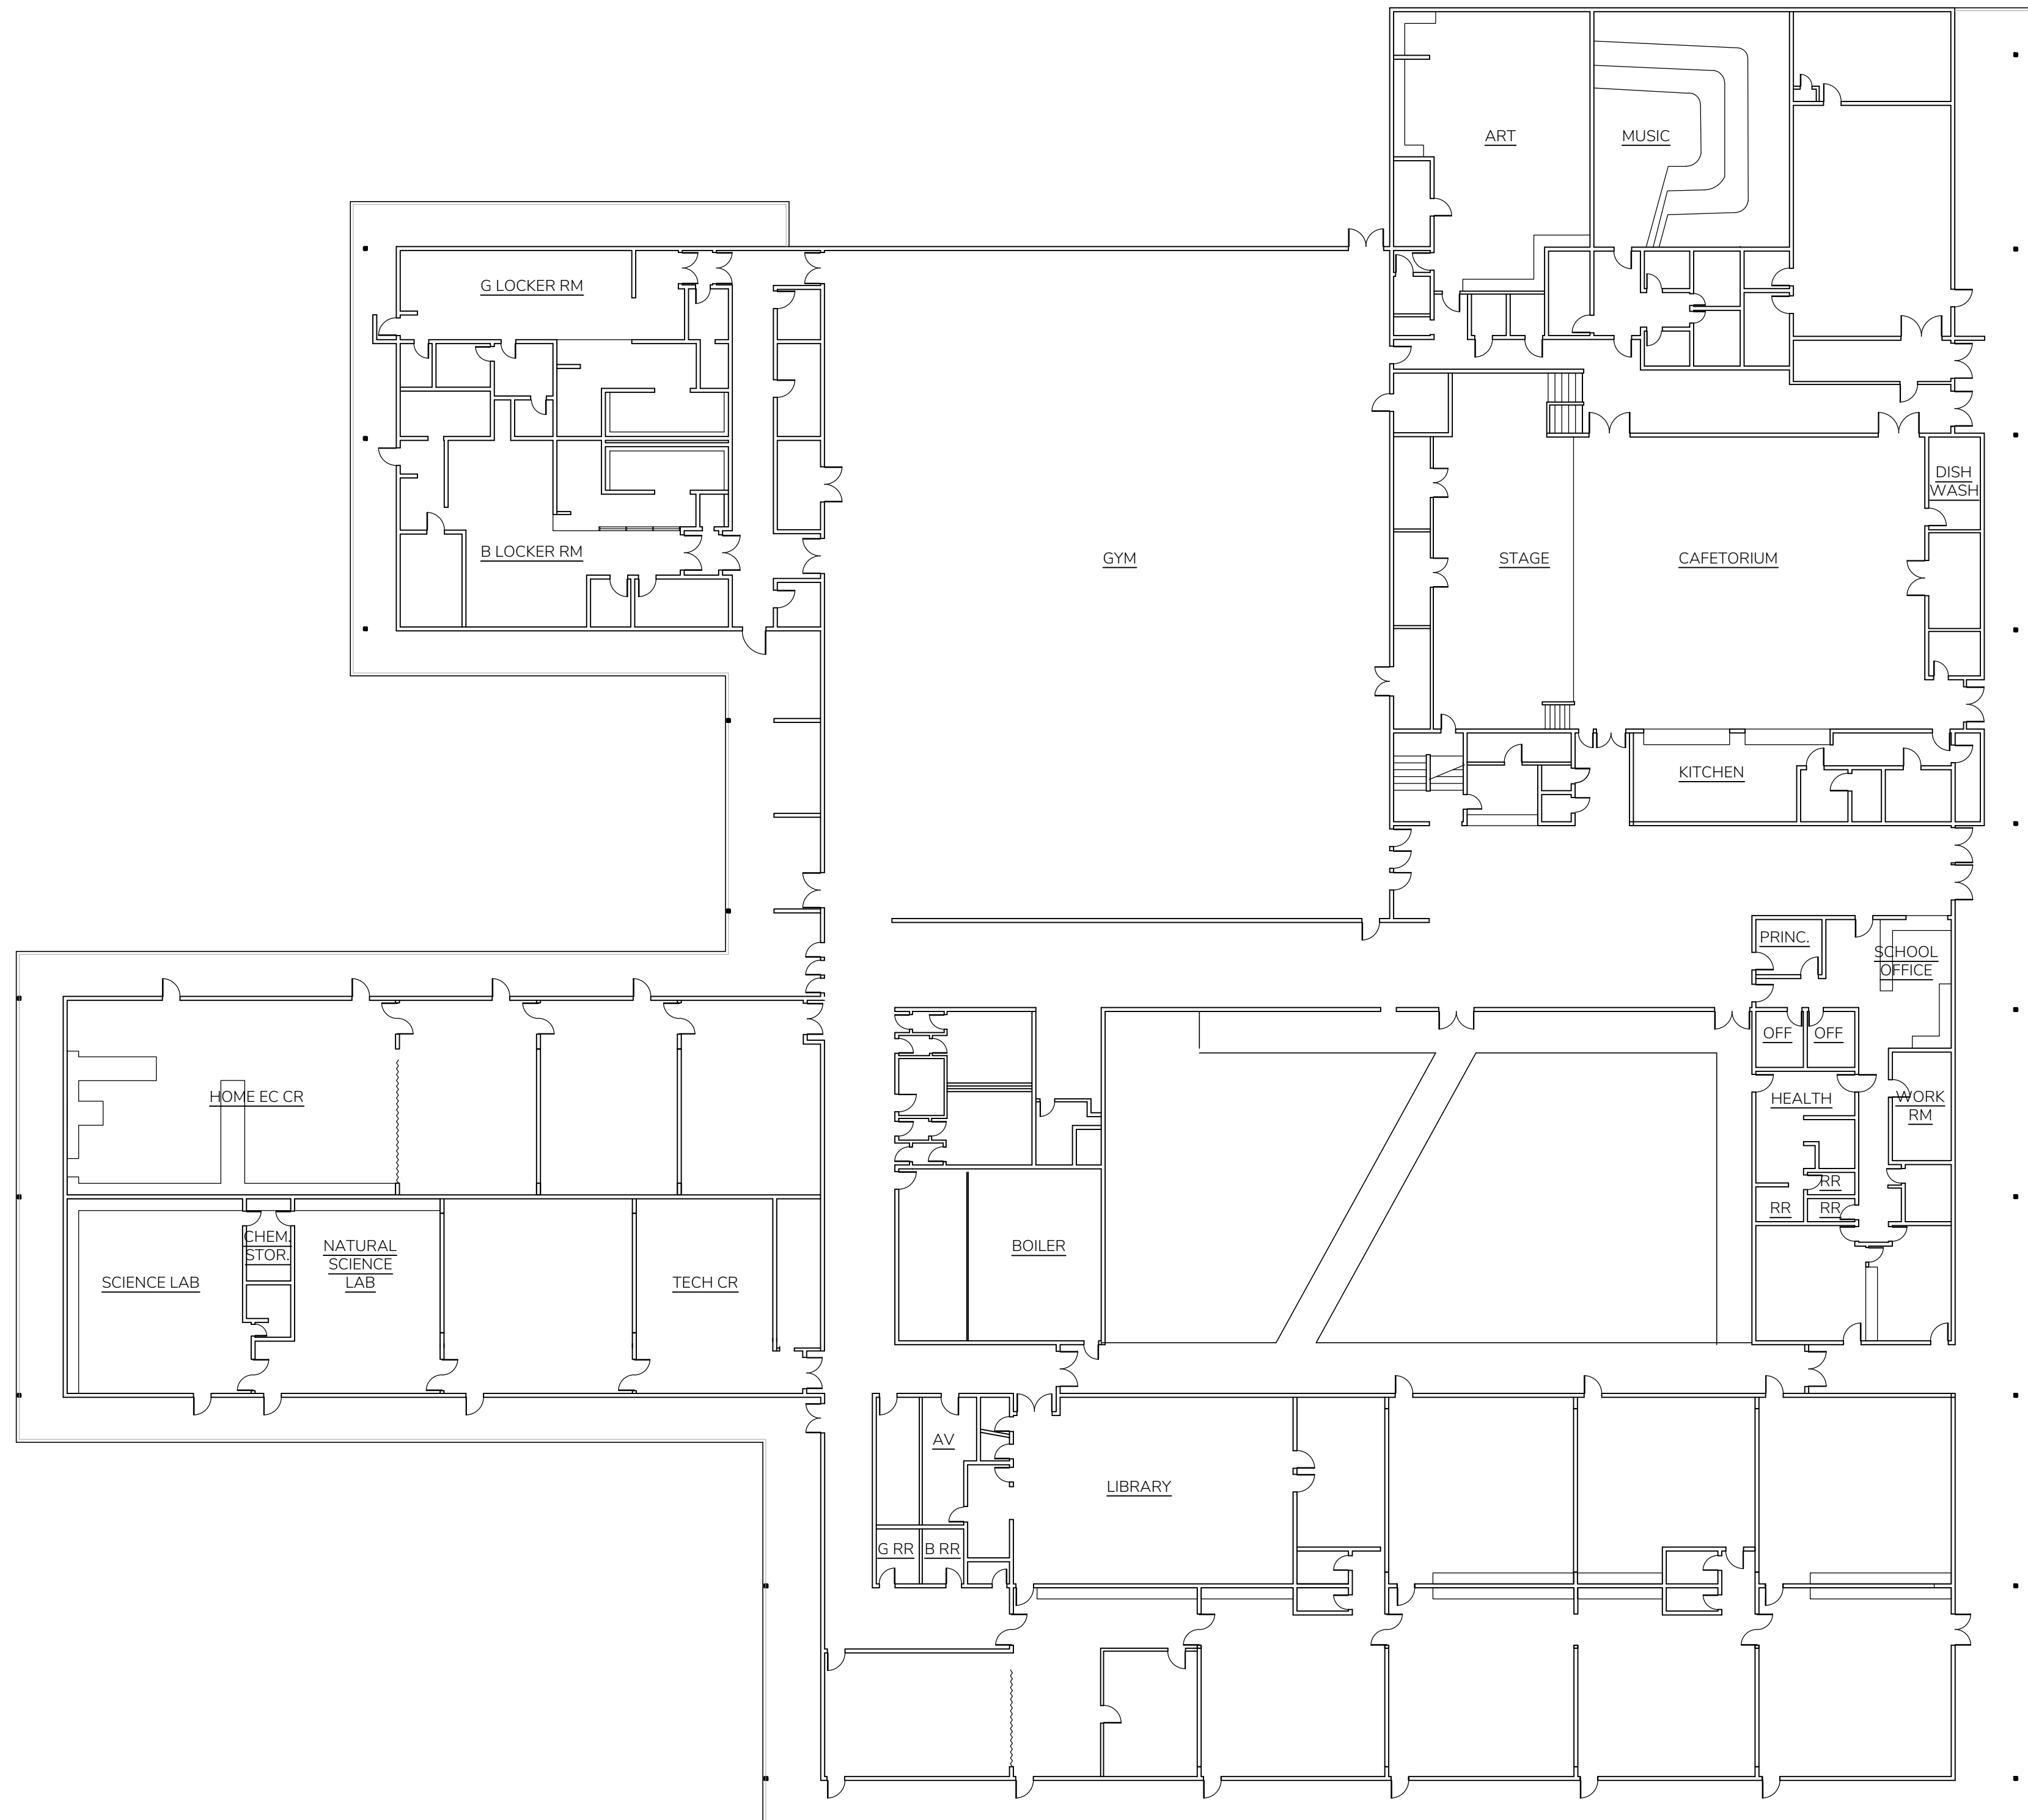
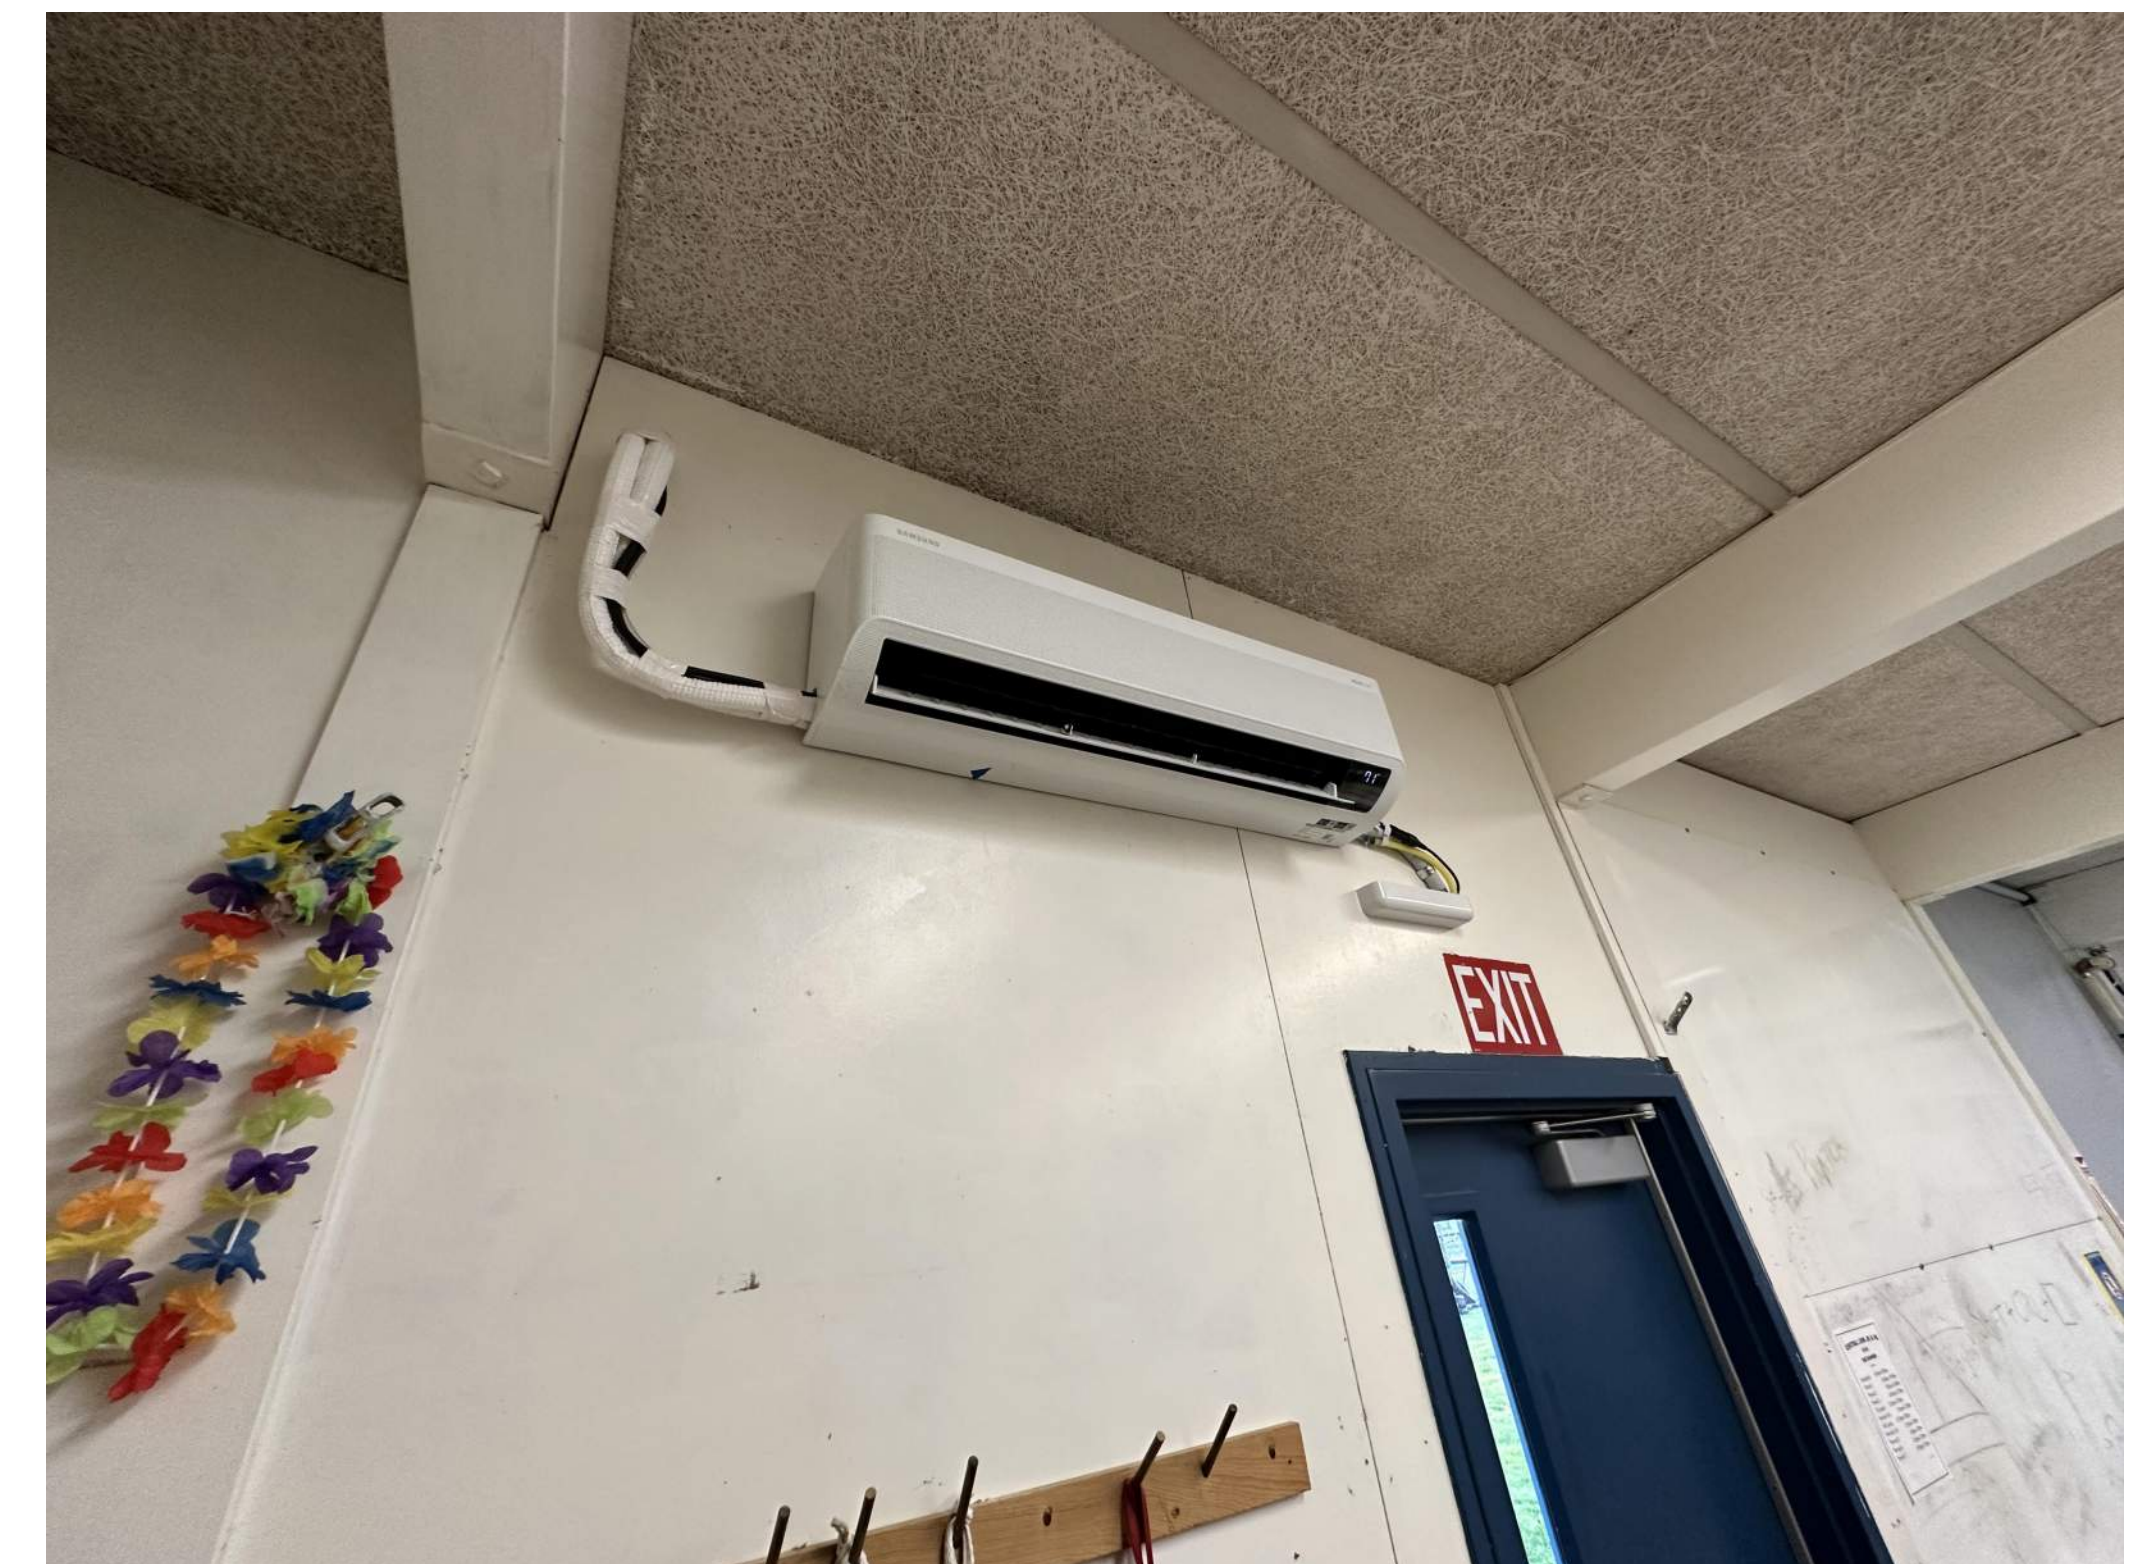
New ductless heatpumps do not provide adequate ventilation.

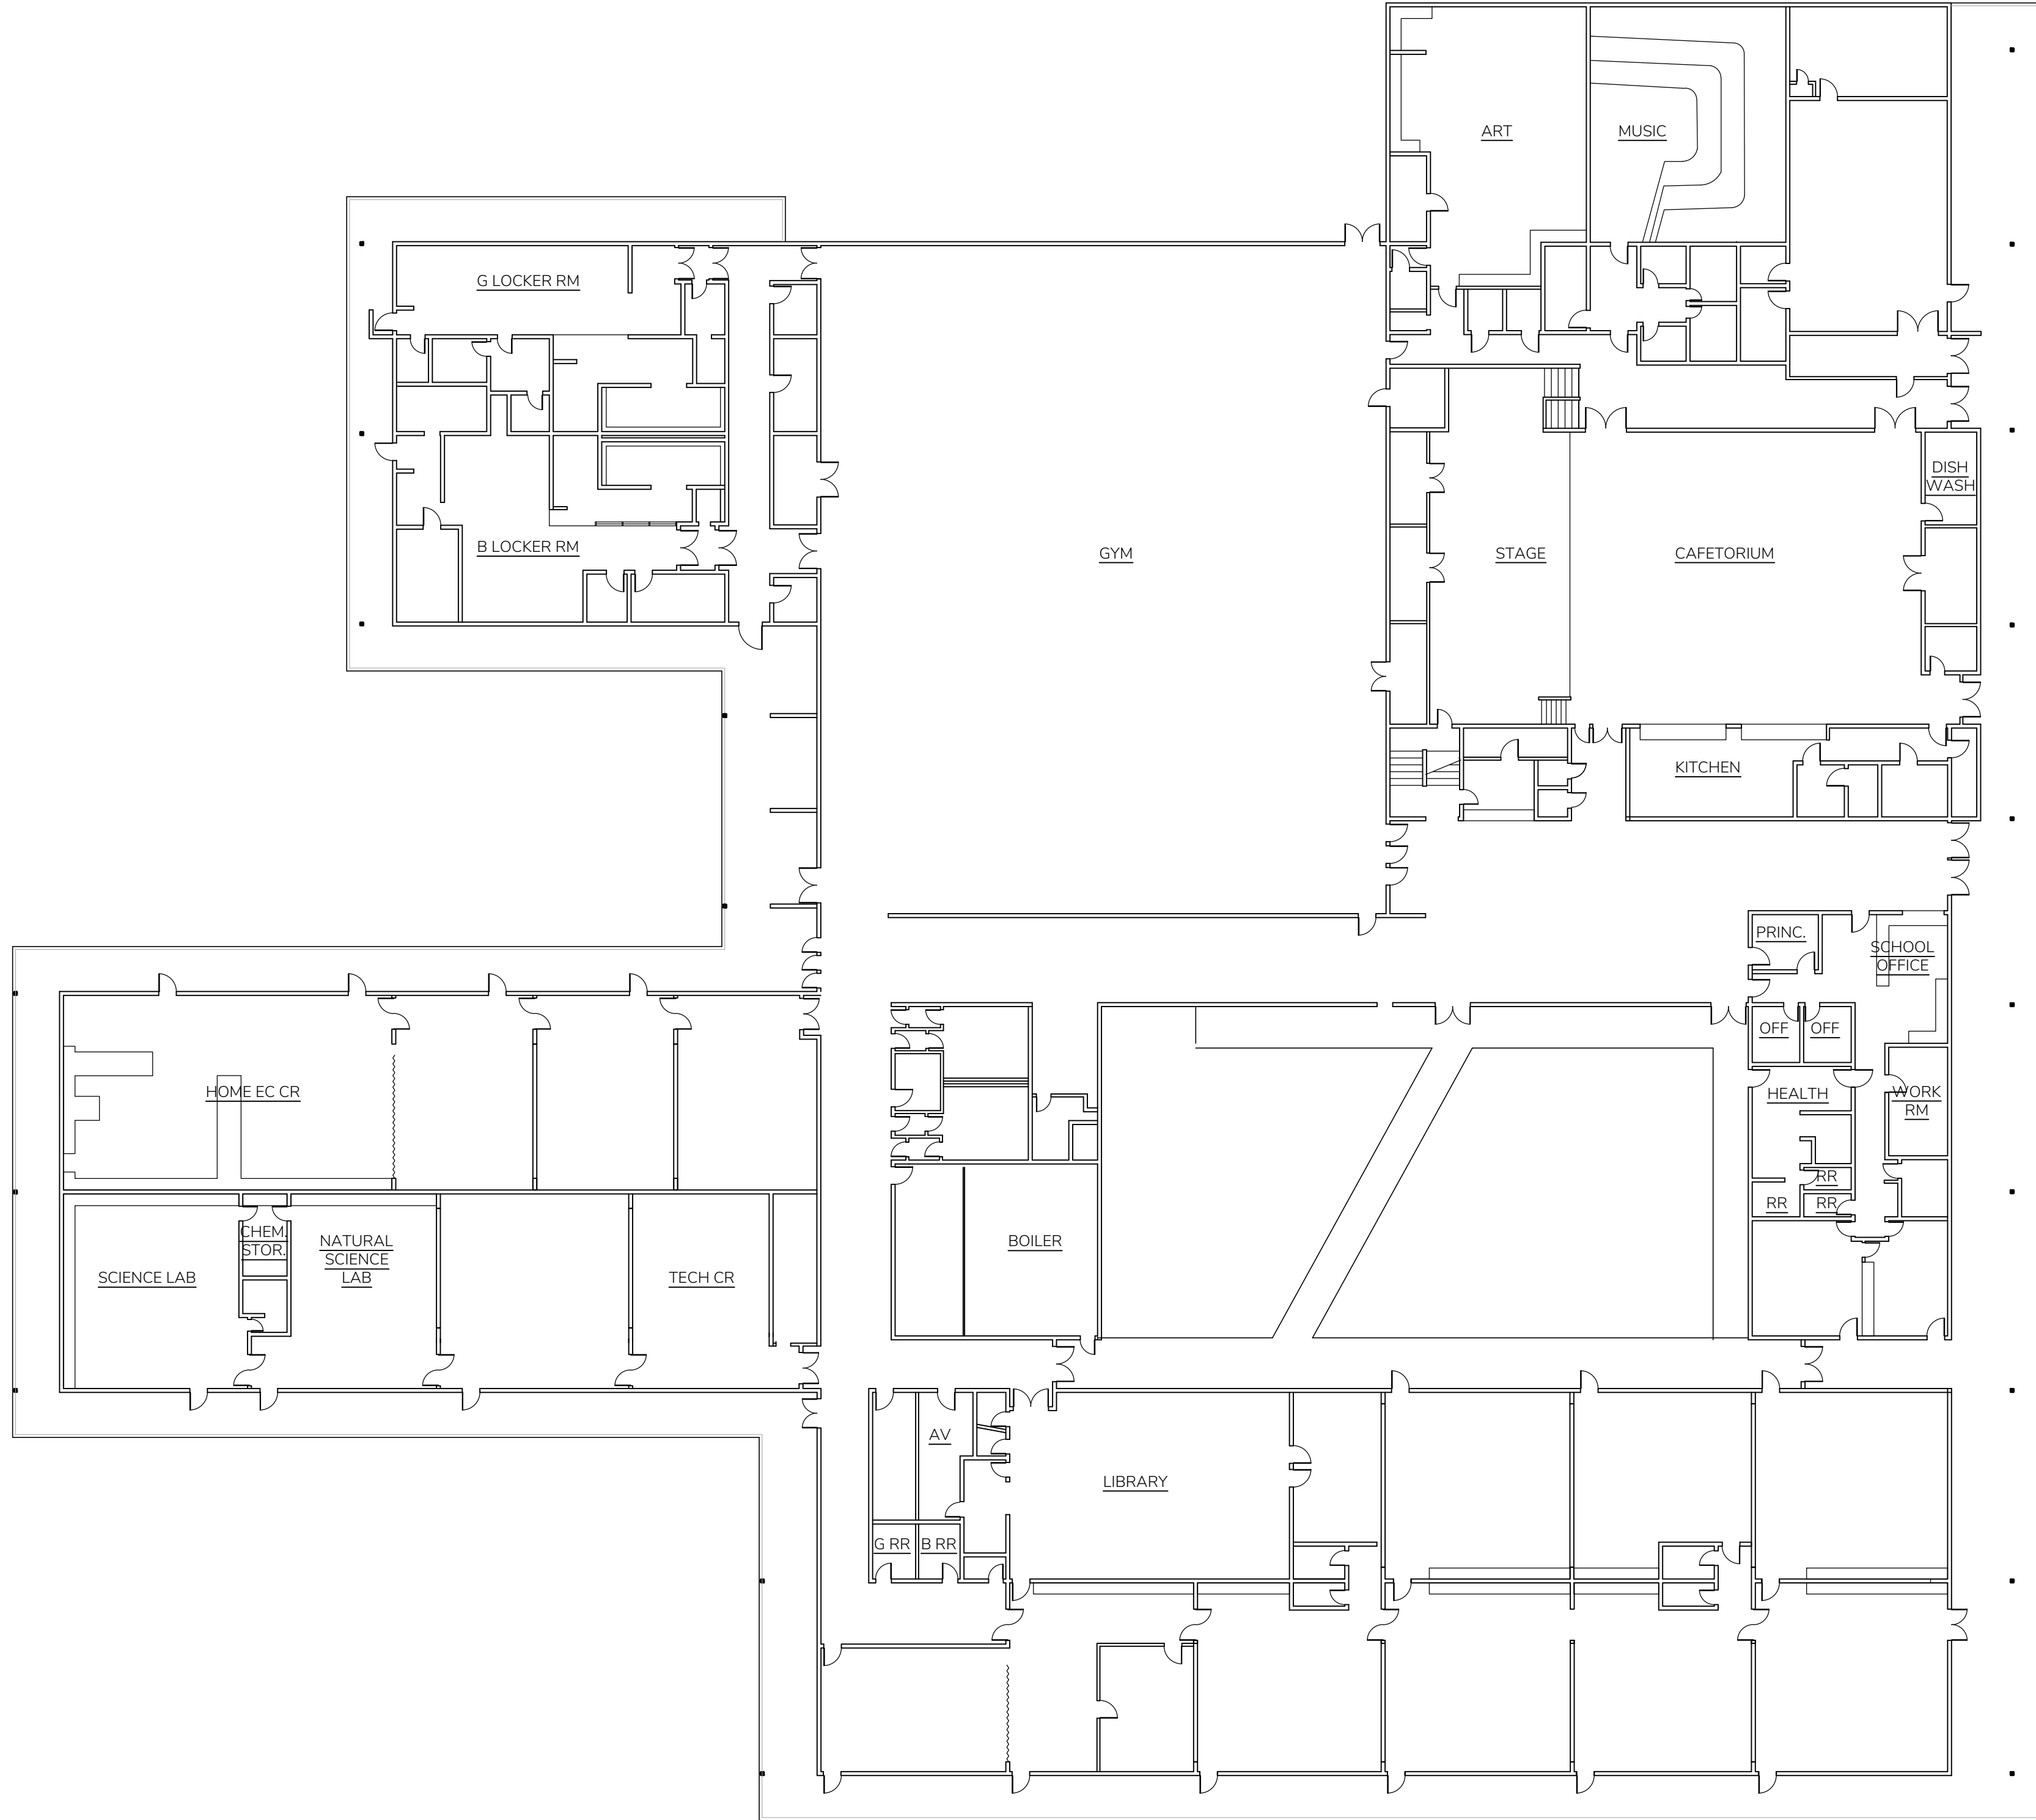
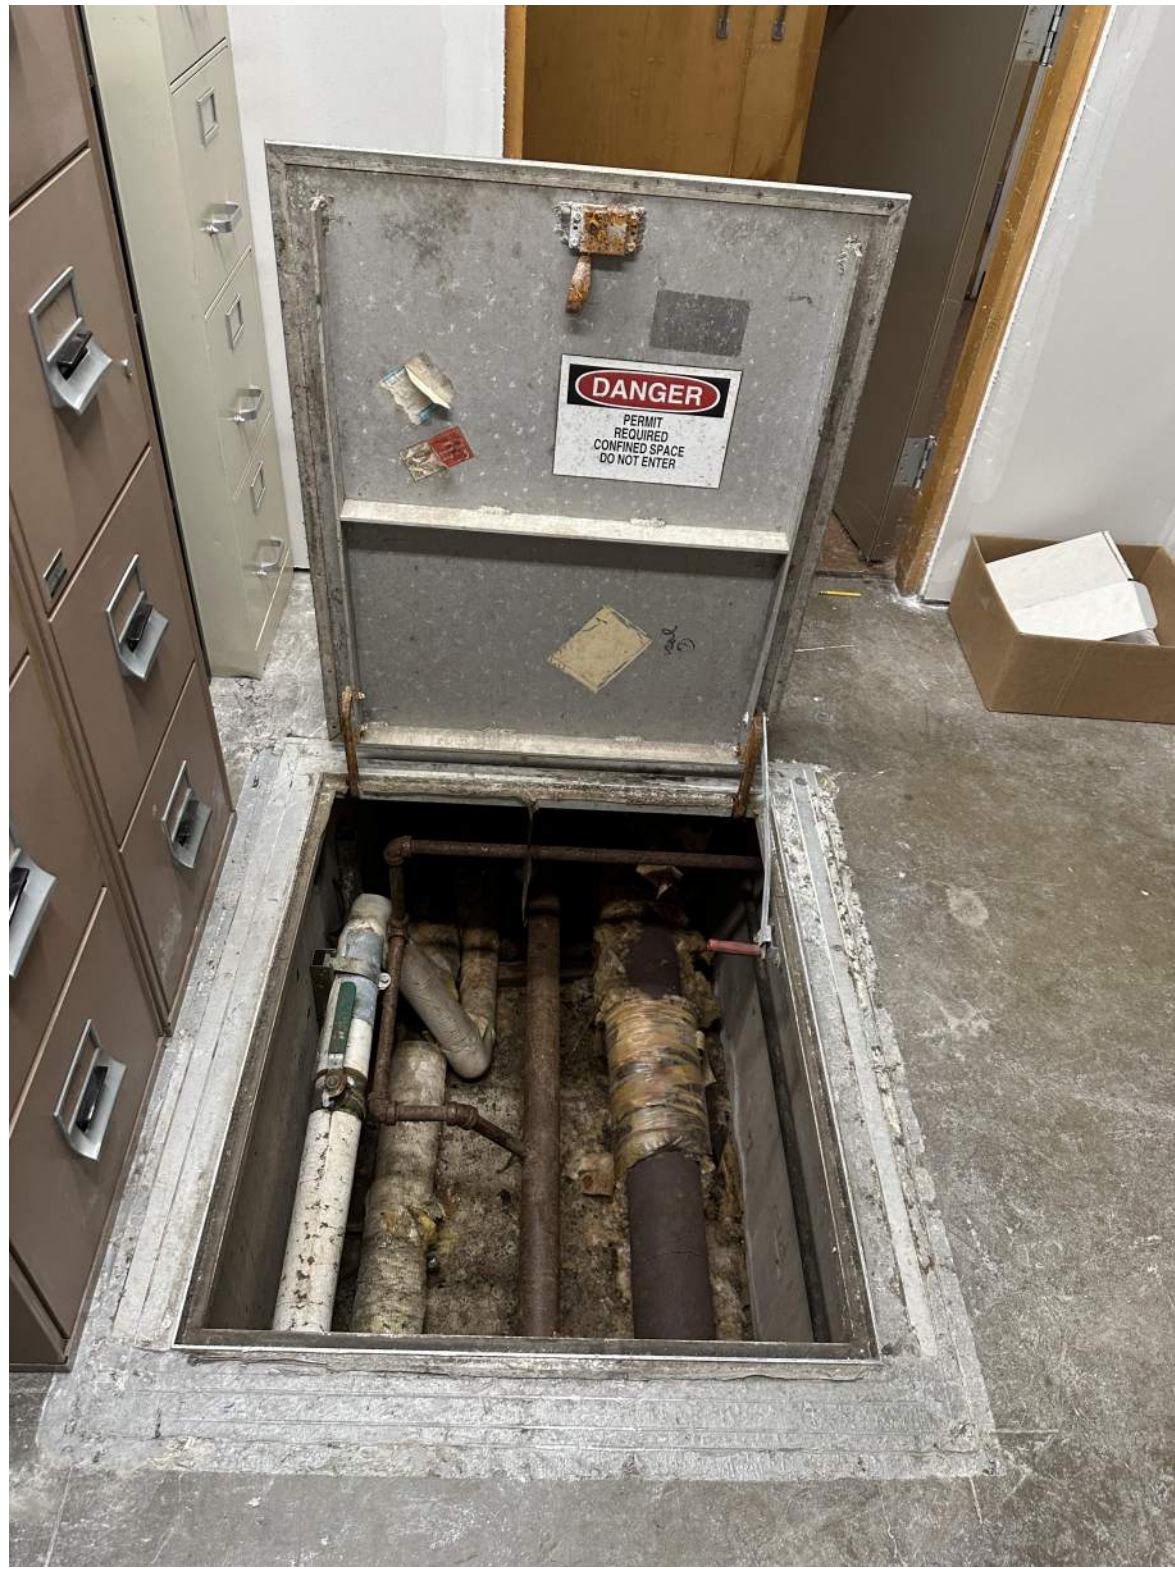
Water and sanitary pipe system is beyond useful life.

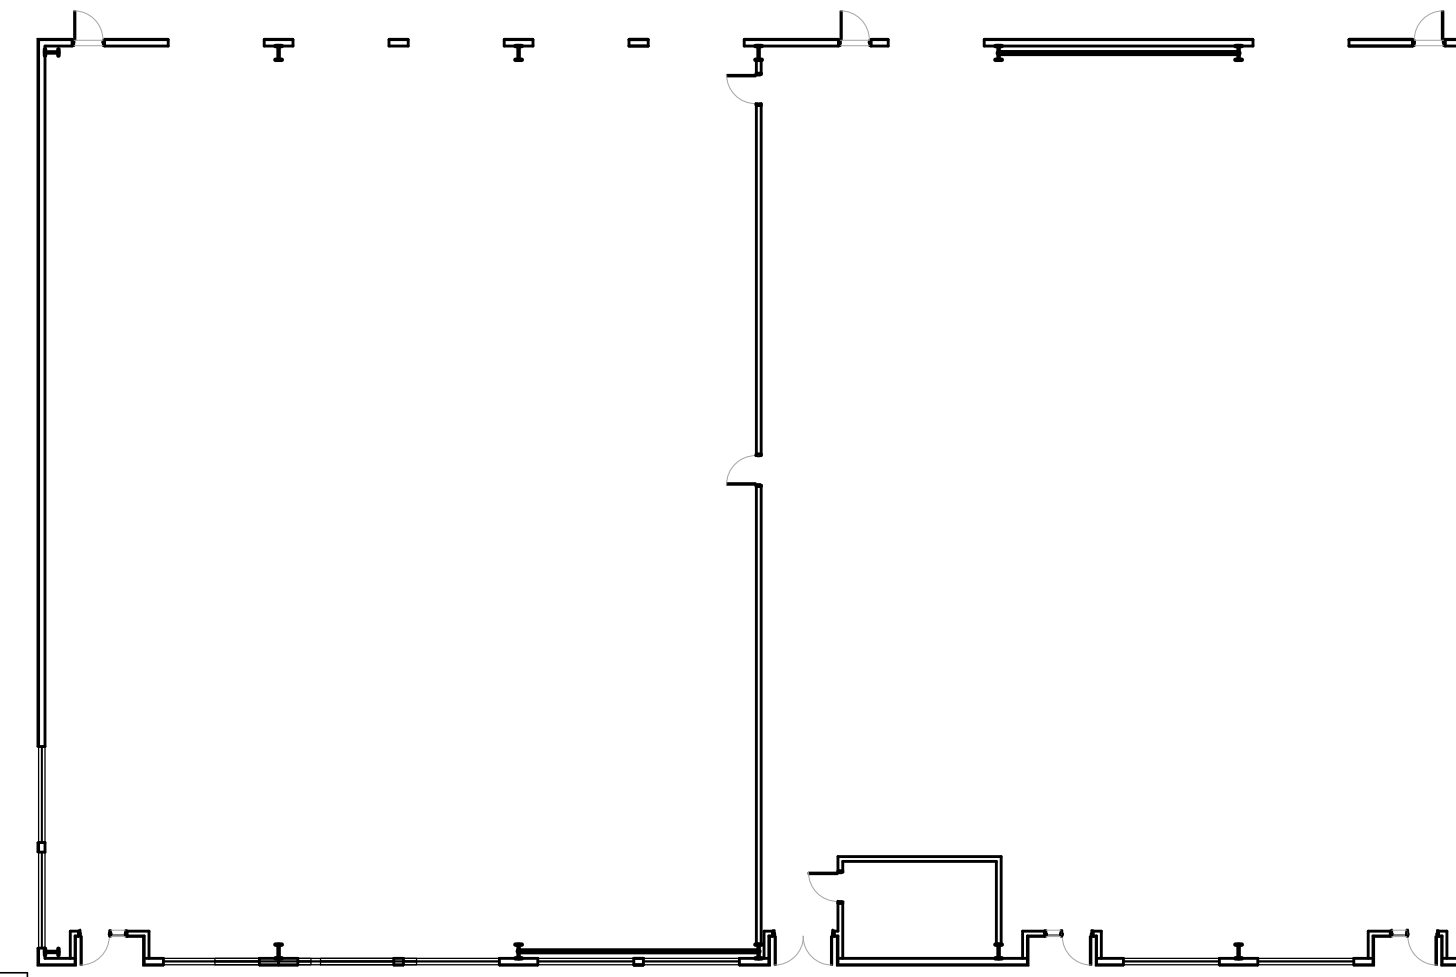
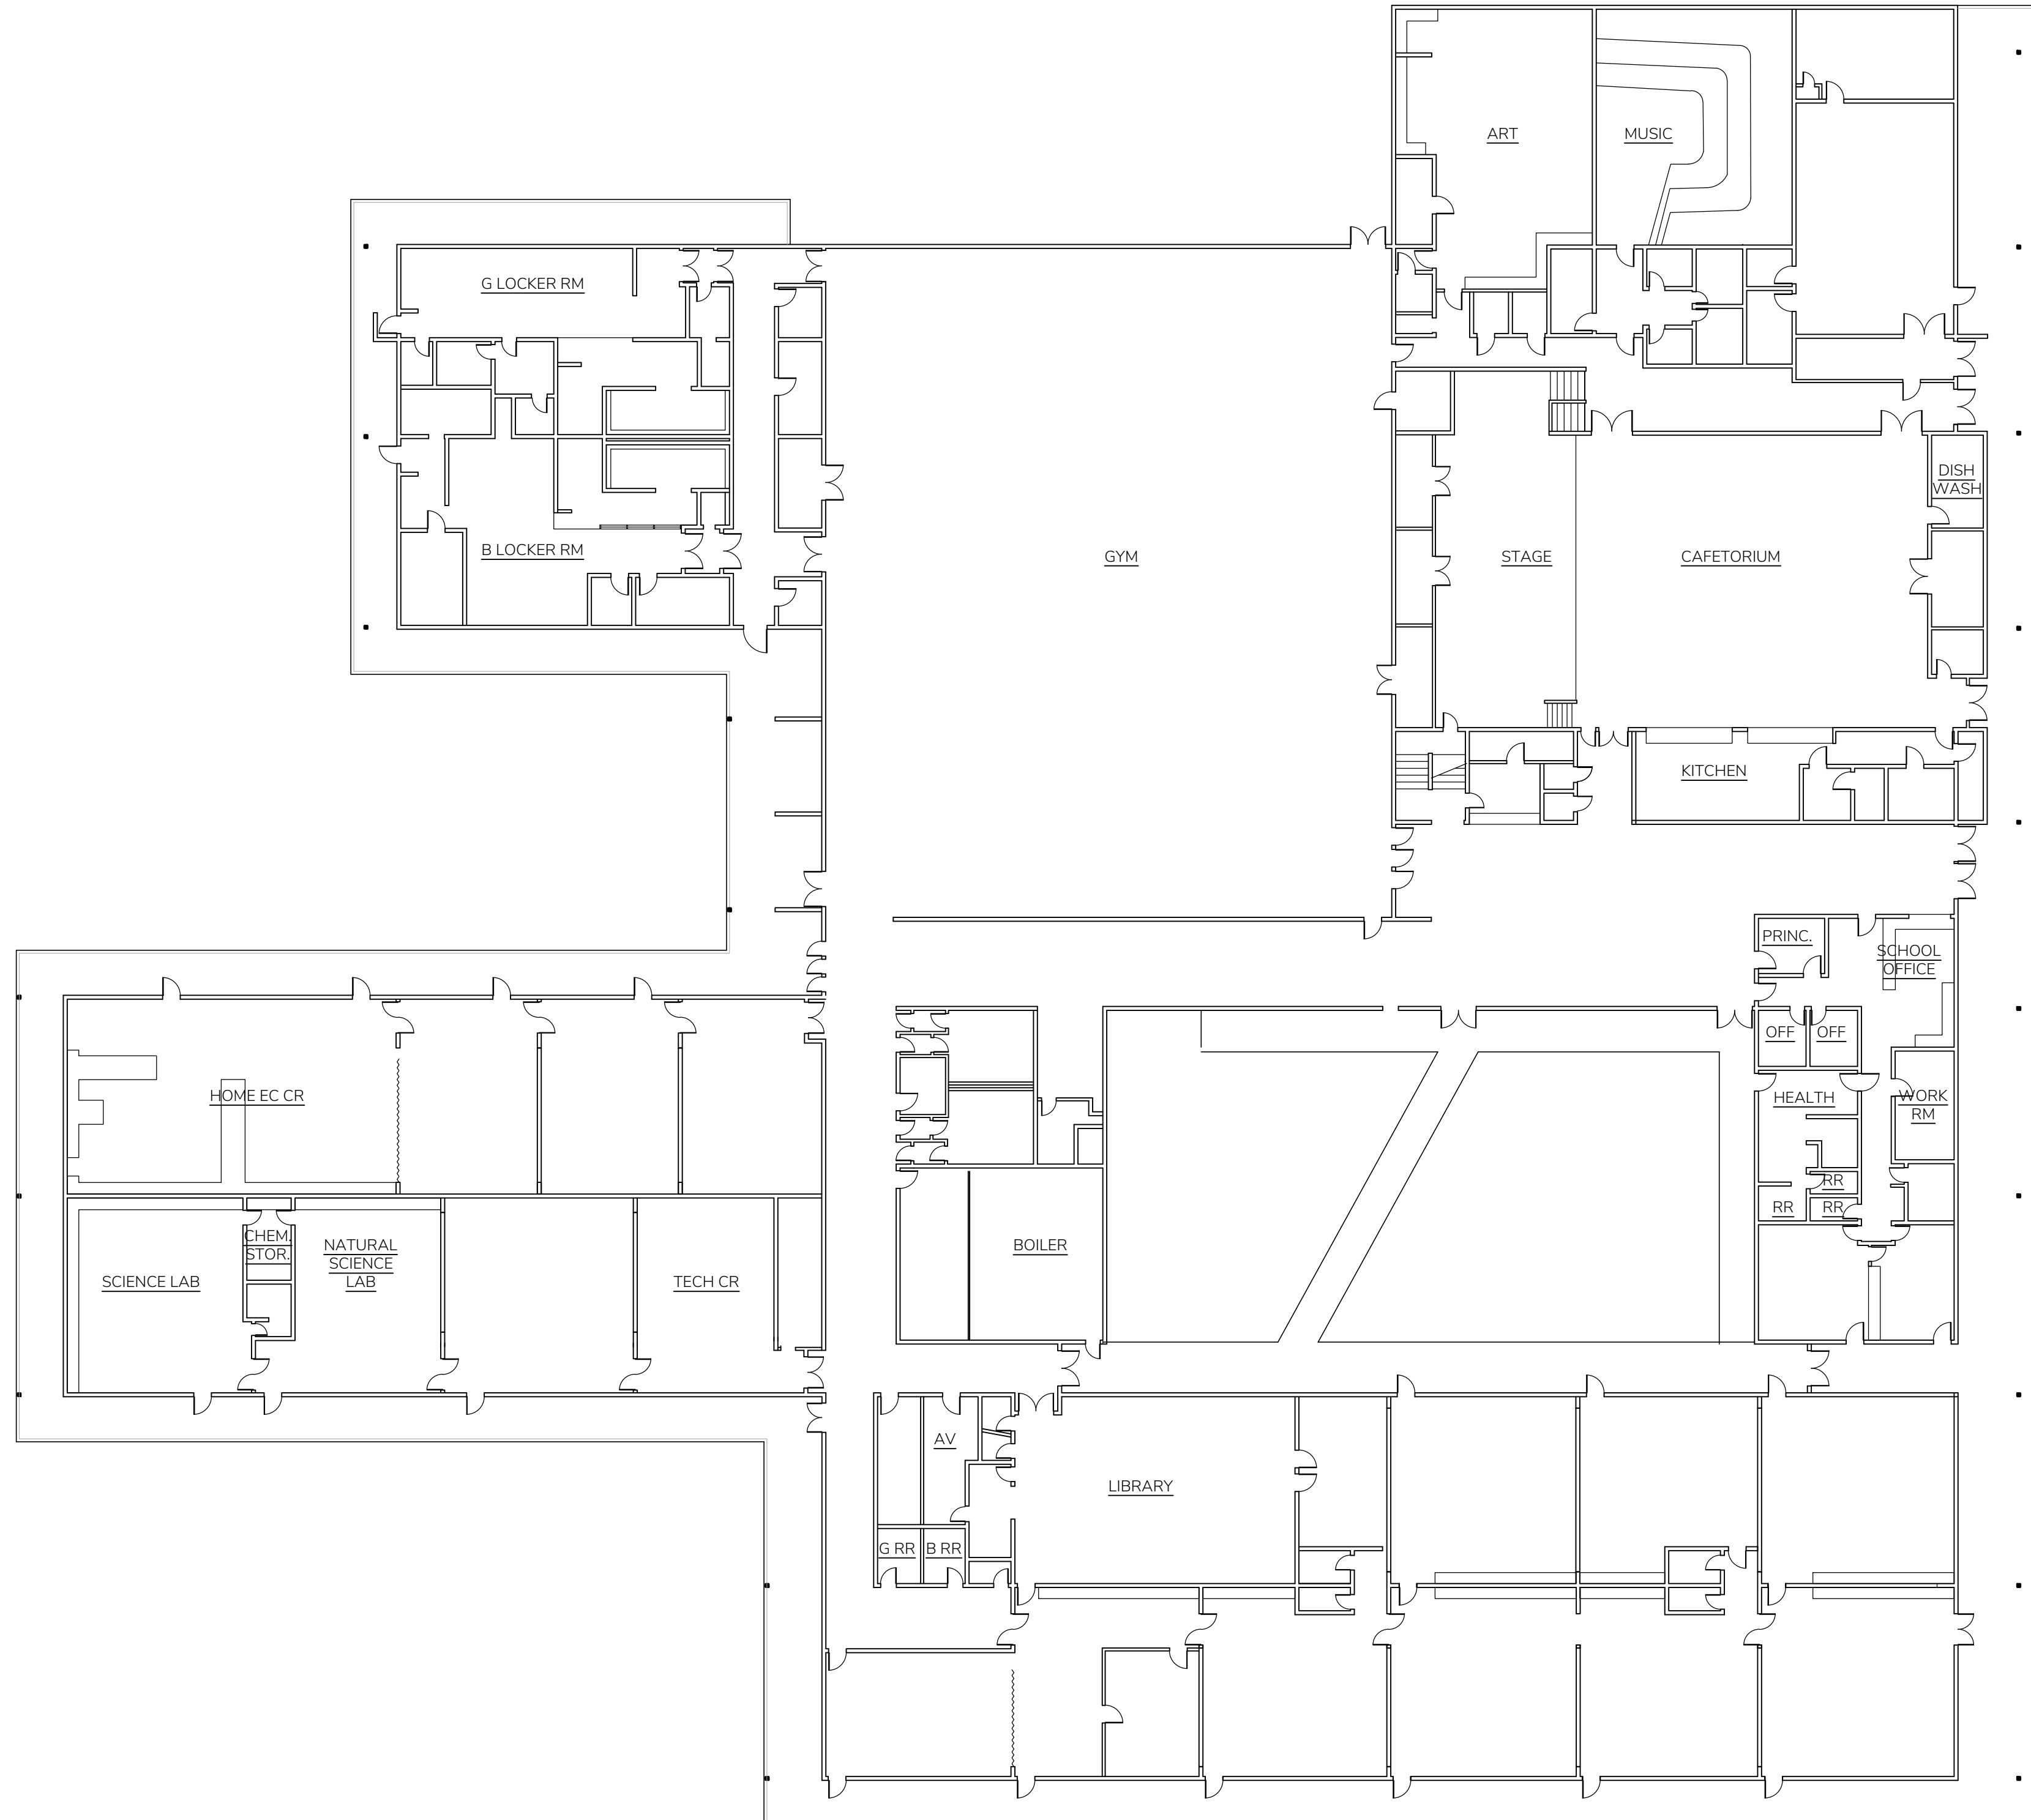
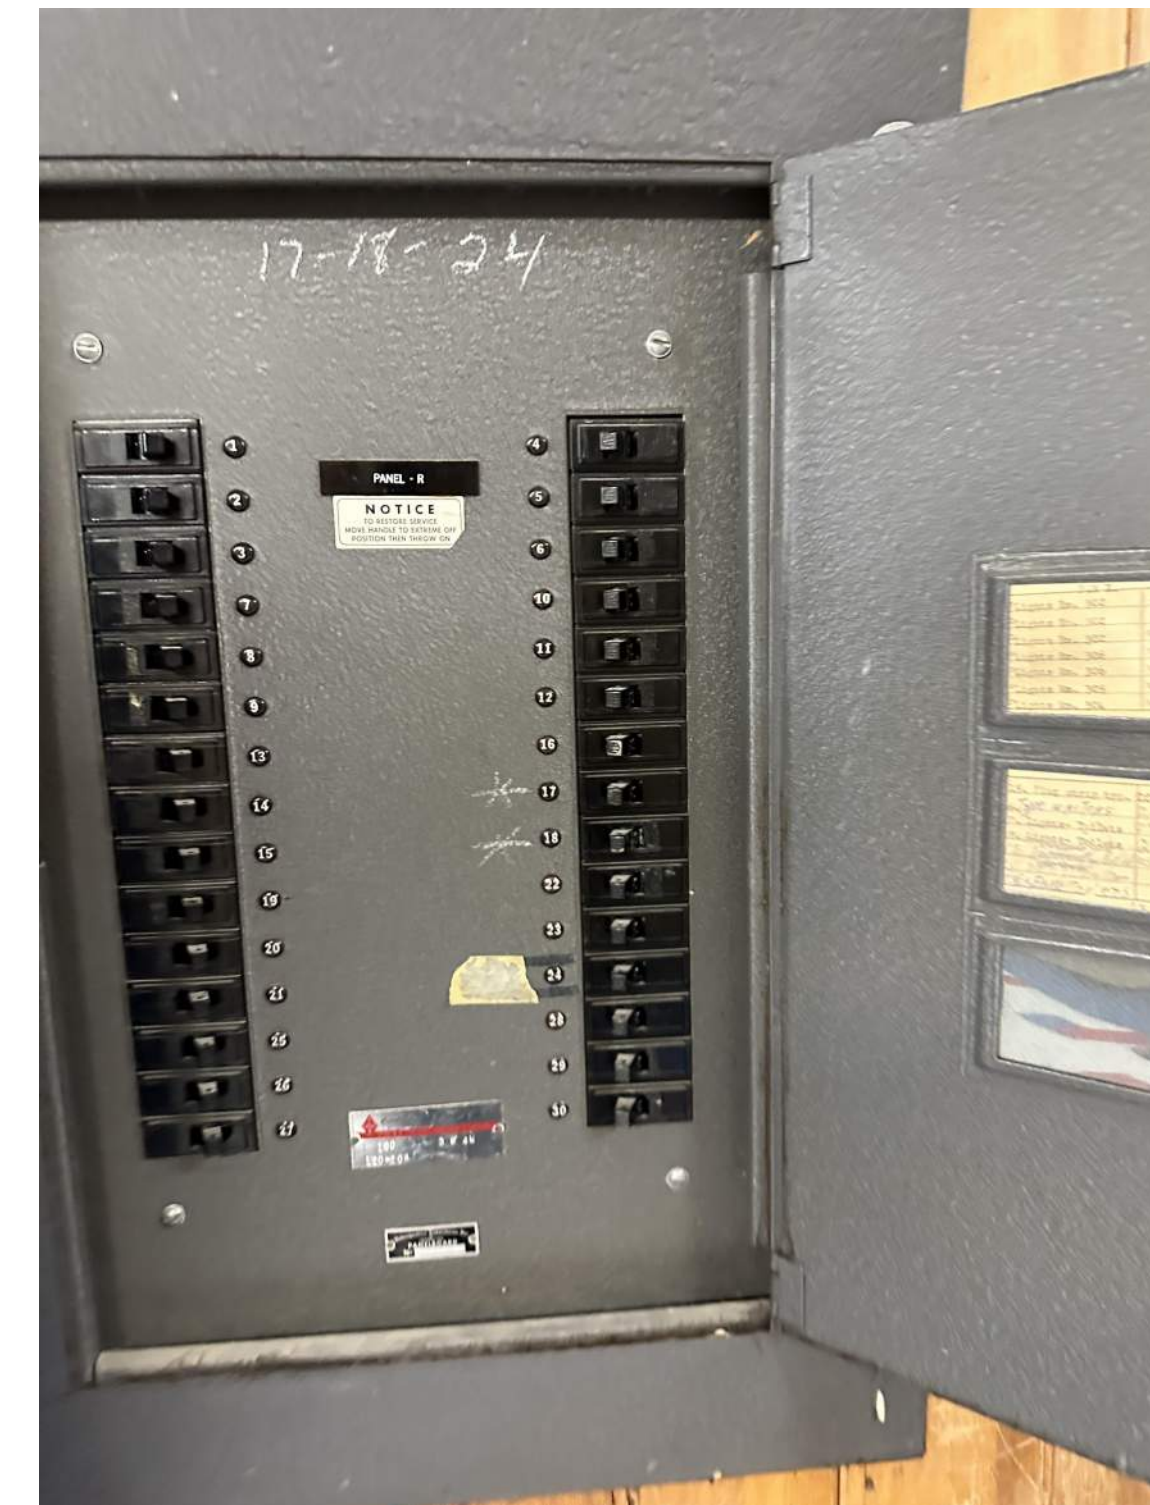
Electrical switchgear and panels installed prior to 1986 exceed useful life.
