COMMUNITY BOND ADVISORY COMMITTEE MEETING #3

Central Linn School District
March 19, 2024

FACILITY ASSESSMENT EXECUTIVE SUMMARY

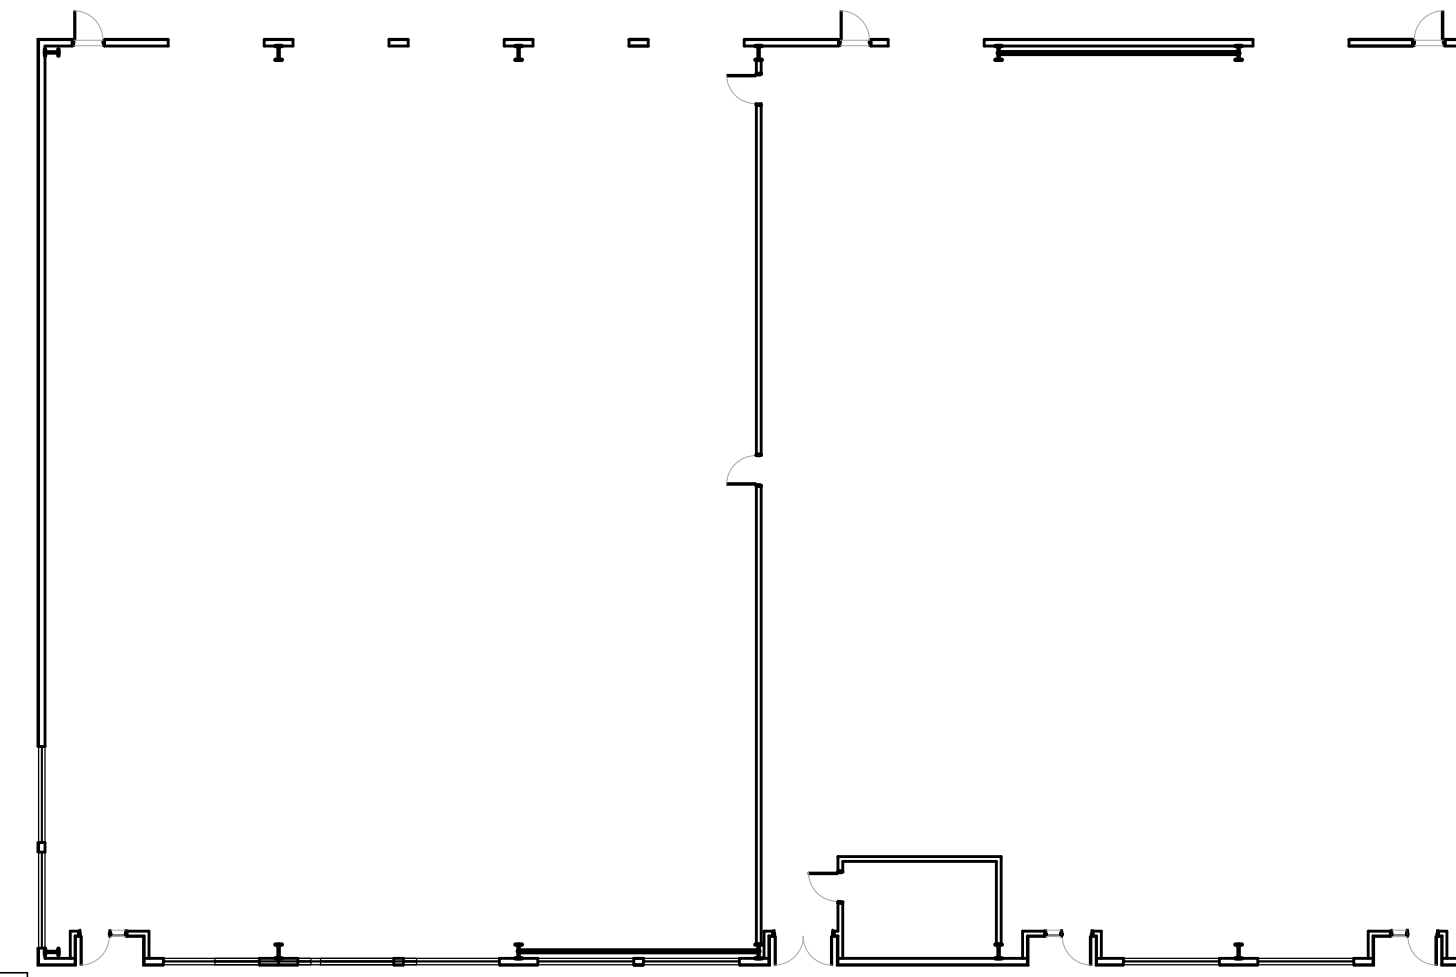
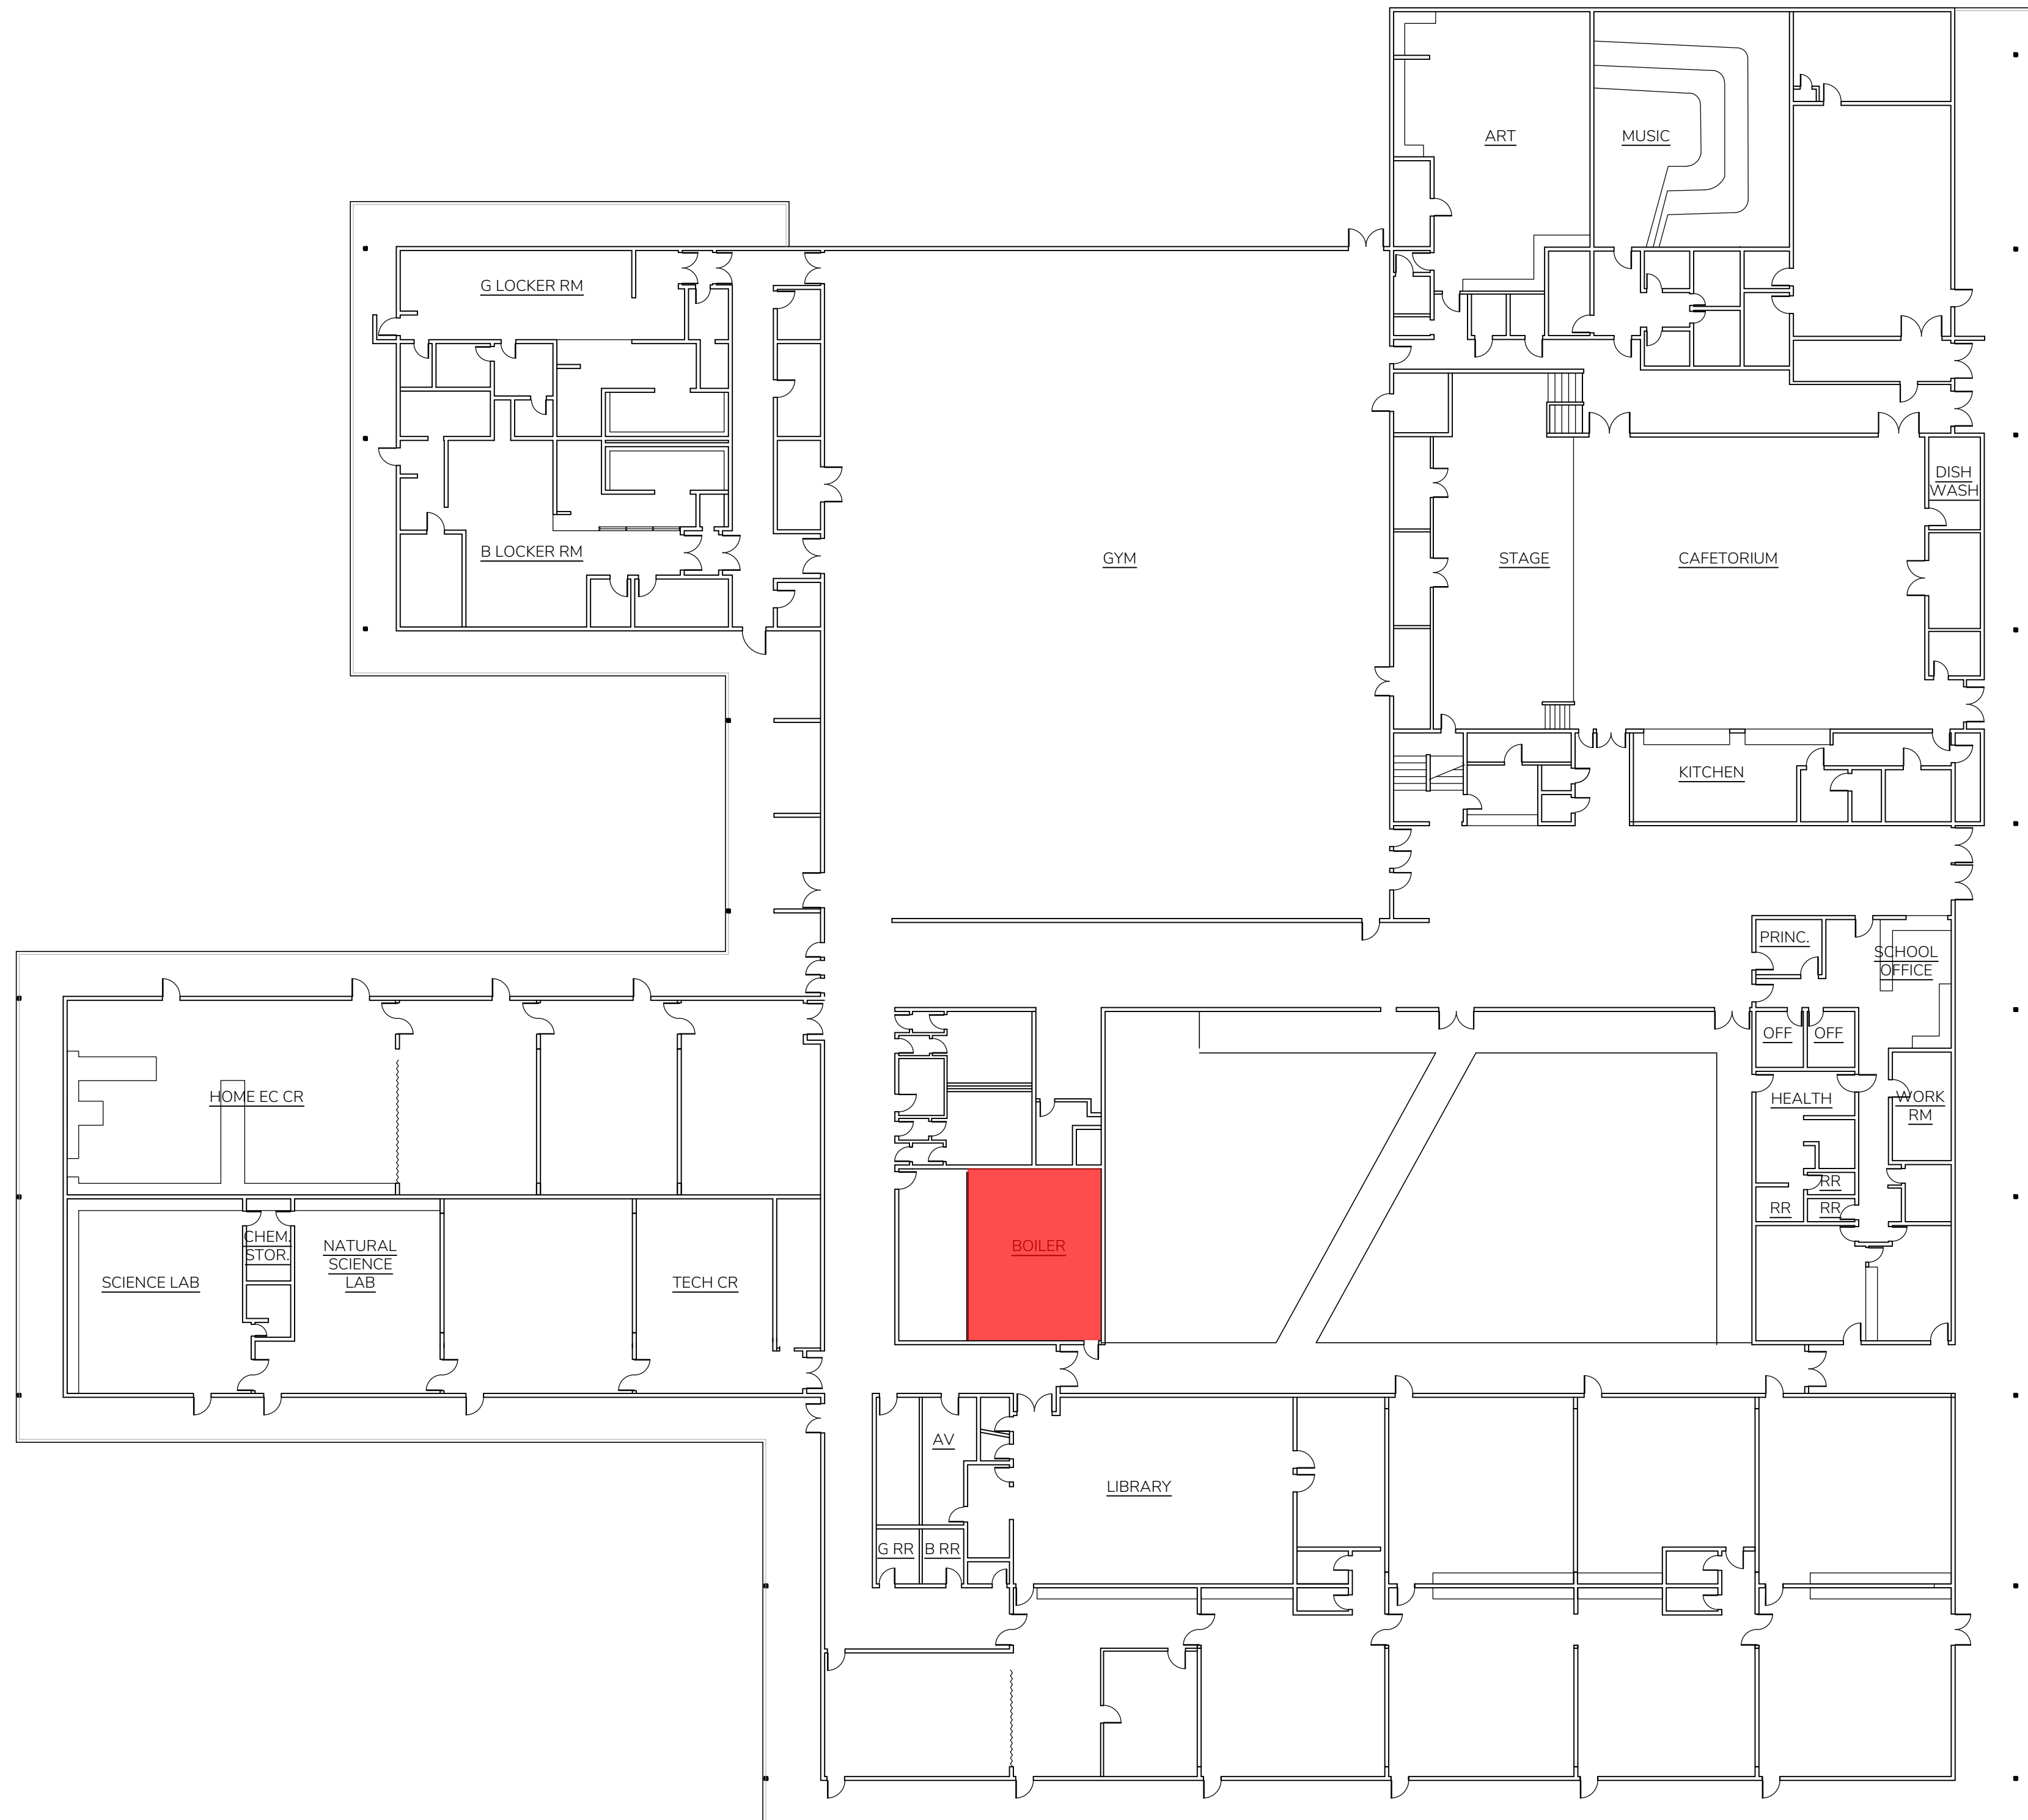
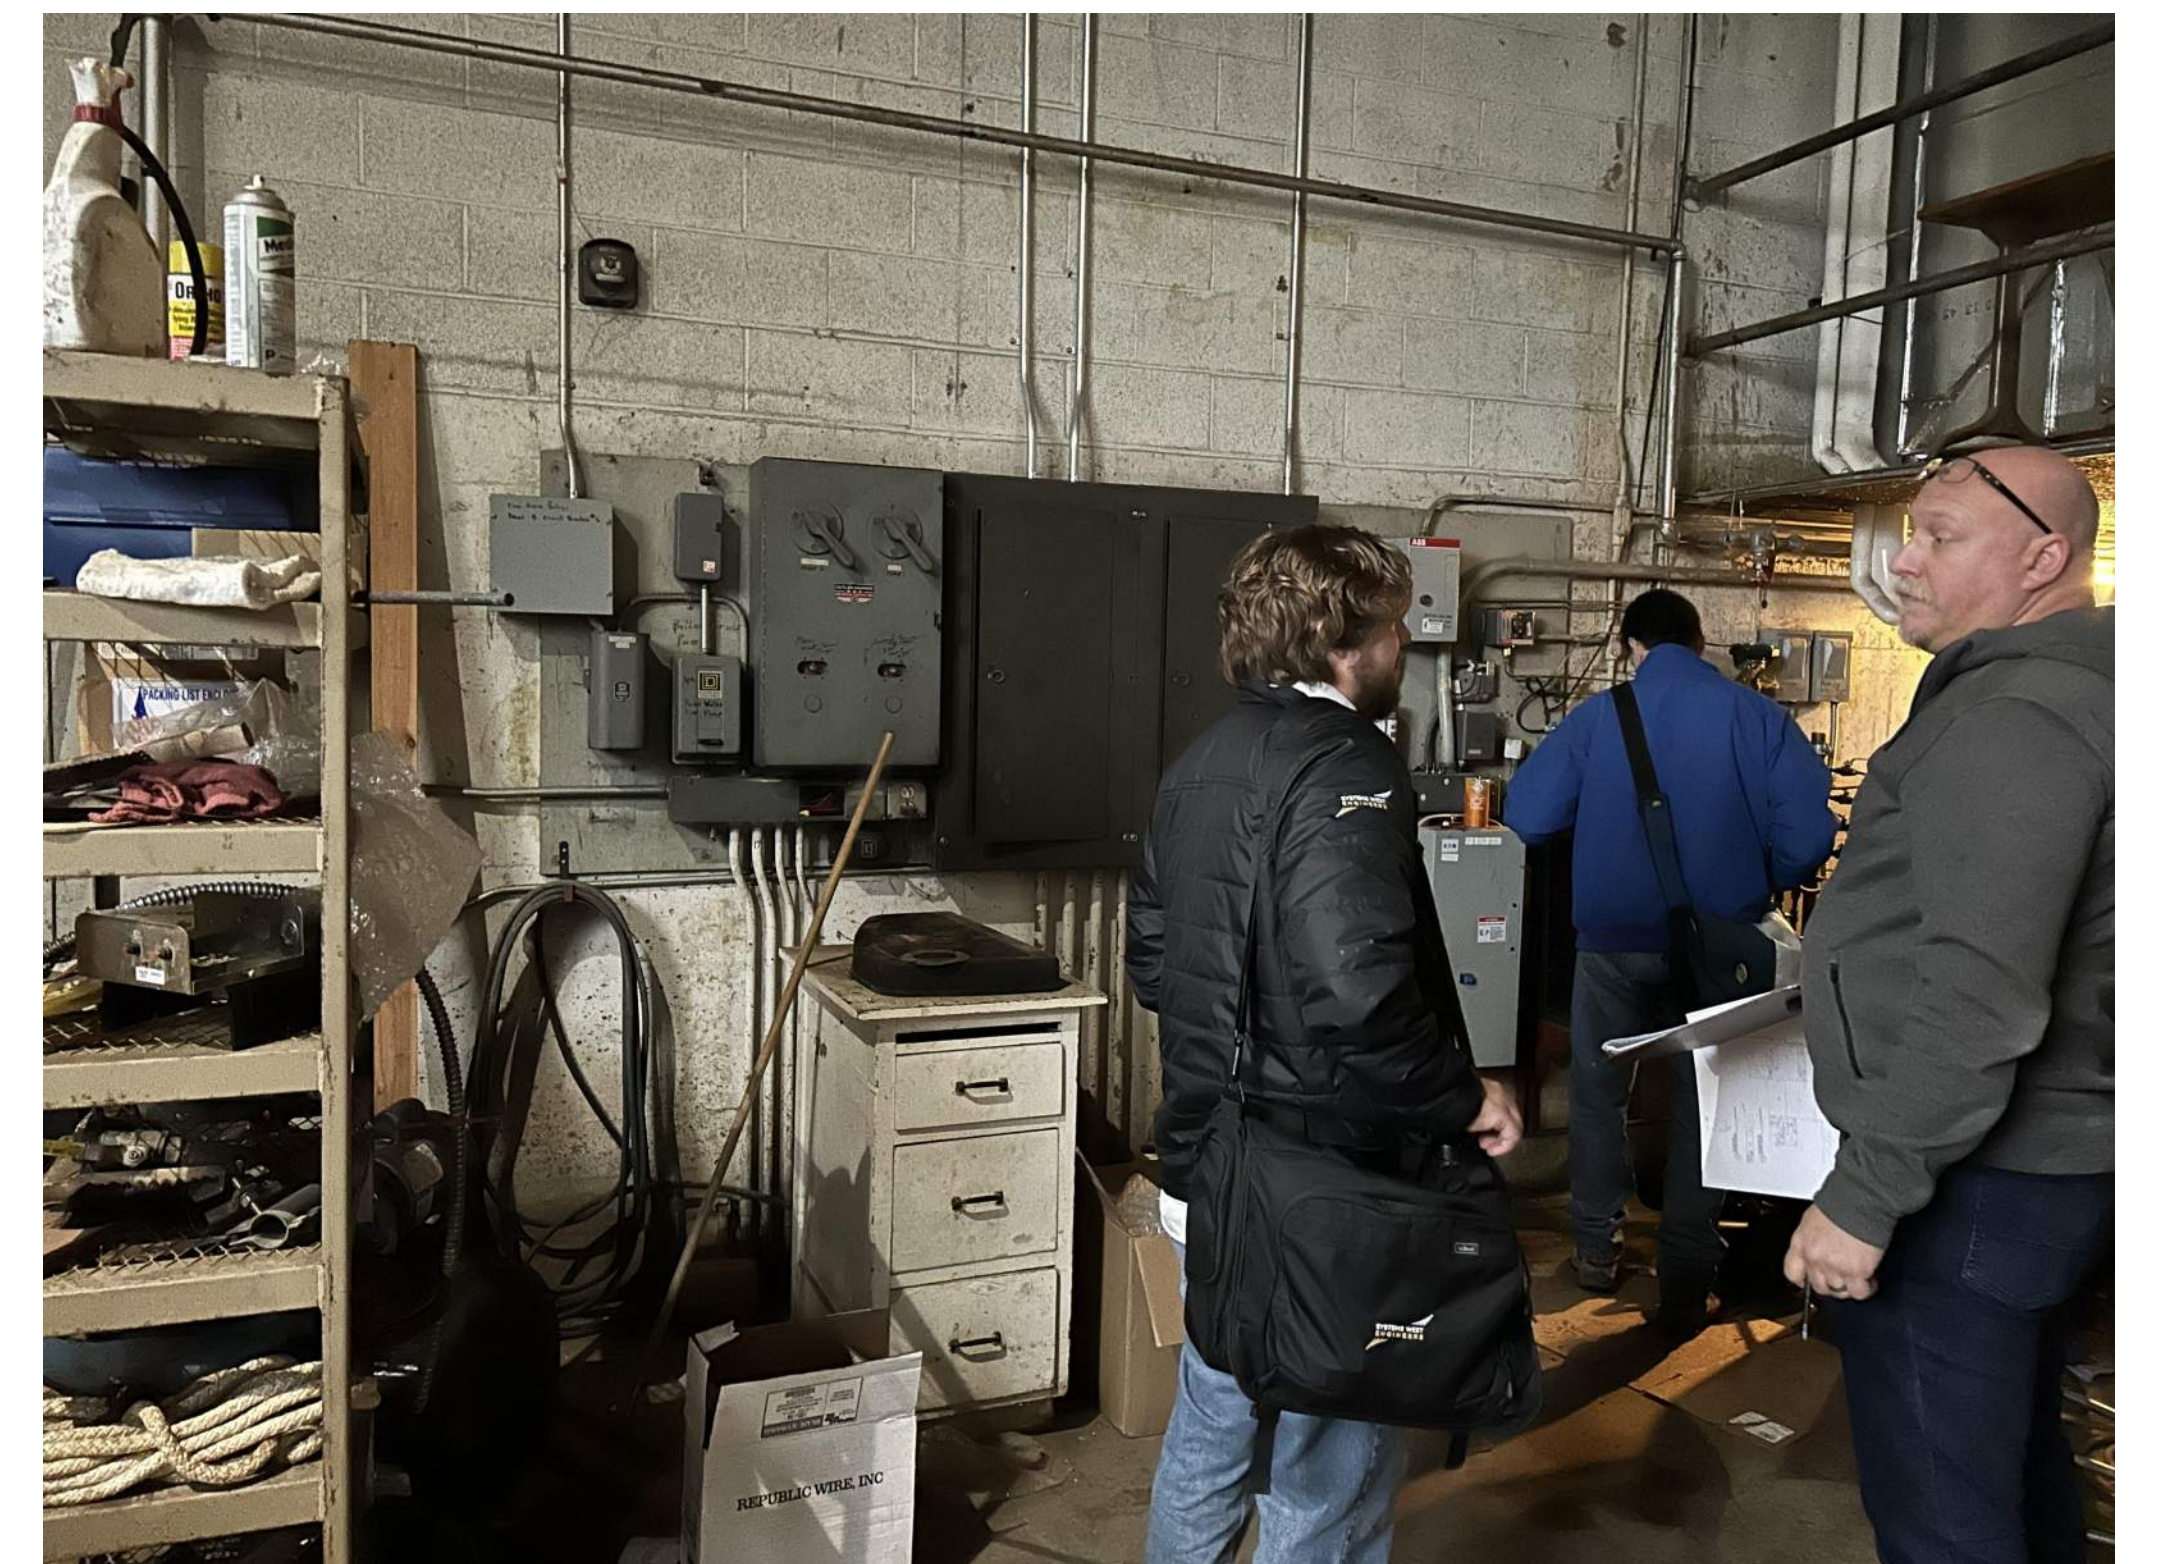
Electrical transformers are located in building, which is not typical.

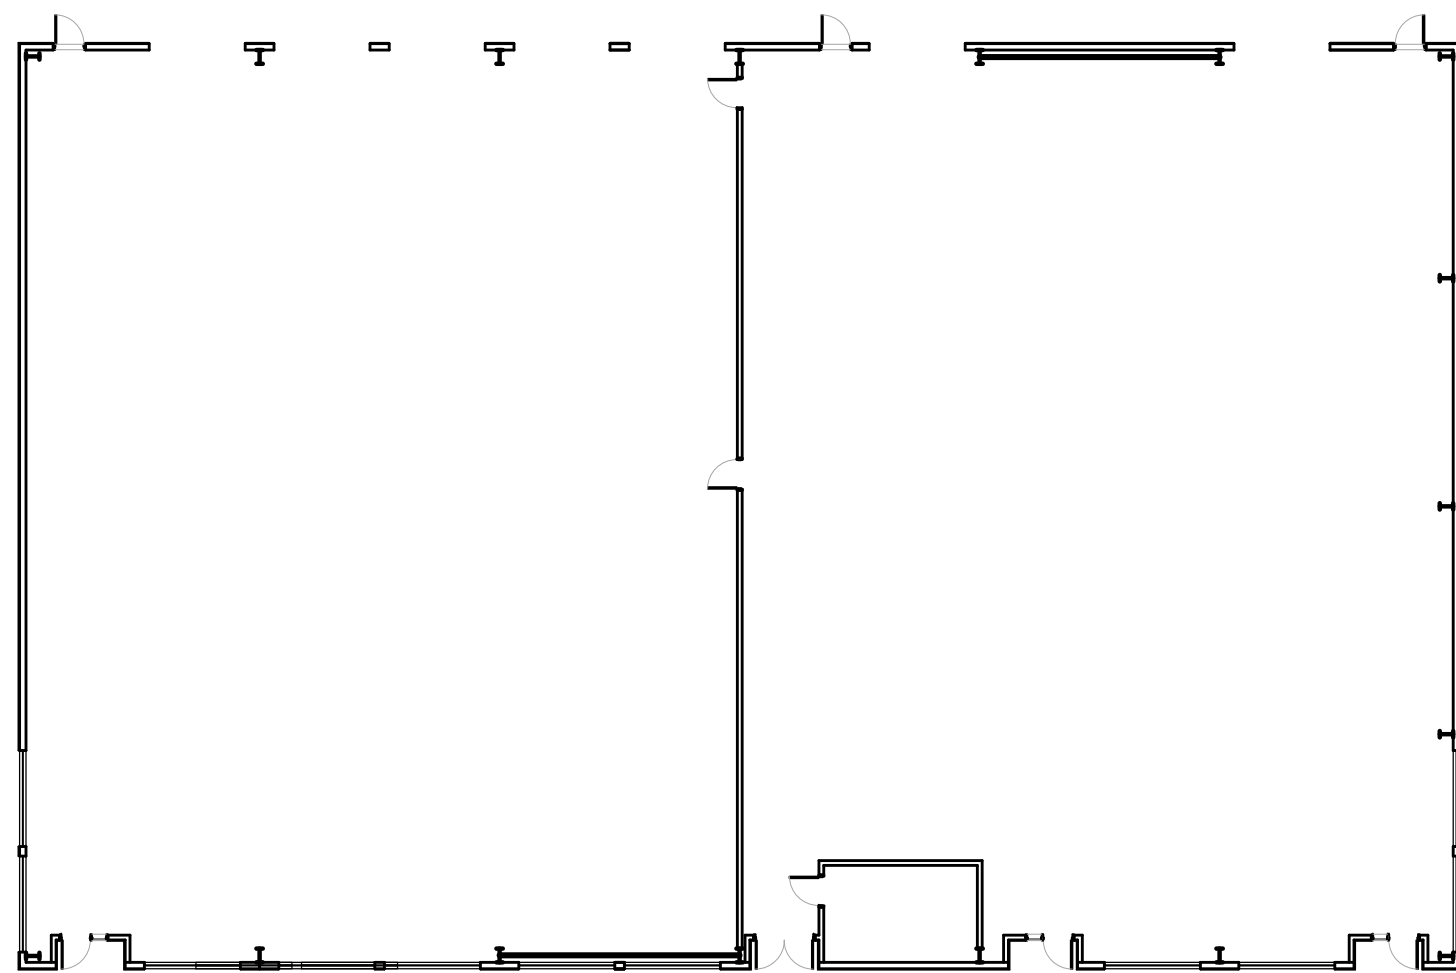
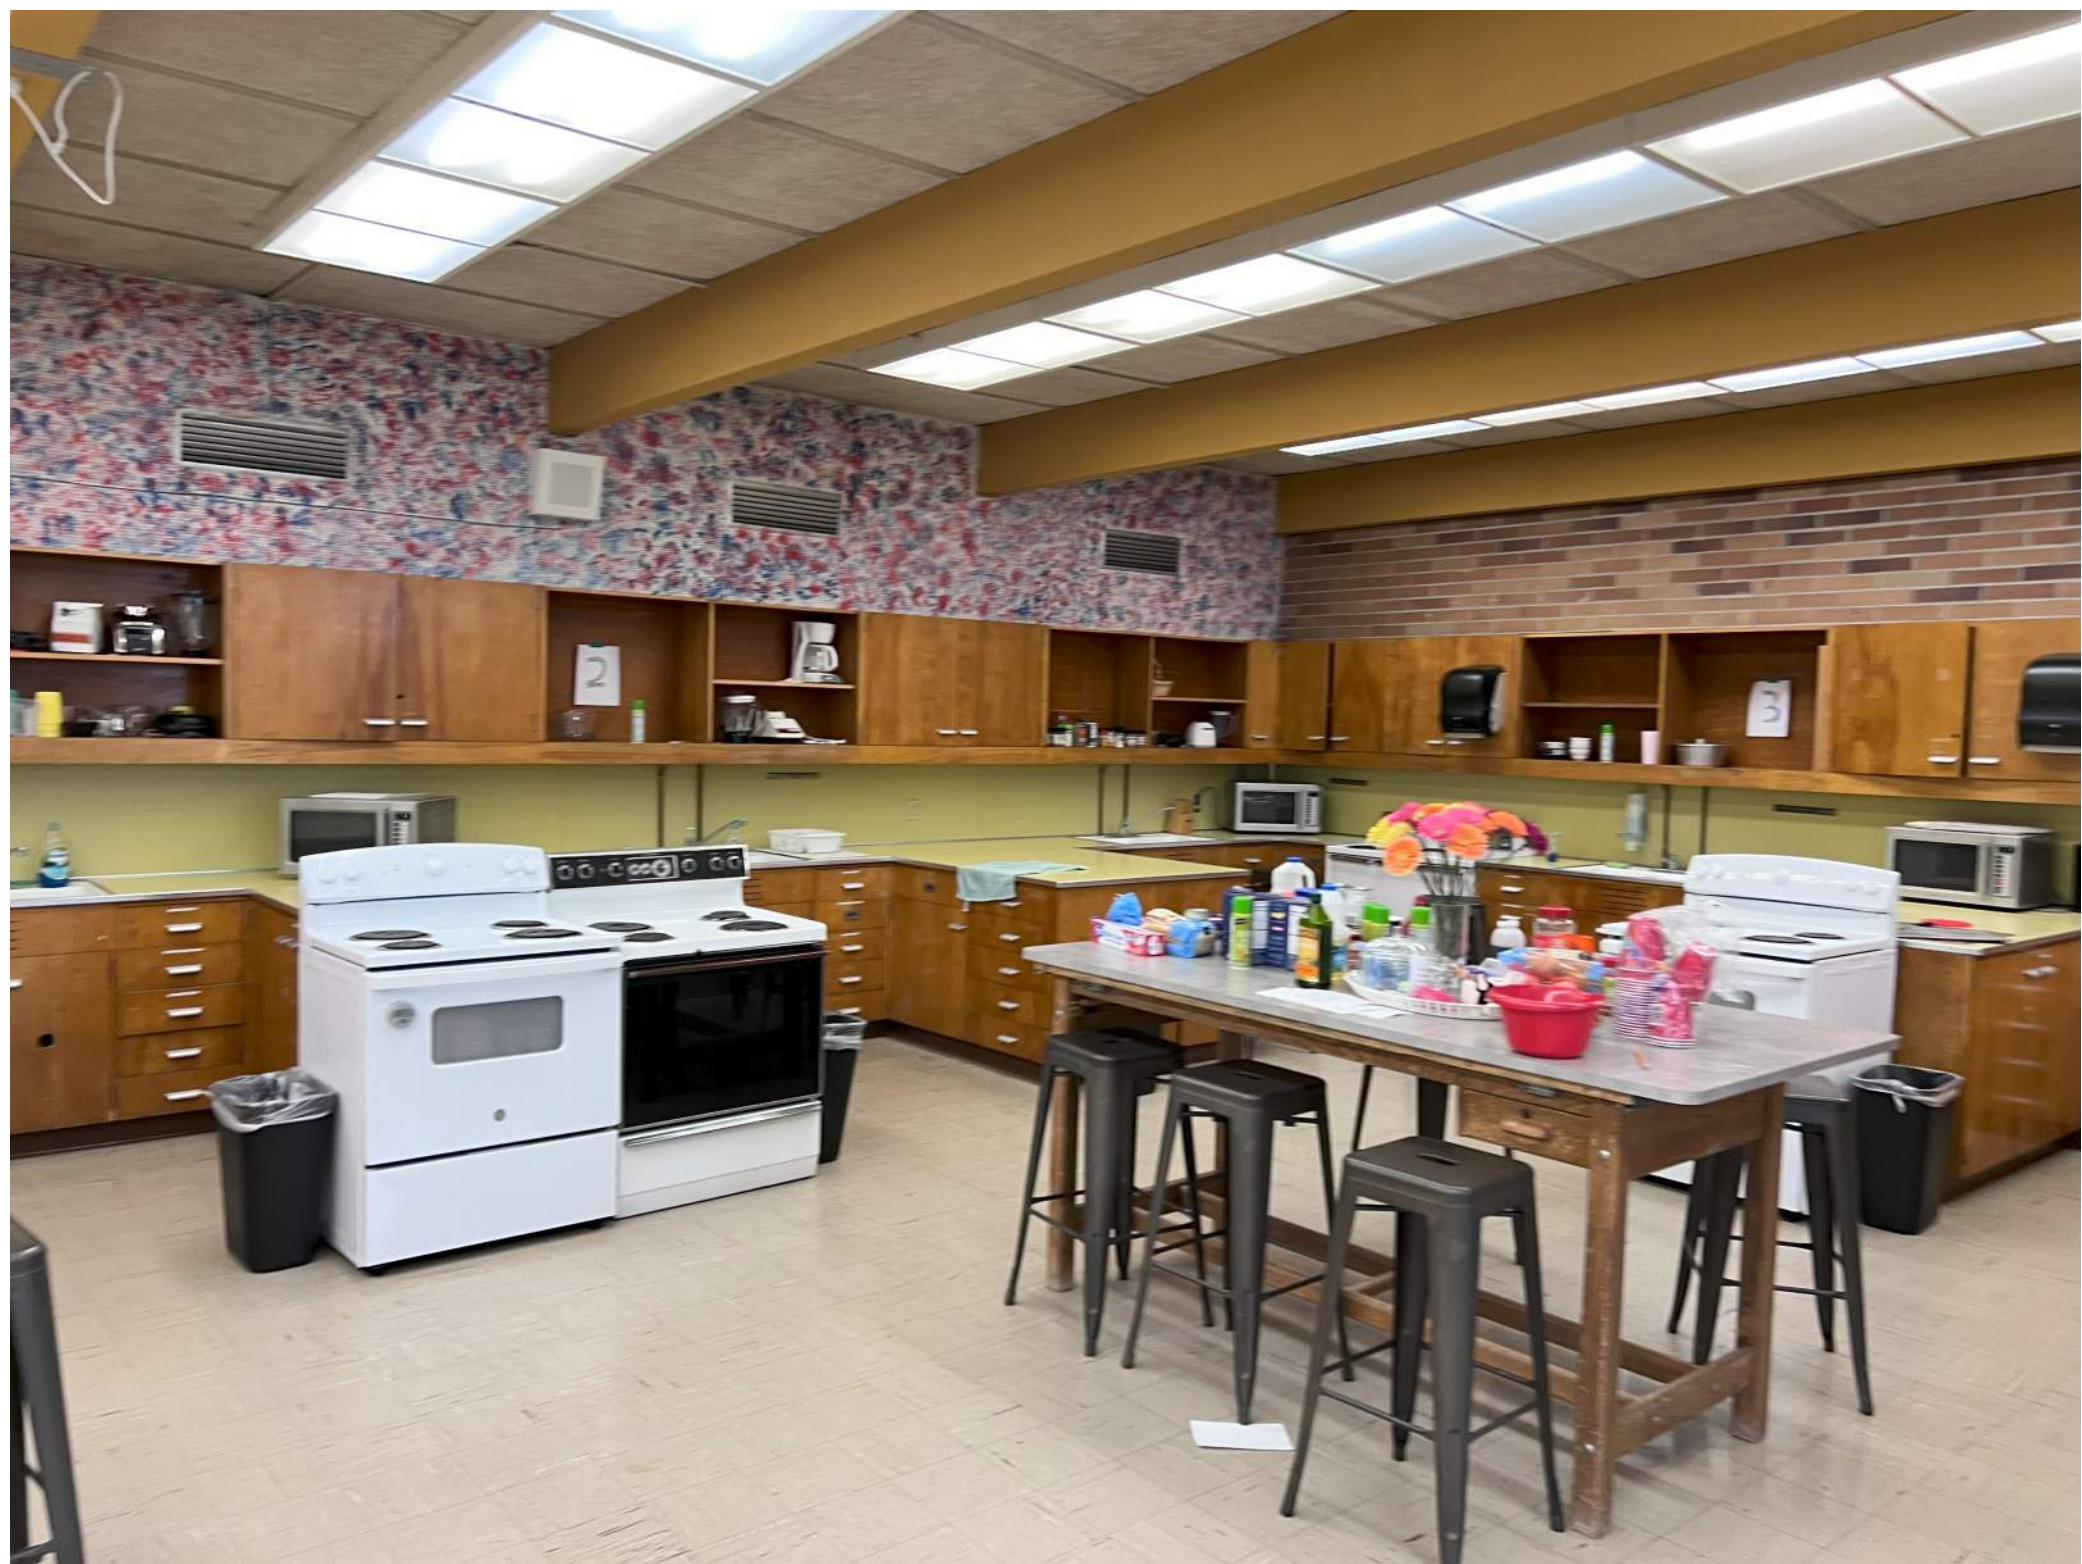
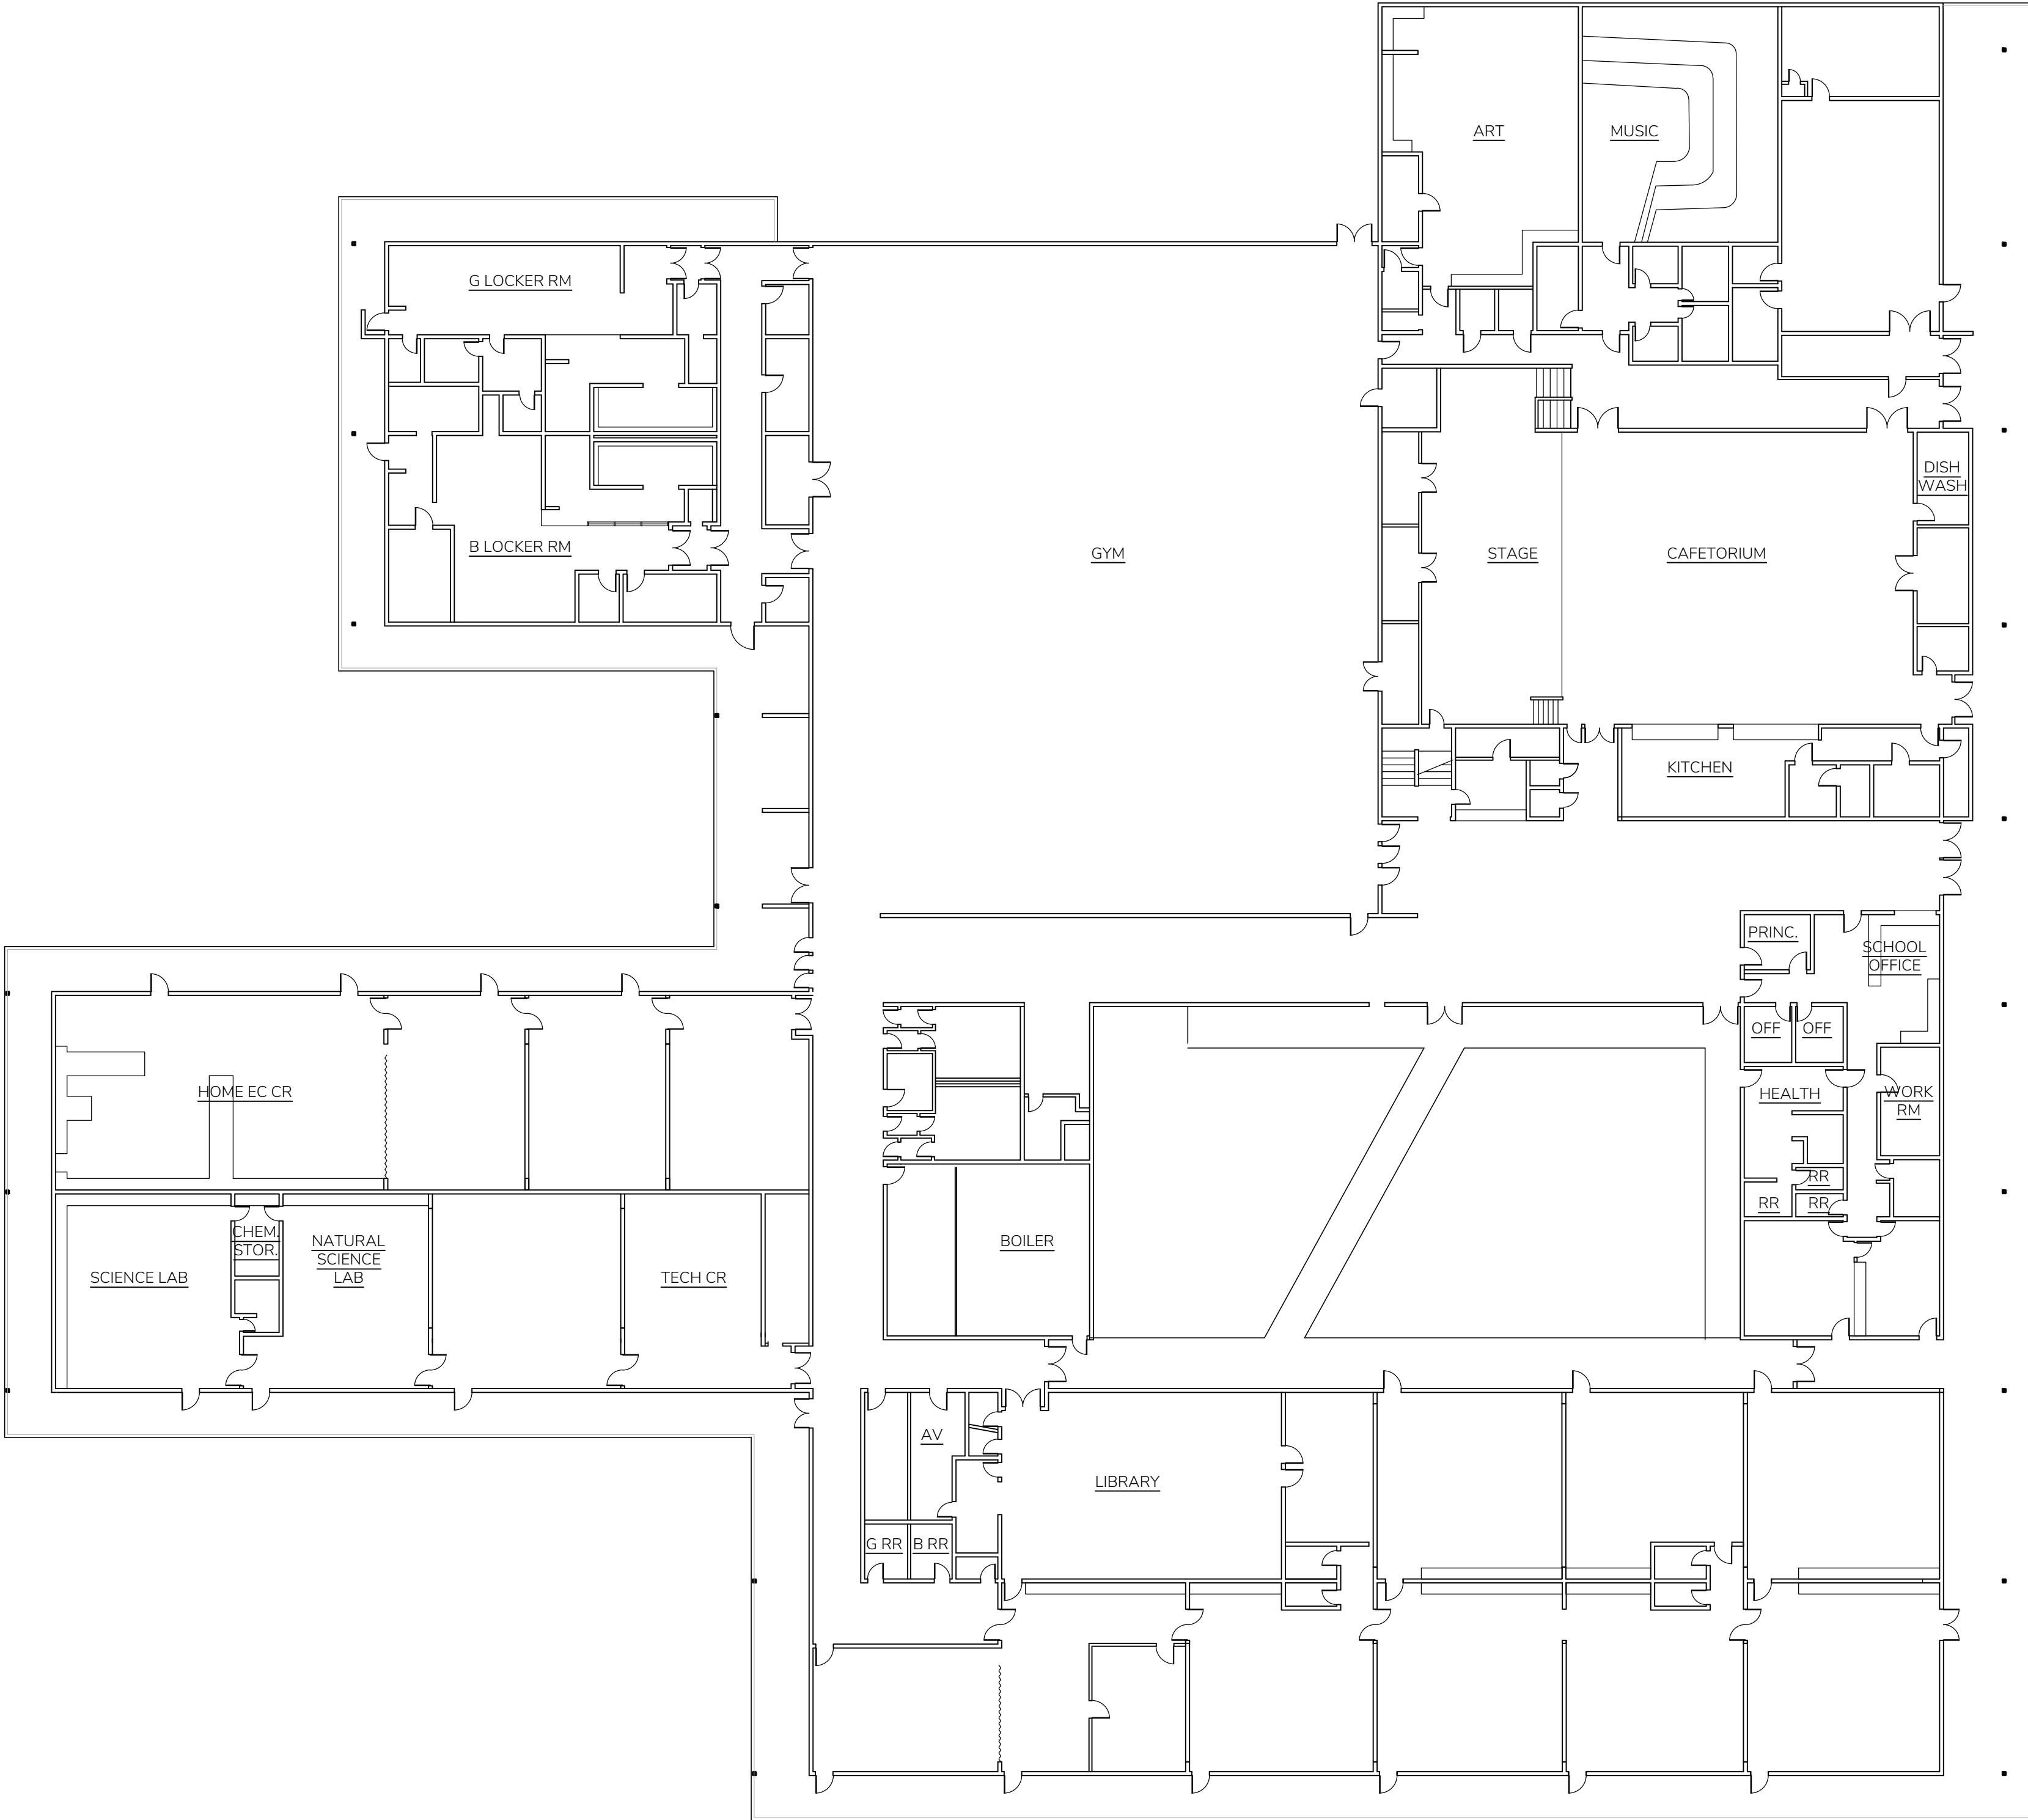
Original materials and surfaces are worn and tired looking.
