COMMUNITY BOND ADVISORY COMMITTEE MEETING #3

Central Linn School District
March 19, 2024

FACILITY ASSESSMENT EXECUTIVE SUMMARY

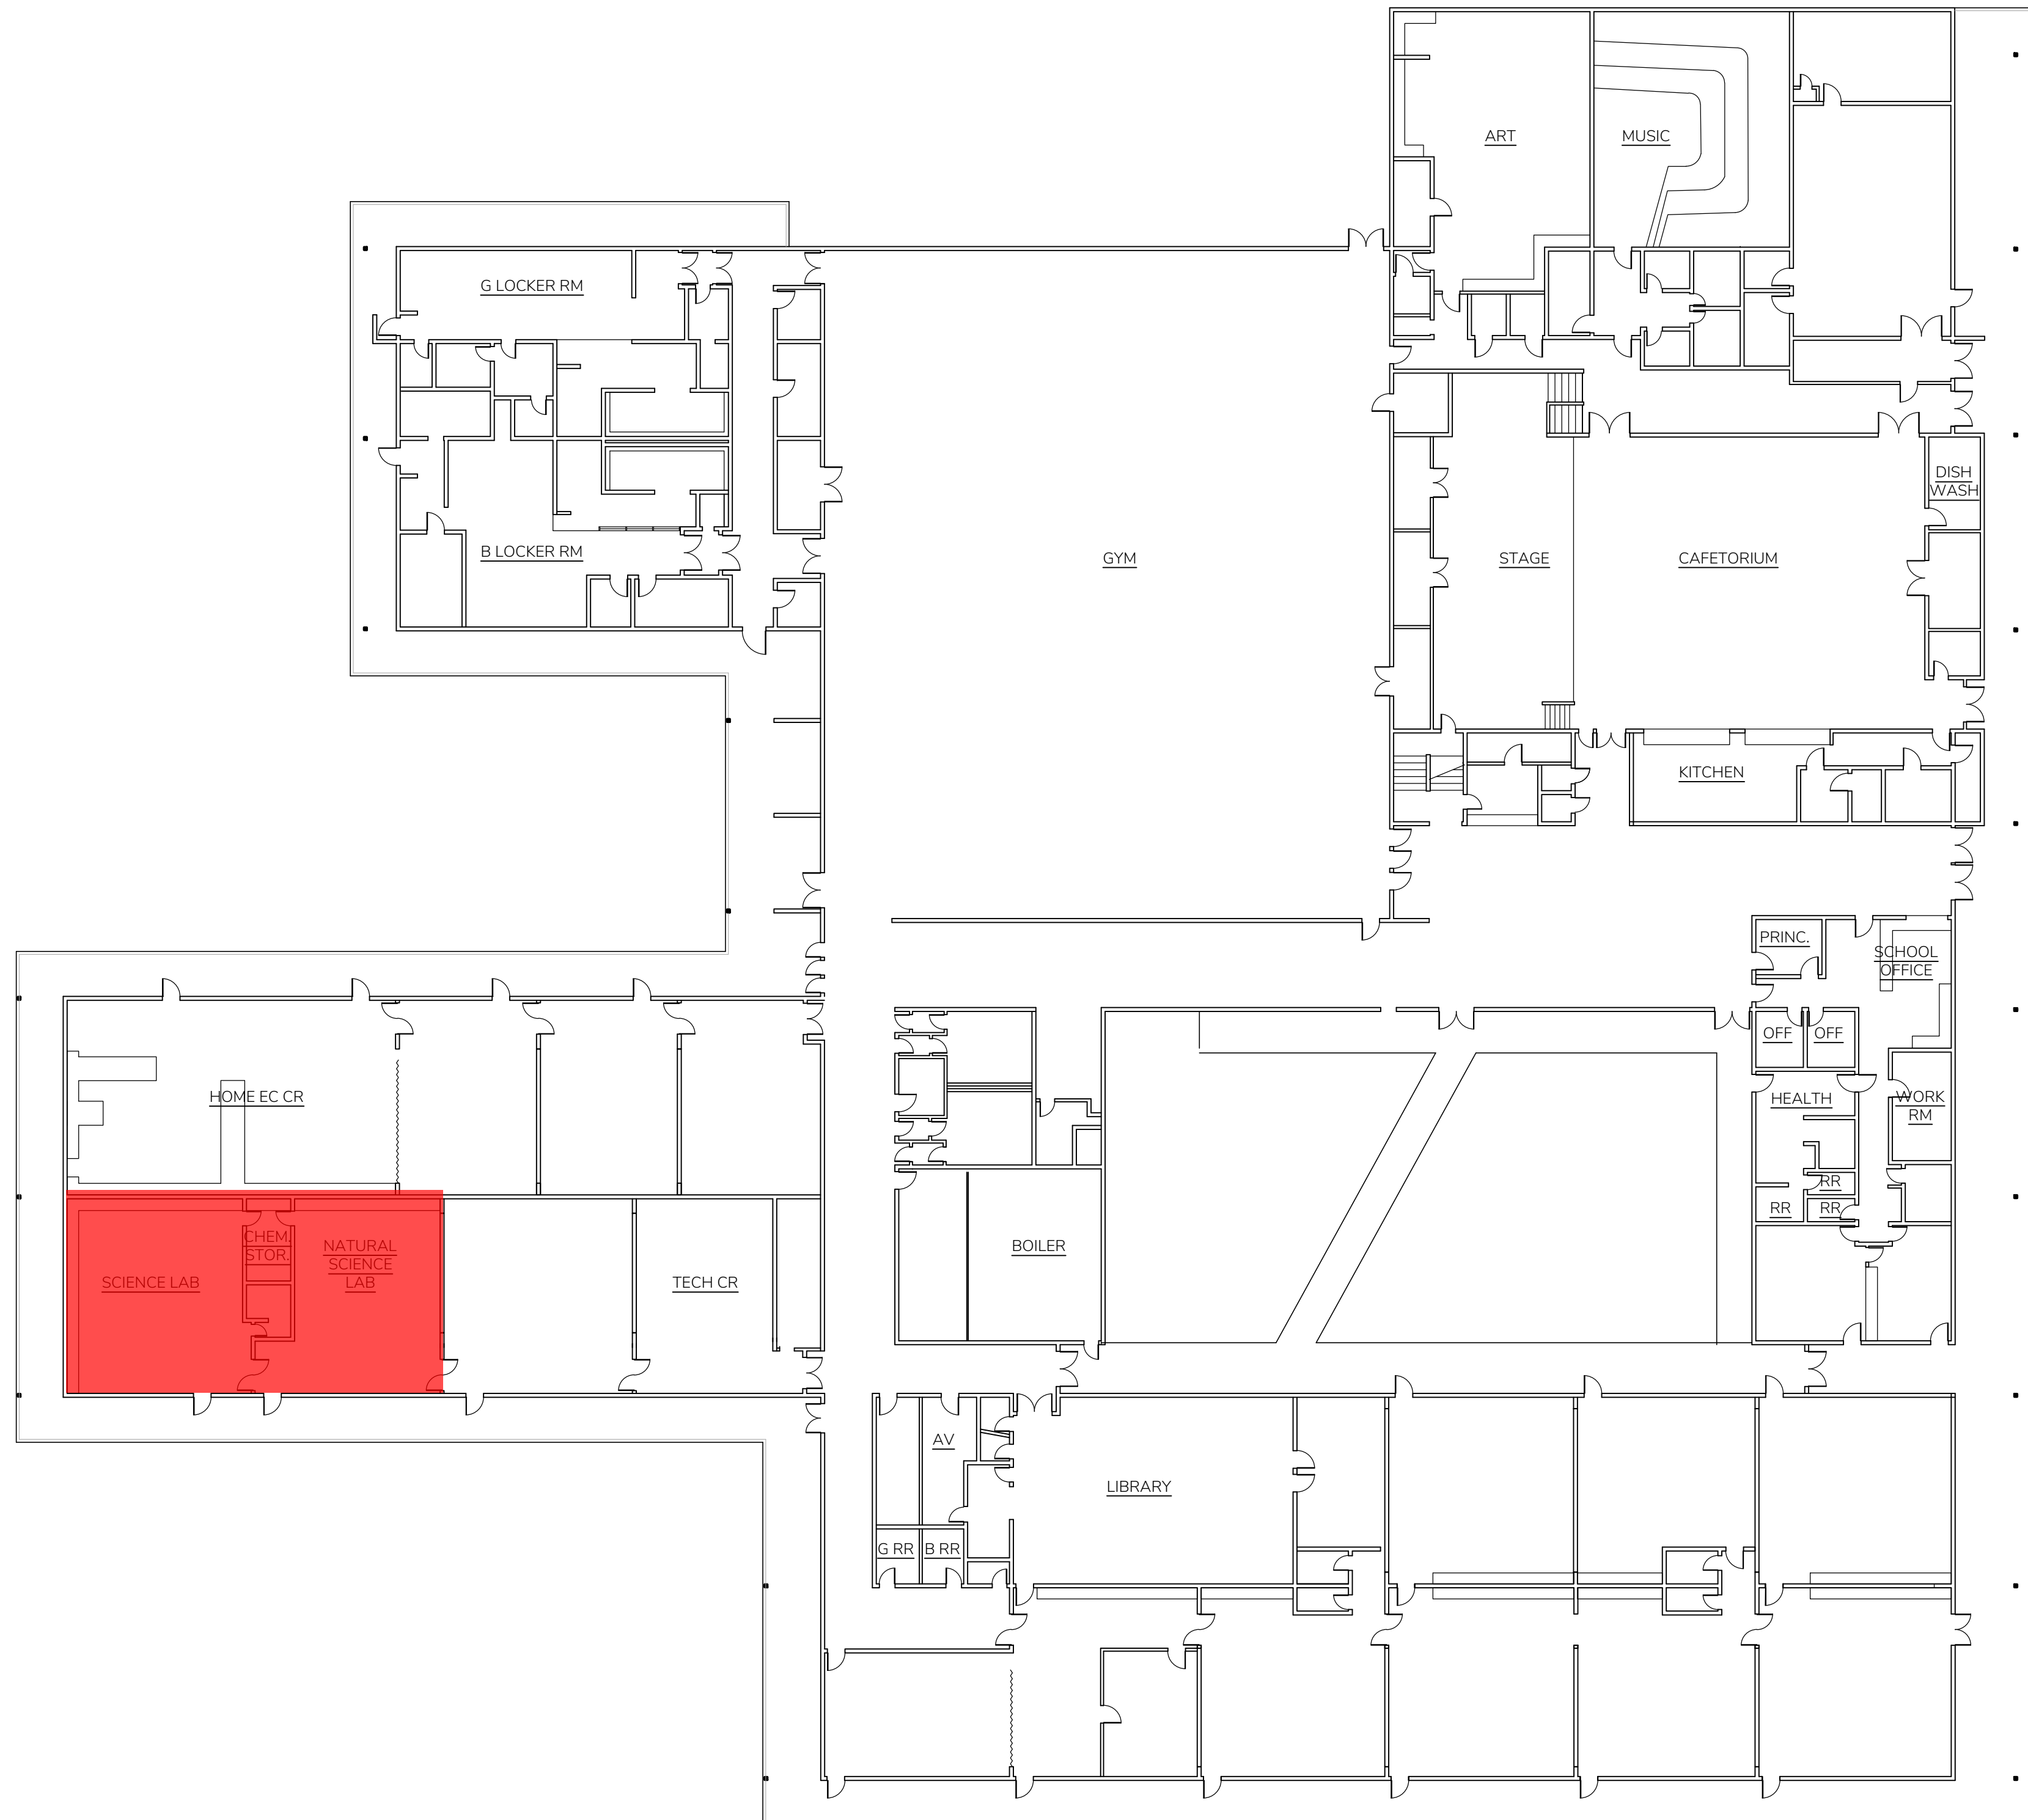
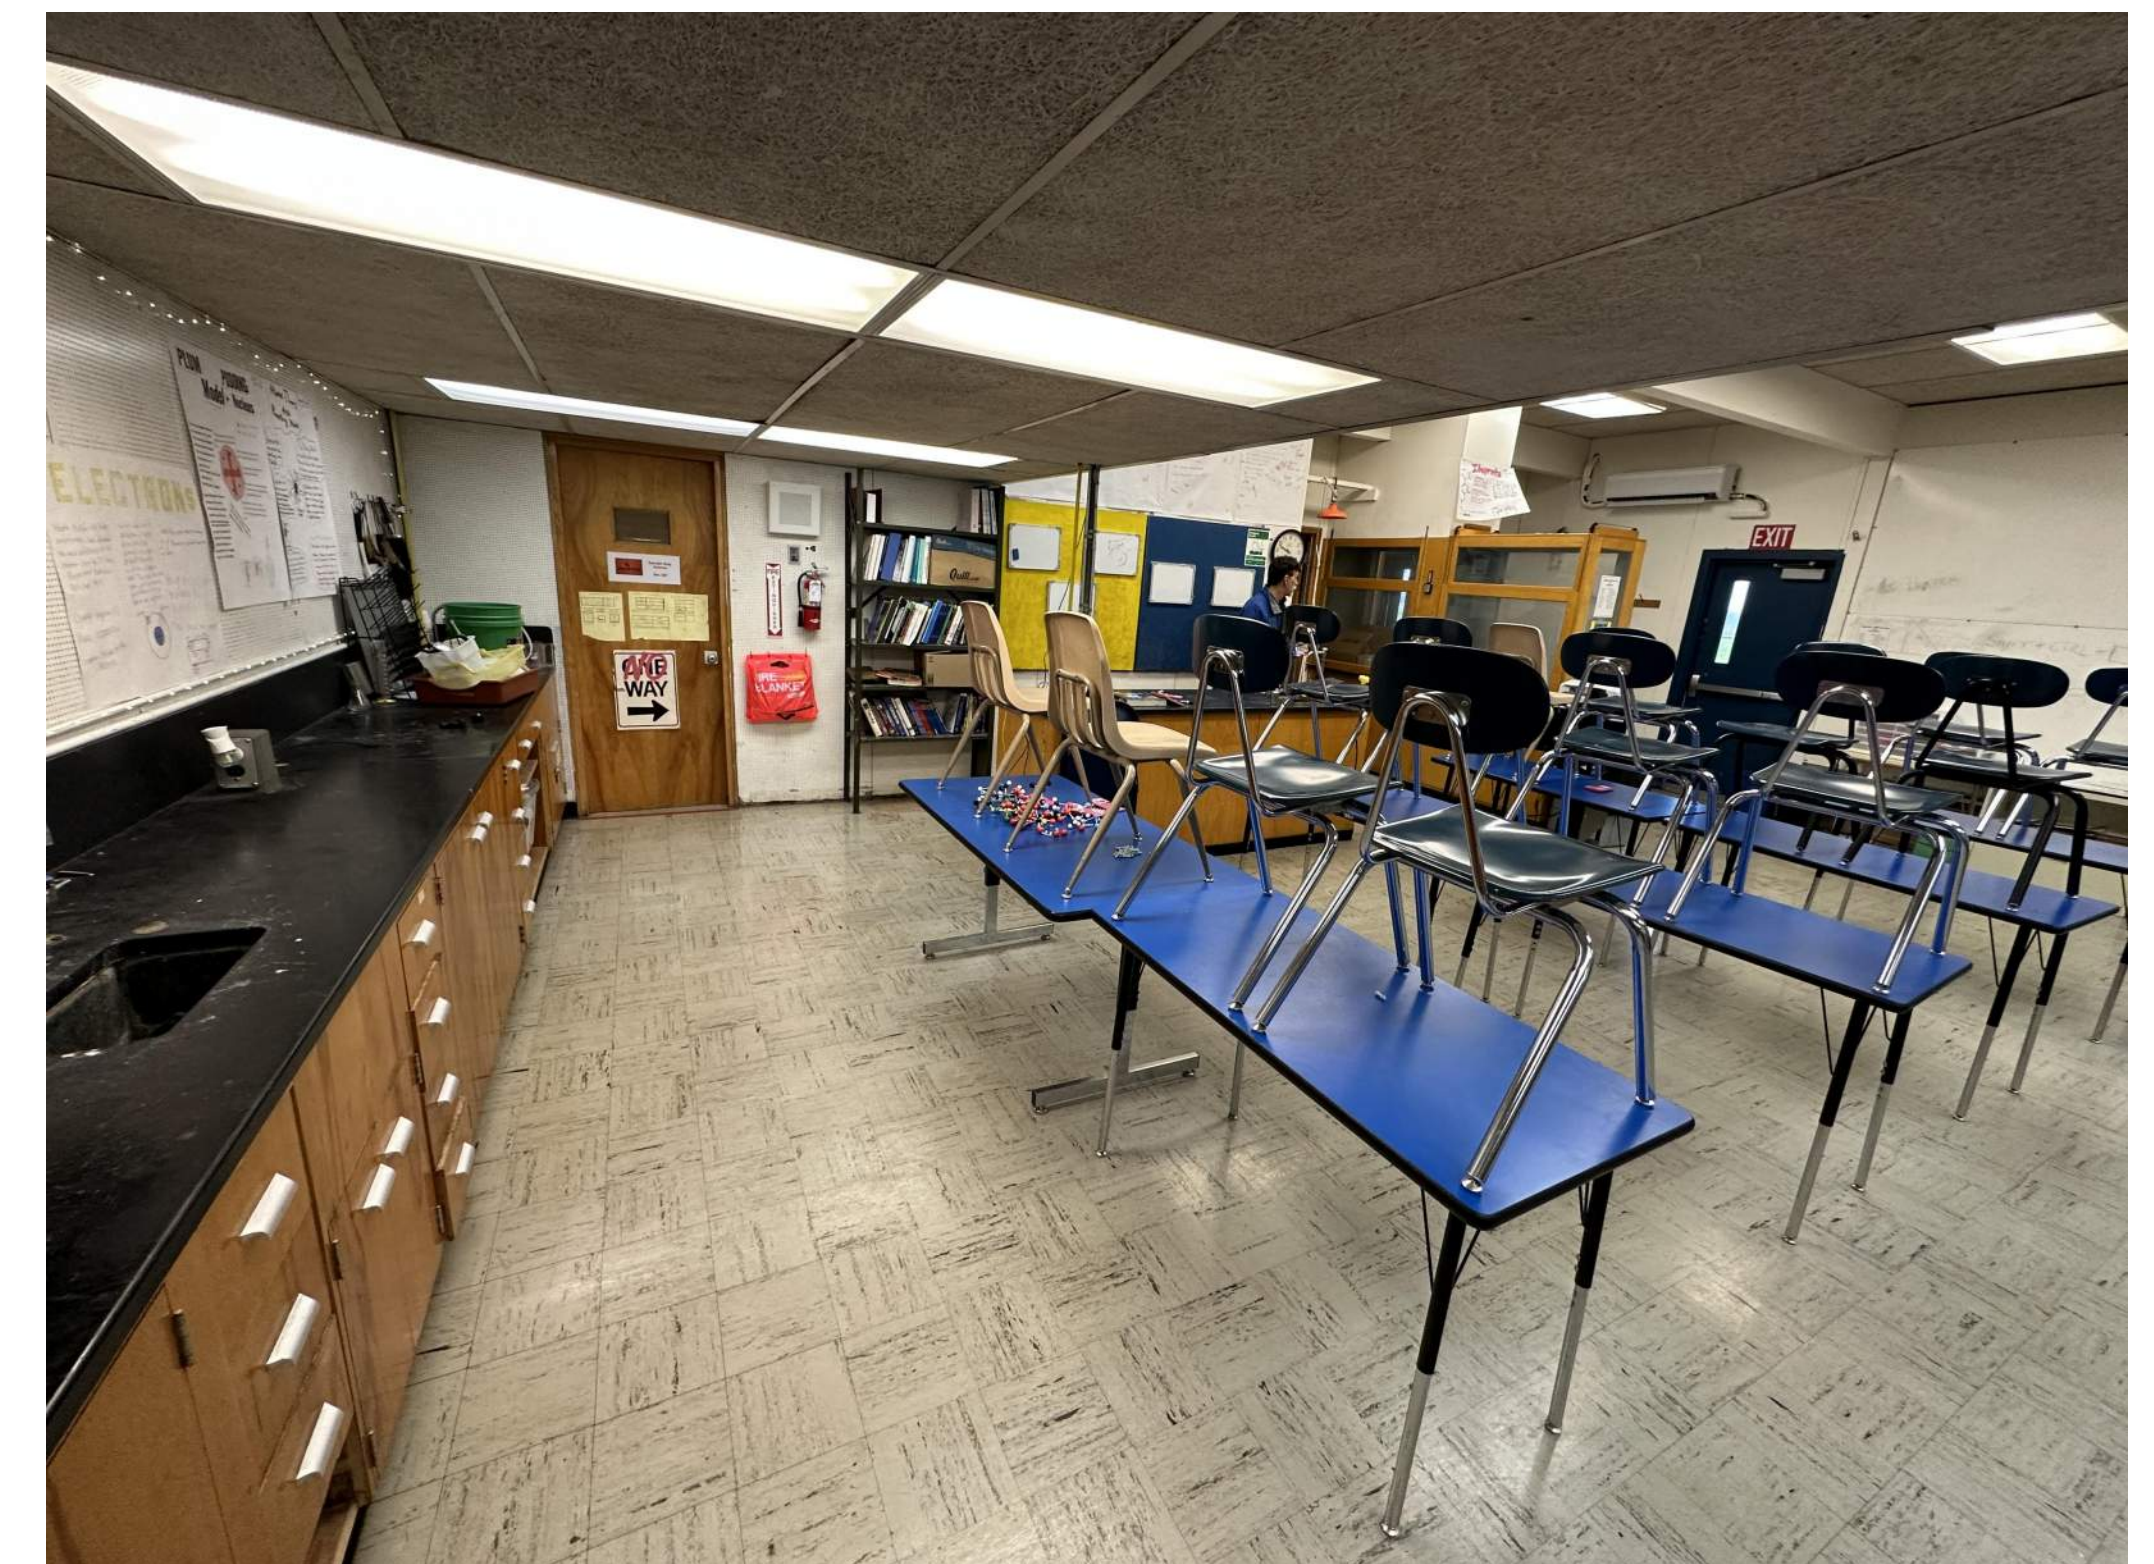
Equipment and storage in science classrooms does not meet current standards.

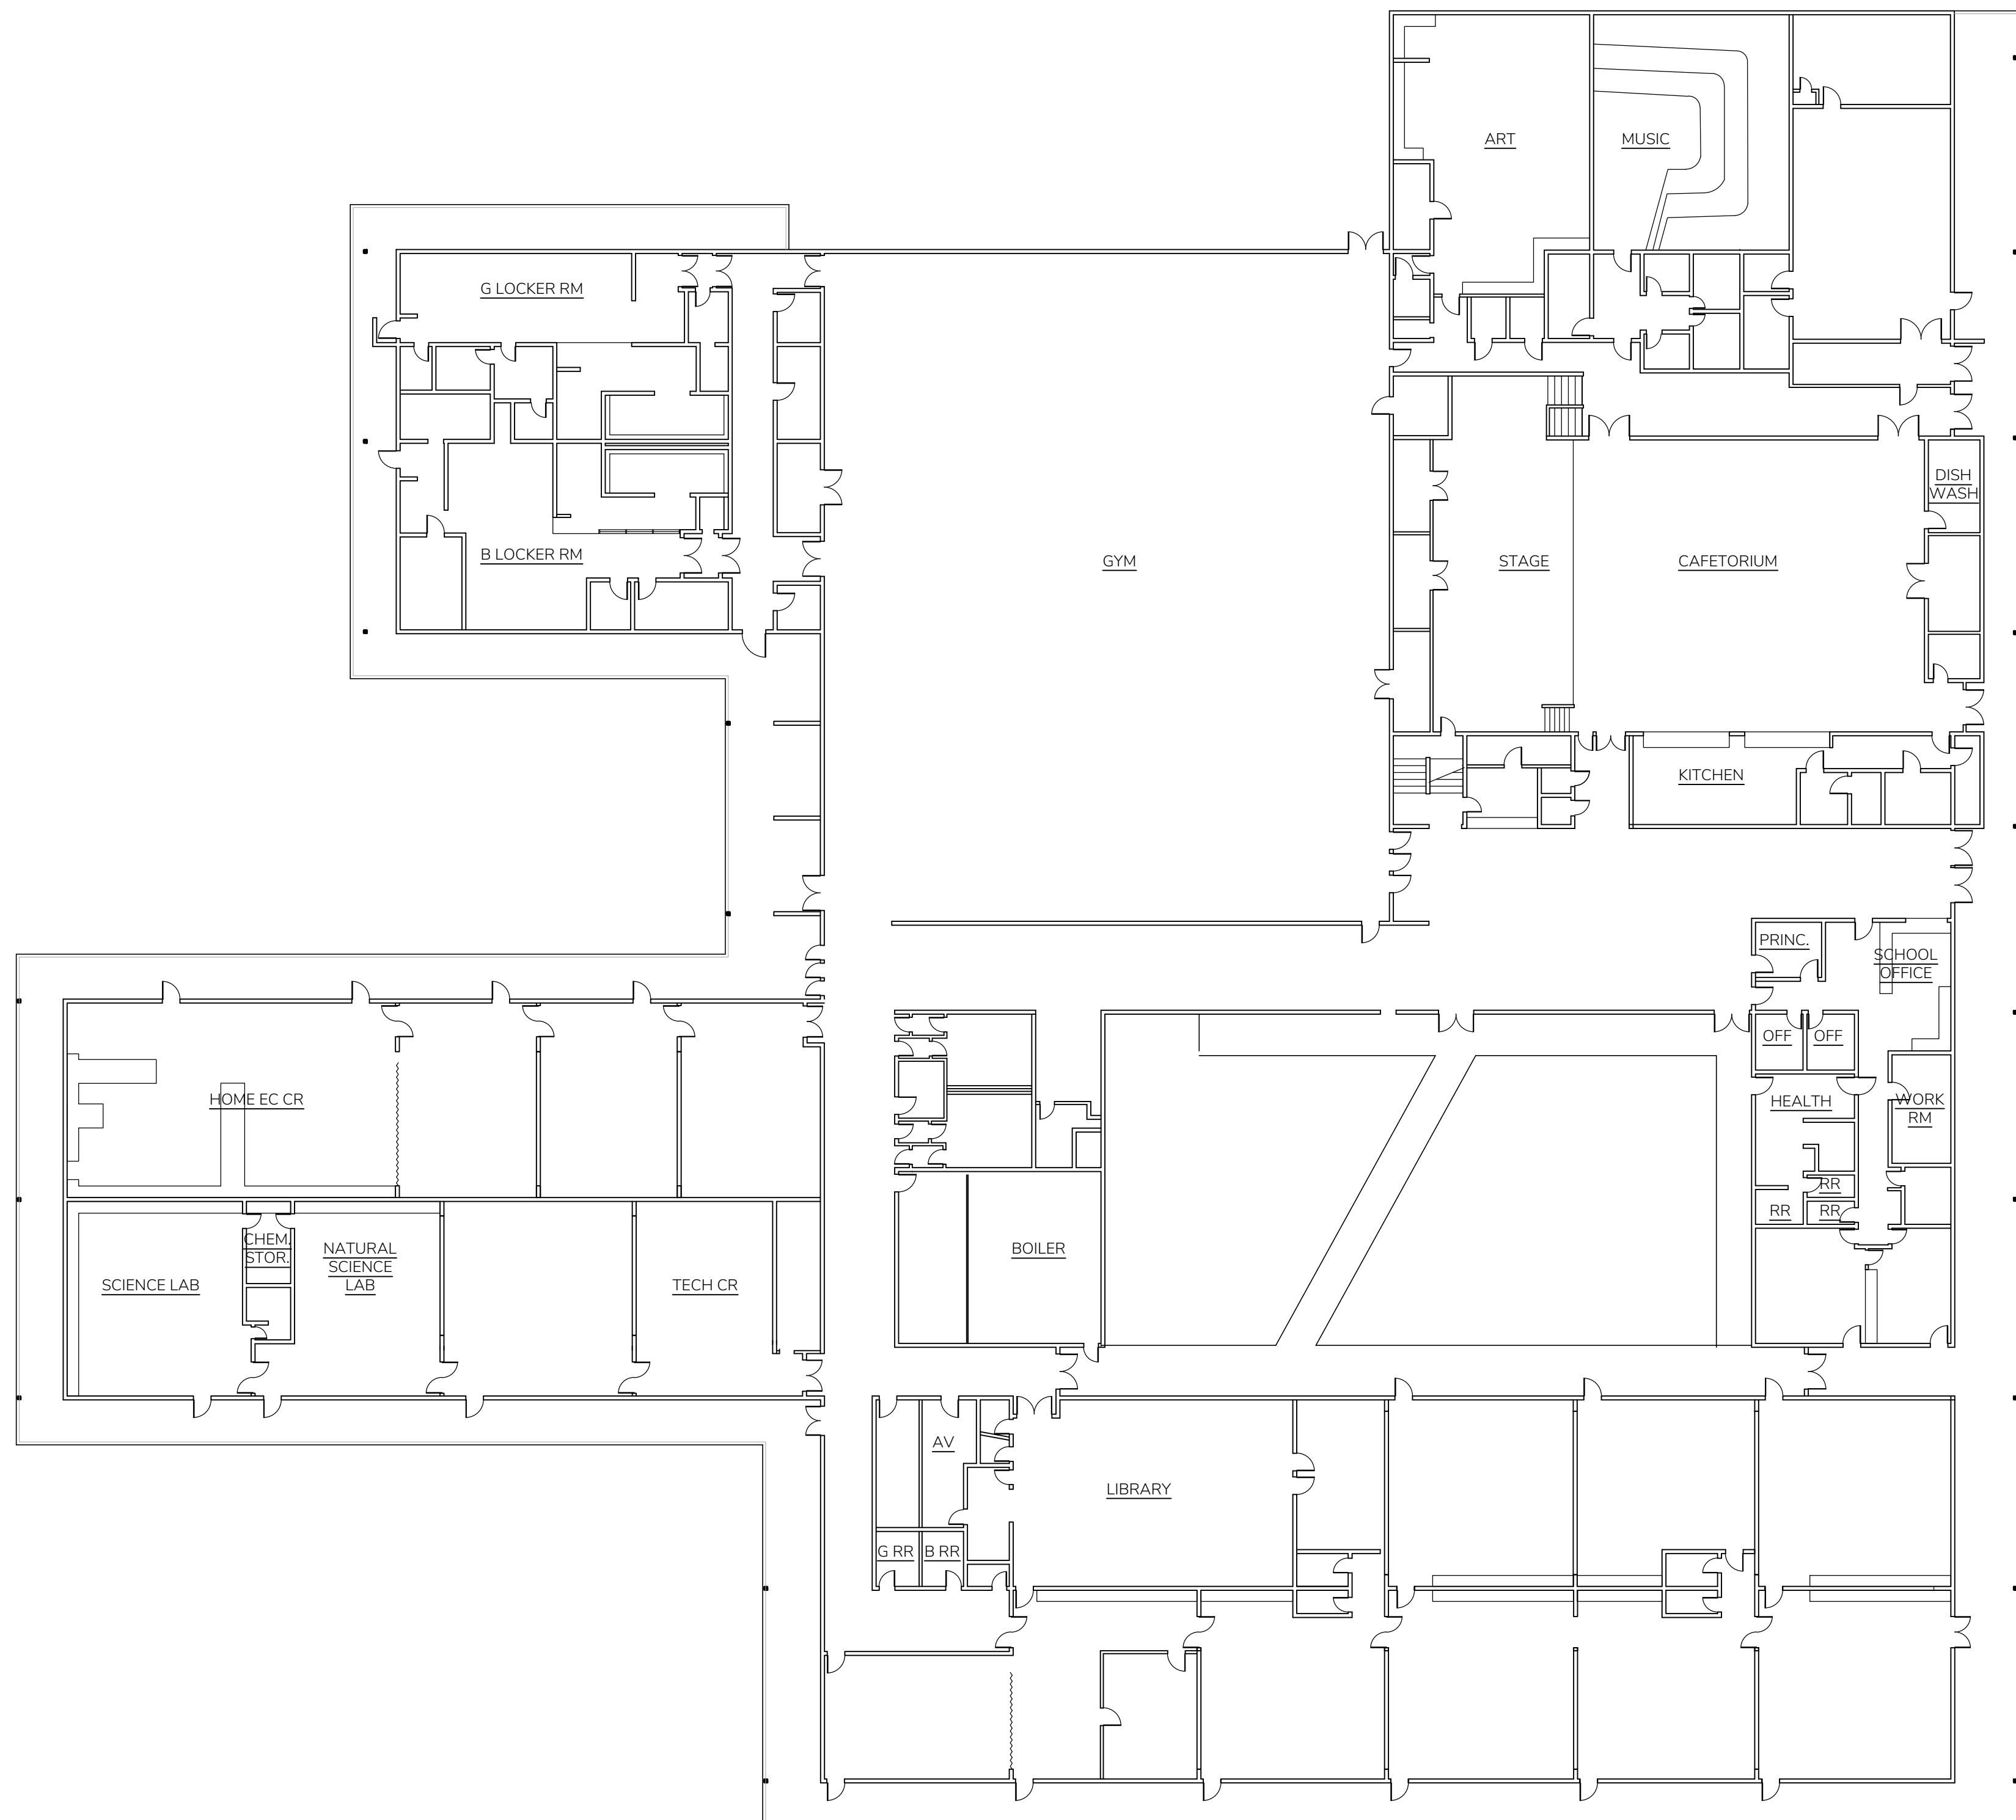
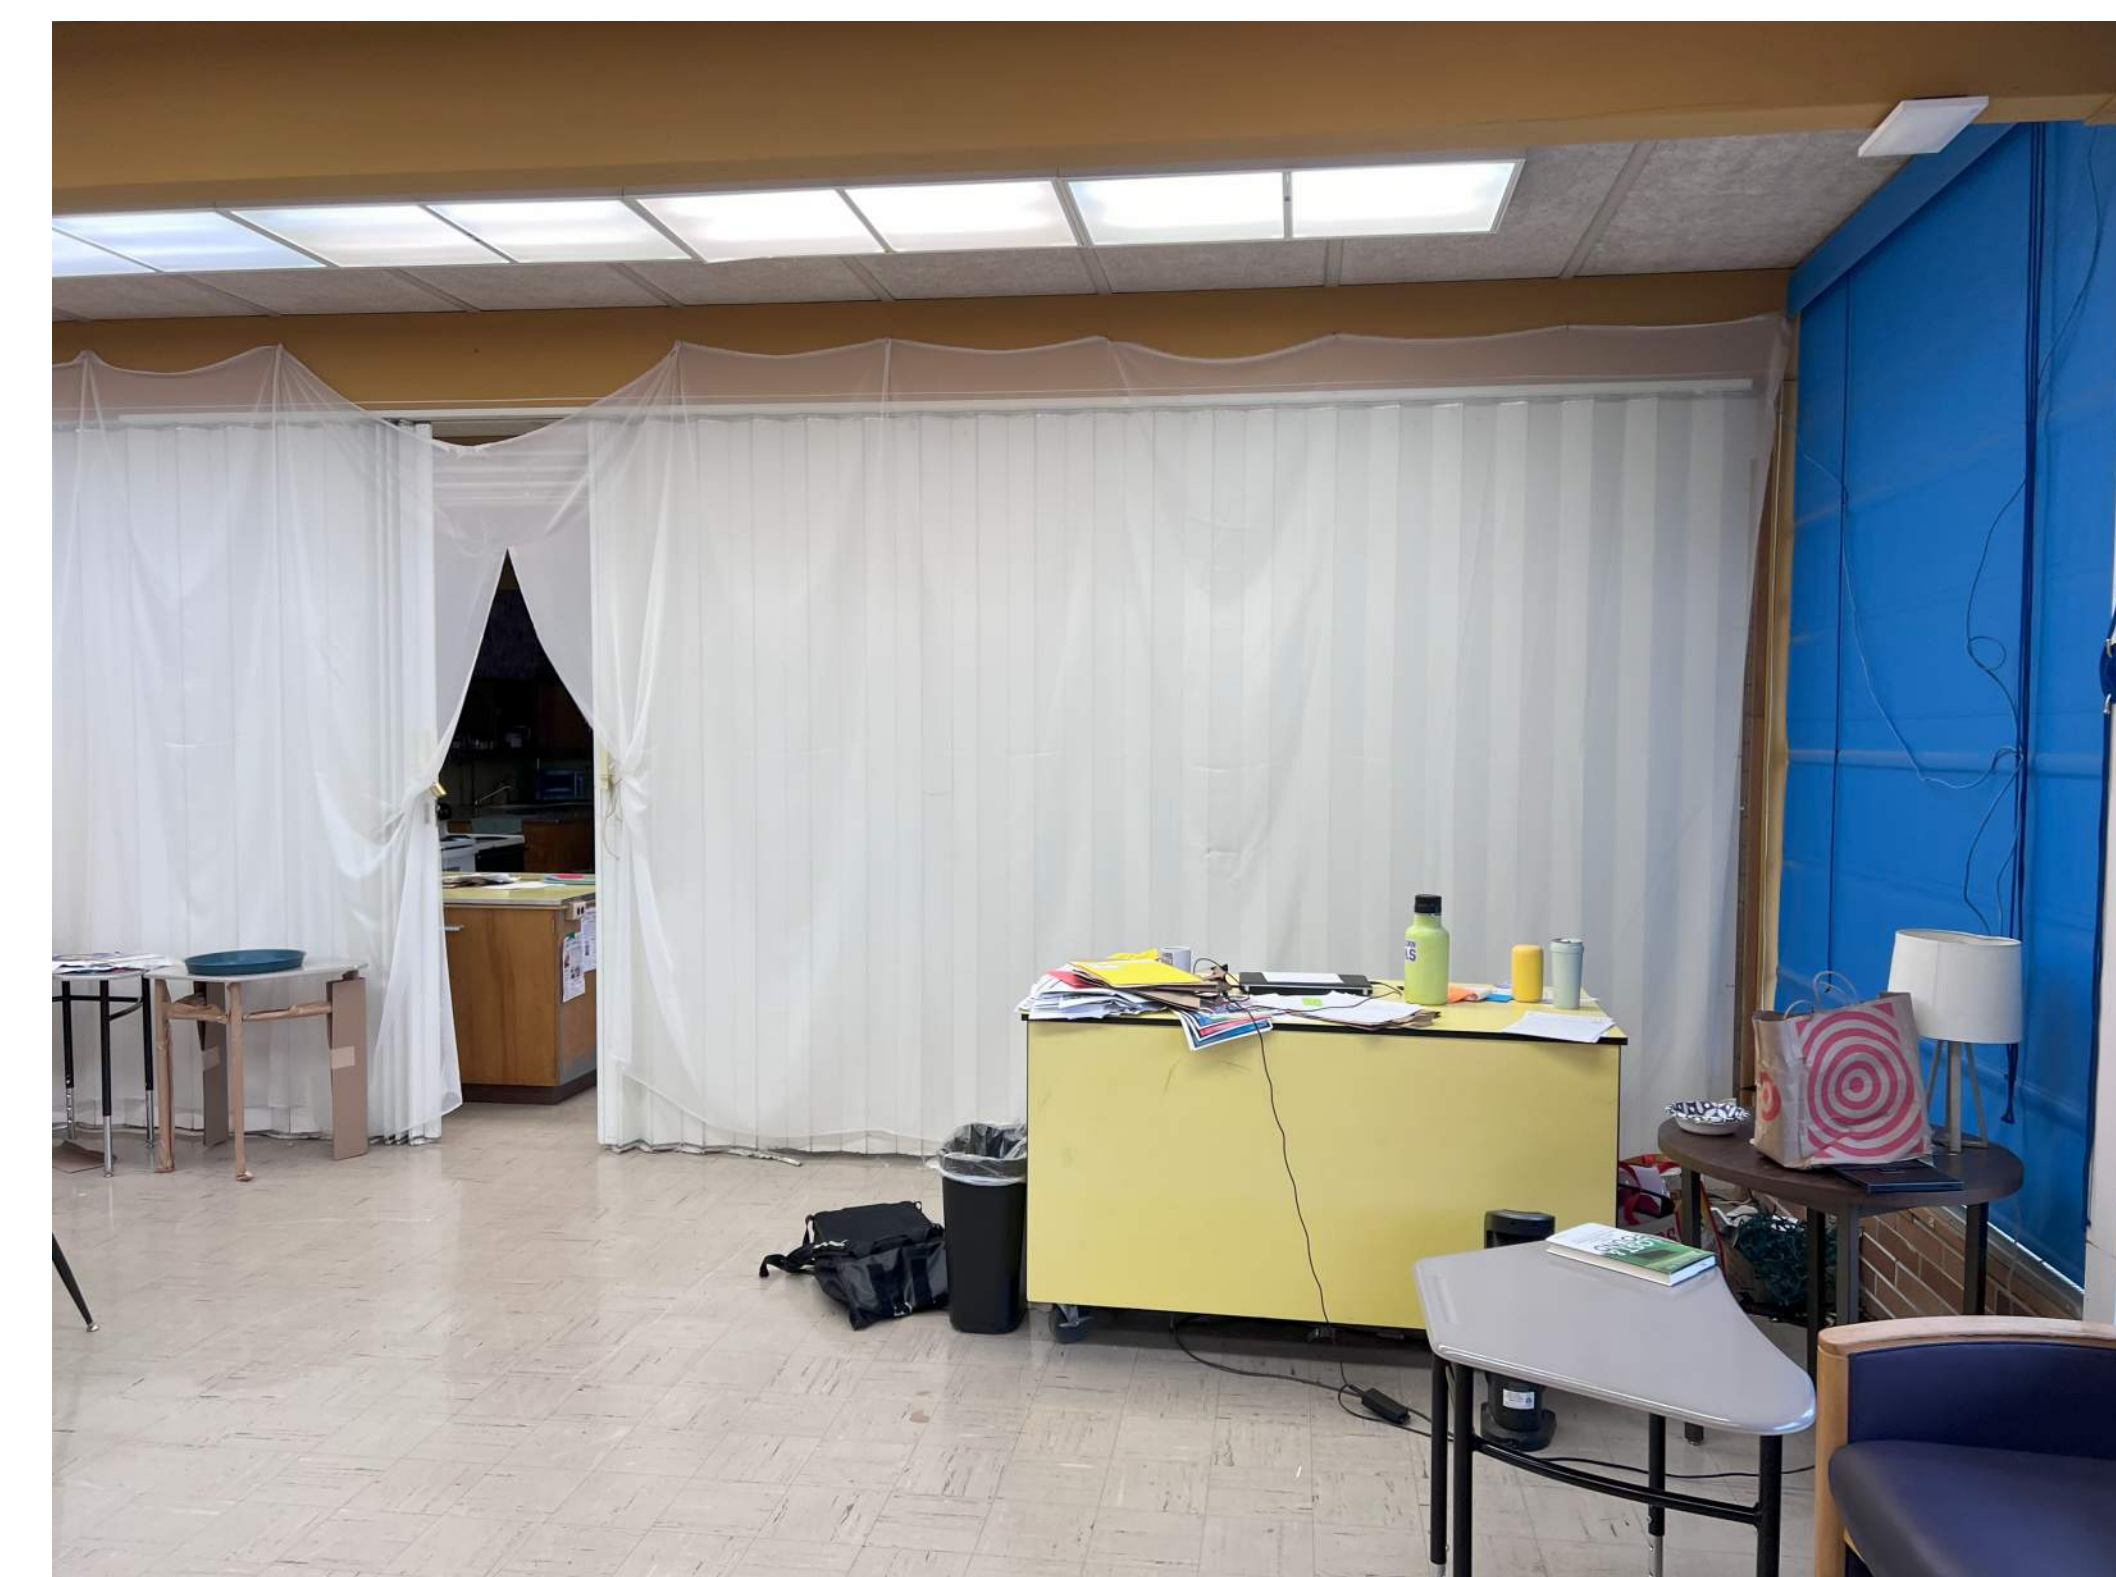
Some classrooms under-utilized
