Central Linn School District Facilities Assessment

March 21, 2024

RE: Central Linn School District – Facilities Assessment

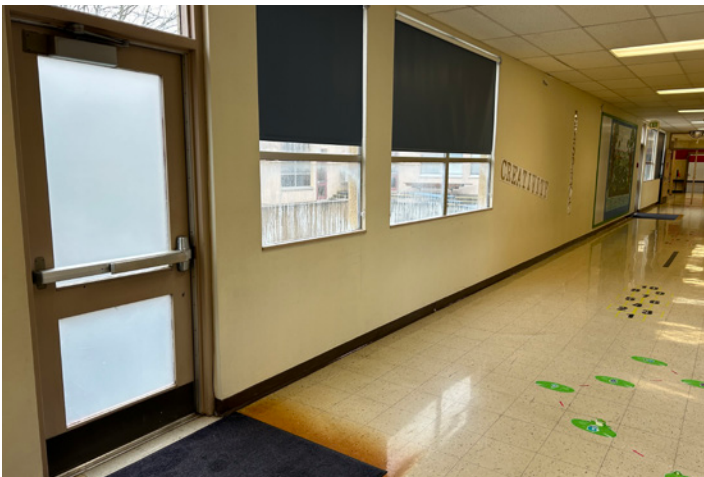
Fogged windows

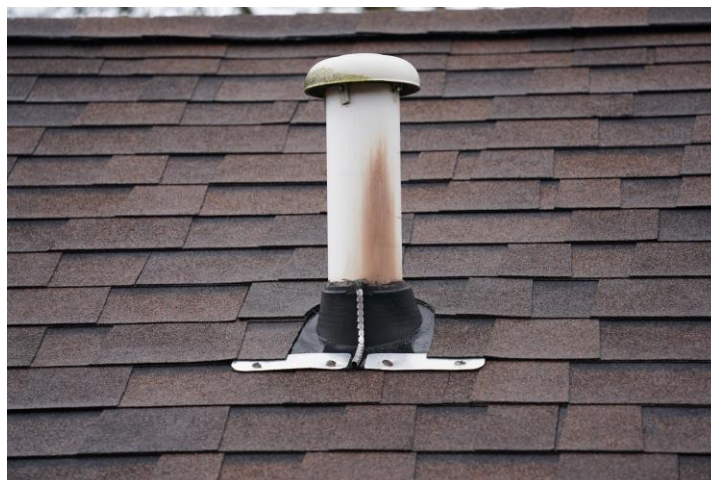
Figure 4 Gas vent pipe

- Expected Useful Life: Based on a visual inspection, the furnaces appear to have 10-15 years of useful life remaining.
- As noted above, at least two areas have conflicting temperature controls with installed mini-split systems.
- Some of the current ducting is made of ductboard, which is prone to air leakage and damage.
- Trane manuals indicate that PVC is approved for the gas furnace combustion gases; however, one of the vent pipes on the roof shows an unusual coloring that may warrant an investigation to verify discoloration is not from burning (Figure 4).

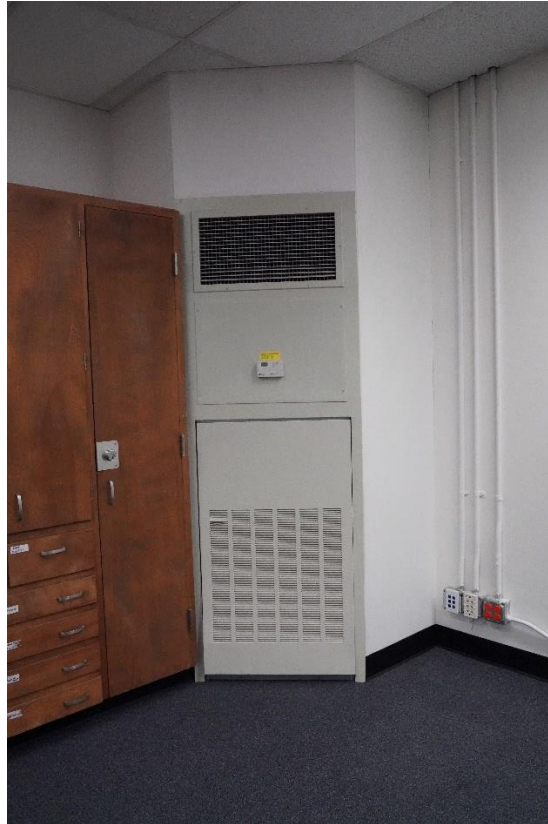
Construction drawings indicate that many fan coil units were installed around 1976 (Figure 5). The abandoned fan coil units provided heating and cooling with chilled water and heating water coils. Fan coil units are connected to outside air through the roof or are directly connected to wall louvers.

Figure 5 Abandoned in-place vertical fan coil unit

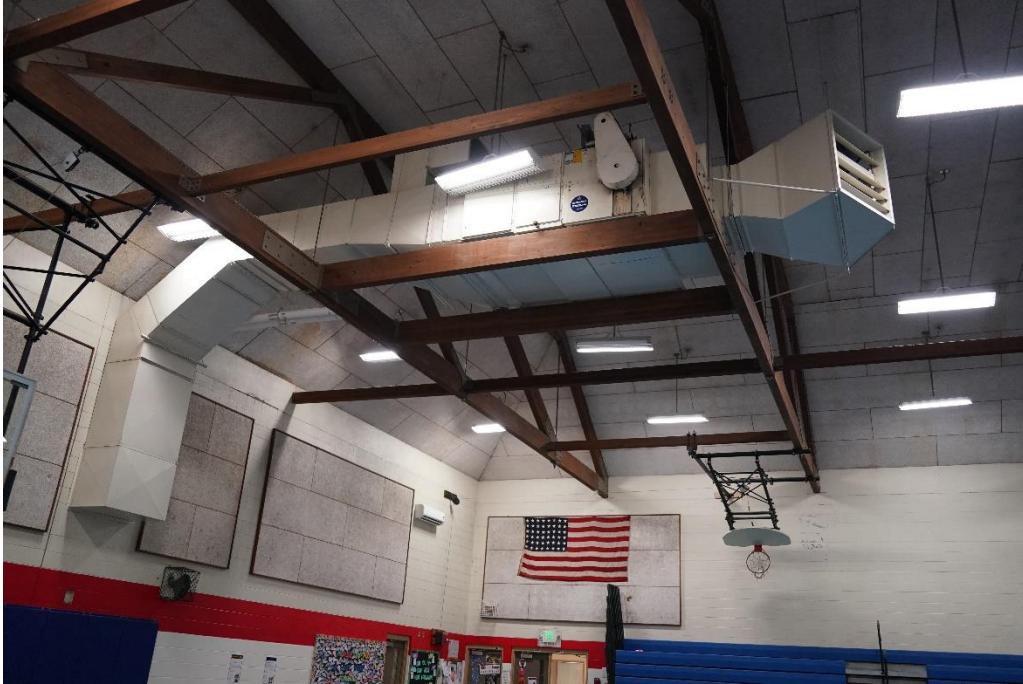
Three heating and ventilating units originally serving the gym (Figure 6), wrestling room, and wood shop are still in place but do not appear to be functional. These spaces are now served with mini-split units as noted above. The gym heating and ventilating unit has preconditioned air through an air-to-air heat exchanger. This heat exchanger is still in place but no longer being used.

Figure 6 Gymnasium heating and ventilating unit

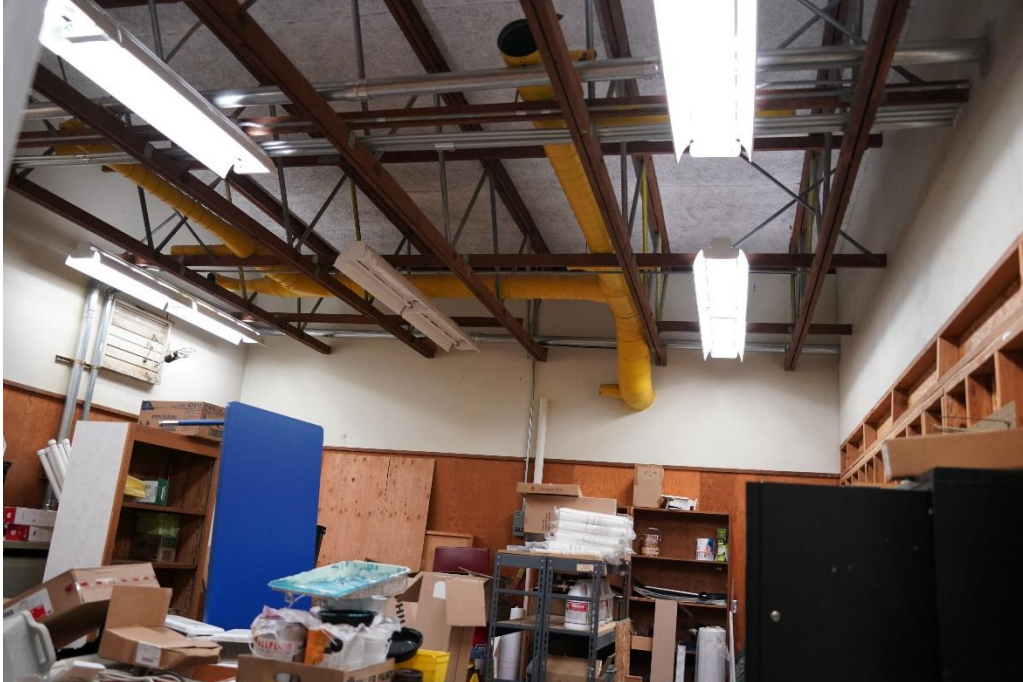
The wood shop dust collection ductwork was still in place but no longer being used (Figure 8).

Figure 8 Wood shop duct collection ductwork.

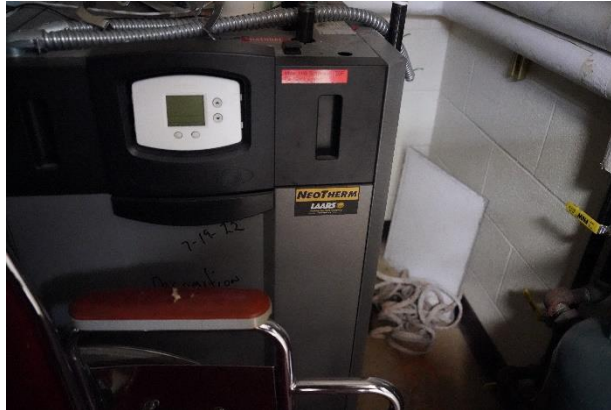
The building was originally served by a steam boiler that has since been decommissioned. The steam boiler was previously connected to a steam convertor to create hot water that was then circulated through the building. In 2011, four 399 MBh Laars Neotherm boilers were installed but were decommissioned in 2022 according to the Owner's representative (Figure 9). Three were abandoned in place and one has been removed from the old boiler room. The boilers are connected in a primary-secondary loop arrangement through a Boiler Buddy

Figure 9 Decommissioned hot water boiler

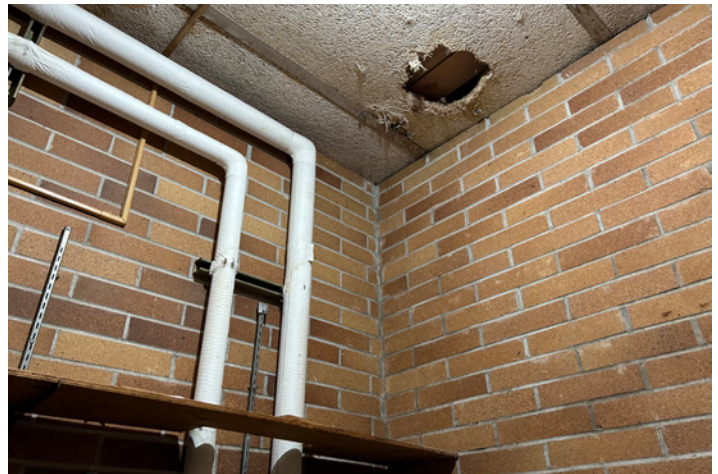
Ceiling damage

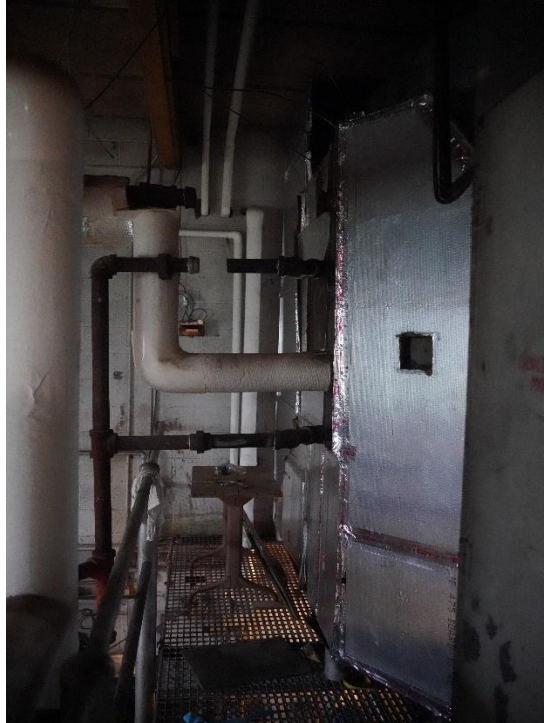
The original air handler for the classrooms, VU-BA-1, provided 16,100 cfm of supply air through a dual duct system that is no longer used (Figure 3).

Figure 3 Original air handling unit, abandoned in place

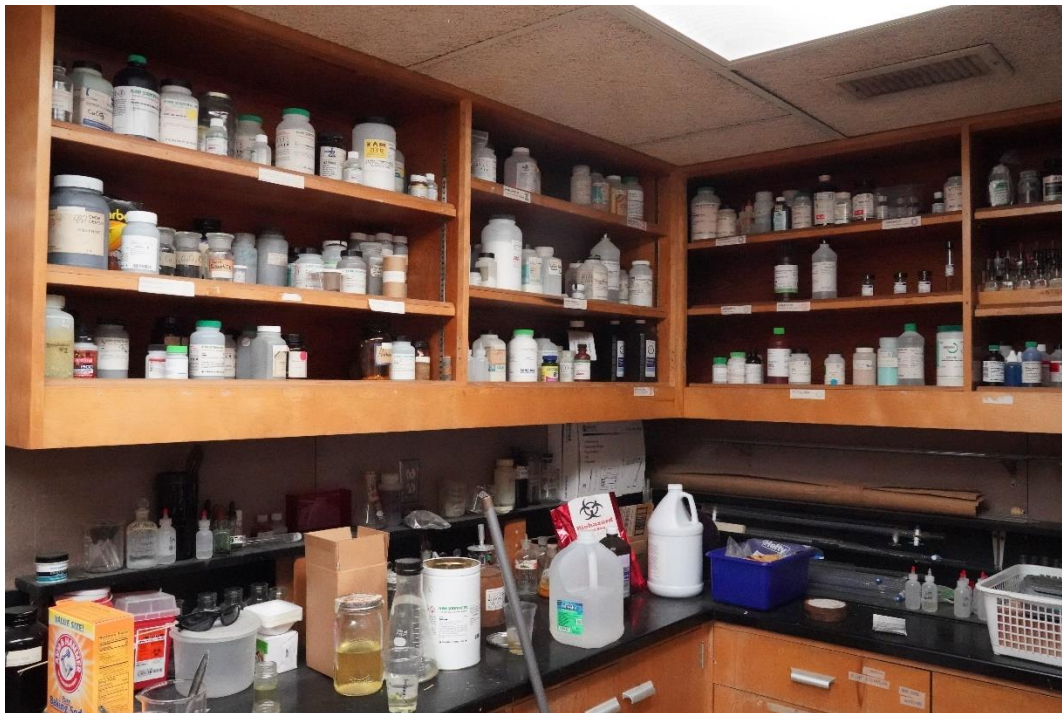
- Chemical Storage: The science classrooms have a chemical storage room. There is one small 6" x 12" ceiling exhaust grille for the room. No air movement was detected (Figure 5).

Figure 5 Chemical storage room

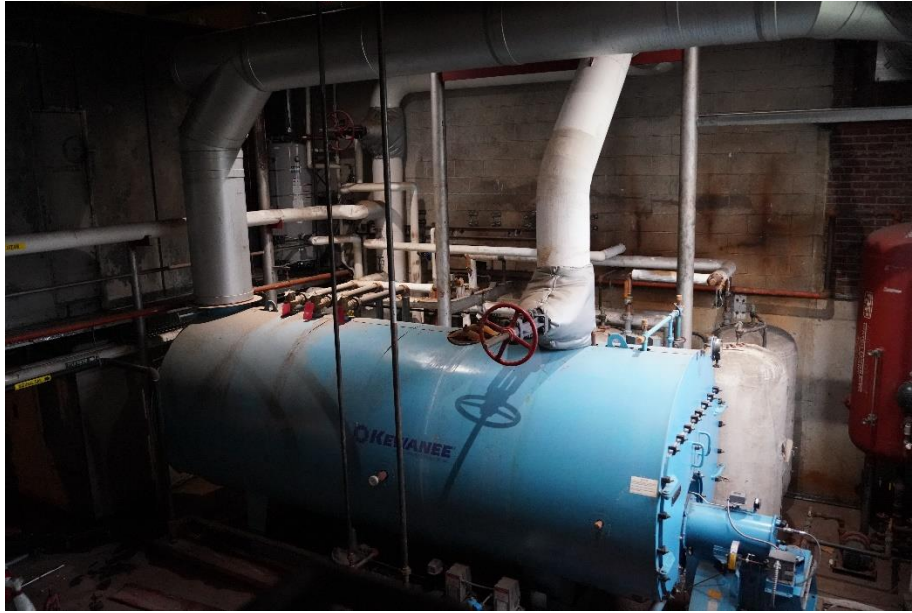
The original source for heating the school was a 5-psig steam boiler and steam distribution system to various steam heating equipment. Much of the original steam piping was installed in the late 1950s or early 1960s. The piping is distributed through much of the school in a tunnel/trench system and some overhead (Figures 12 and 13). The original boiler was replaced in 1997 by a Kewanee natural gas forced draft boiler with a firing range of 2,093 to 10,460 MBH. The steam boiler is out of commission and no longer functional (Figure 14).

Figure 14 Failed steam boiler
