COMMUNITY BOND ADVISORY COMMITTEE MEETING #3

Central Linn School District
March 19, 2024

FACILITY ASSESSMENT EXECUTIVE SUMMARY

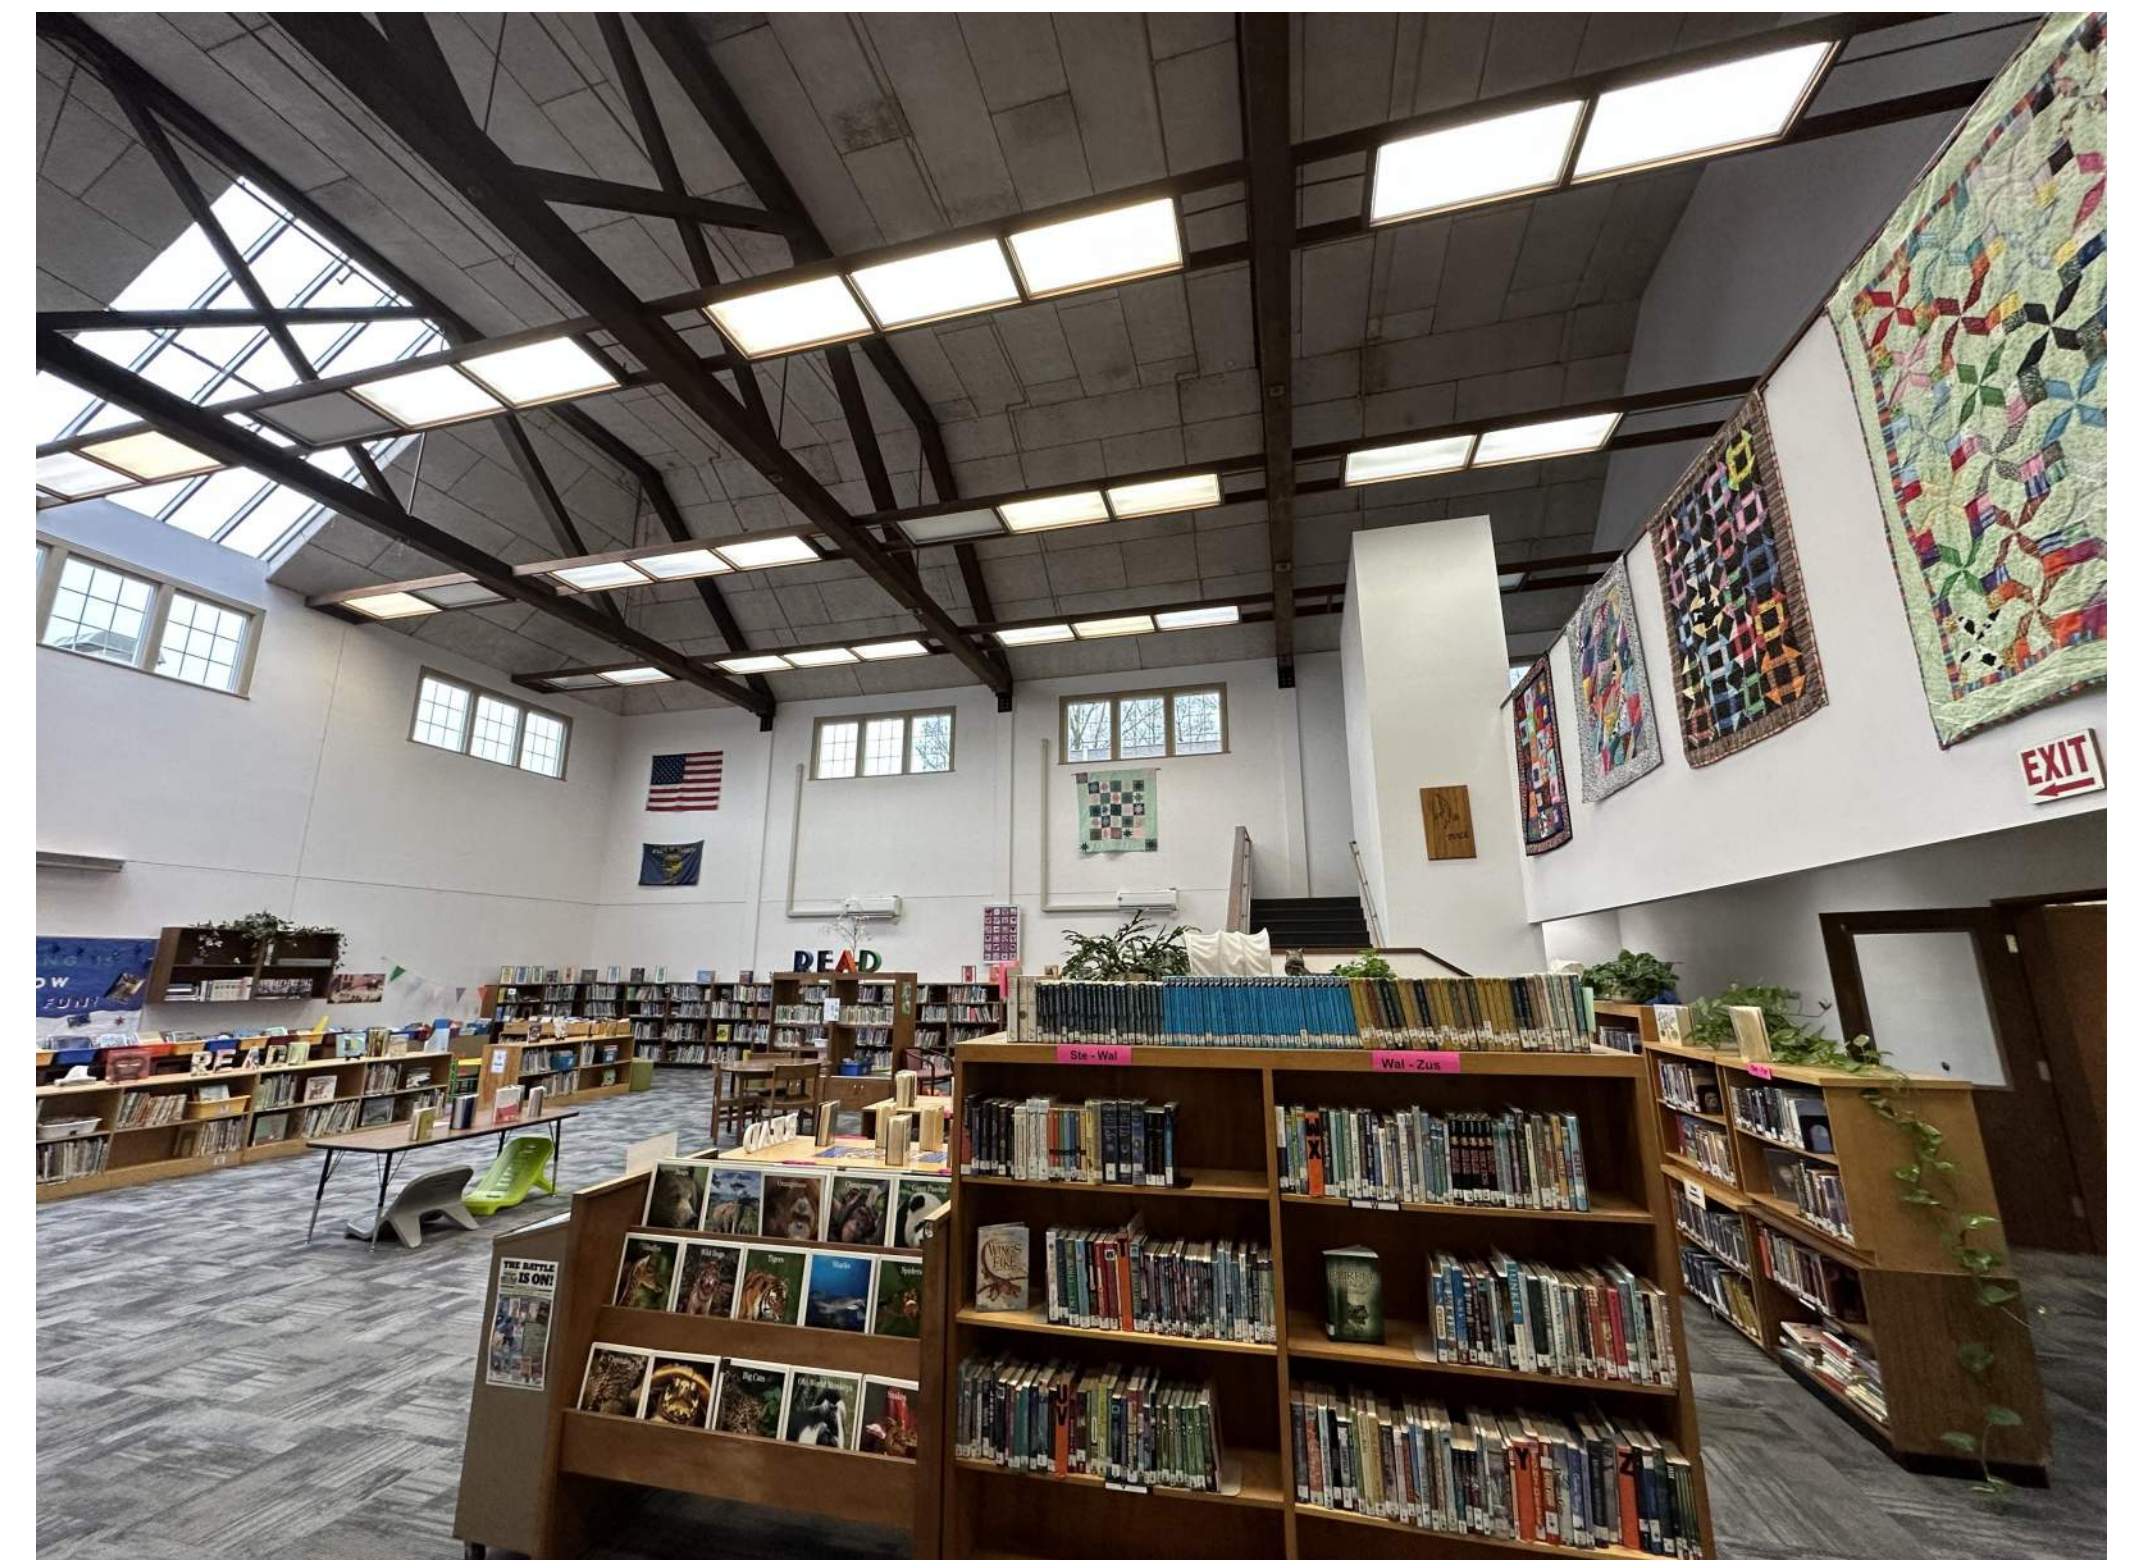
Building Name	Construction Date	Square Footage (SF)	ODE FCA Metrics		
			Replacement Budget per FCA	Physical Condition Budget Total	Facility Condition Index (FCI)
Central Linn Elementary School	1936 original structure; 1976 addition; 1997 repave parking lot; 2005 lighting update; 2020 seismic improvement to library	65,795 SF	\$56,039,831	\$14,532,262	25.9%

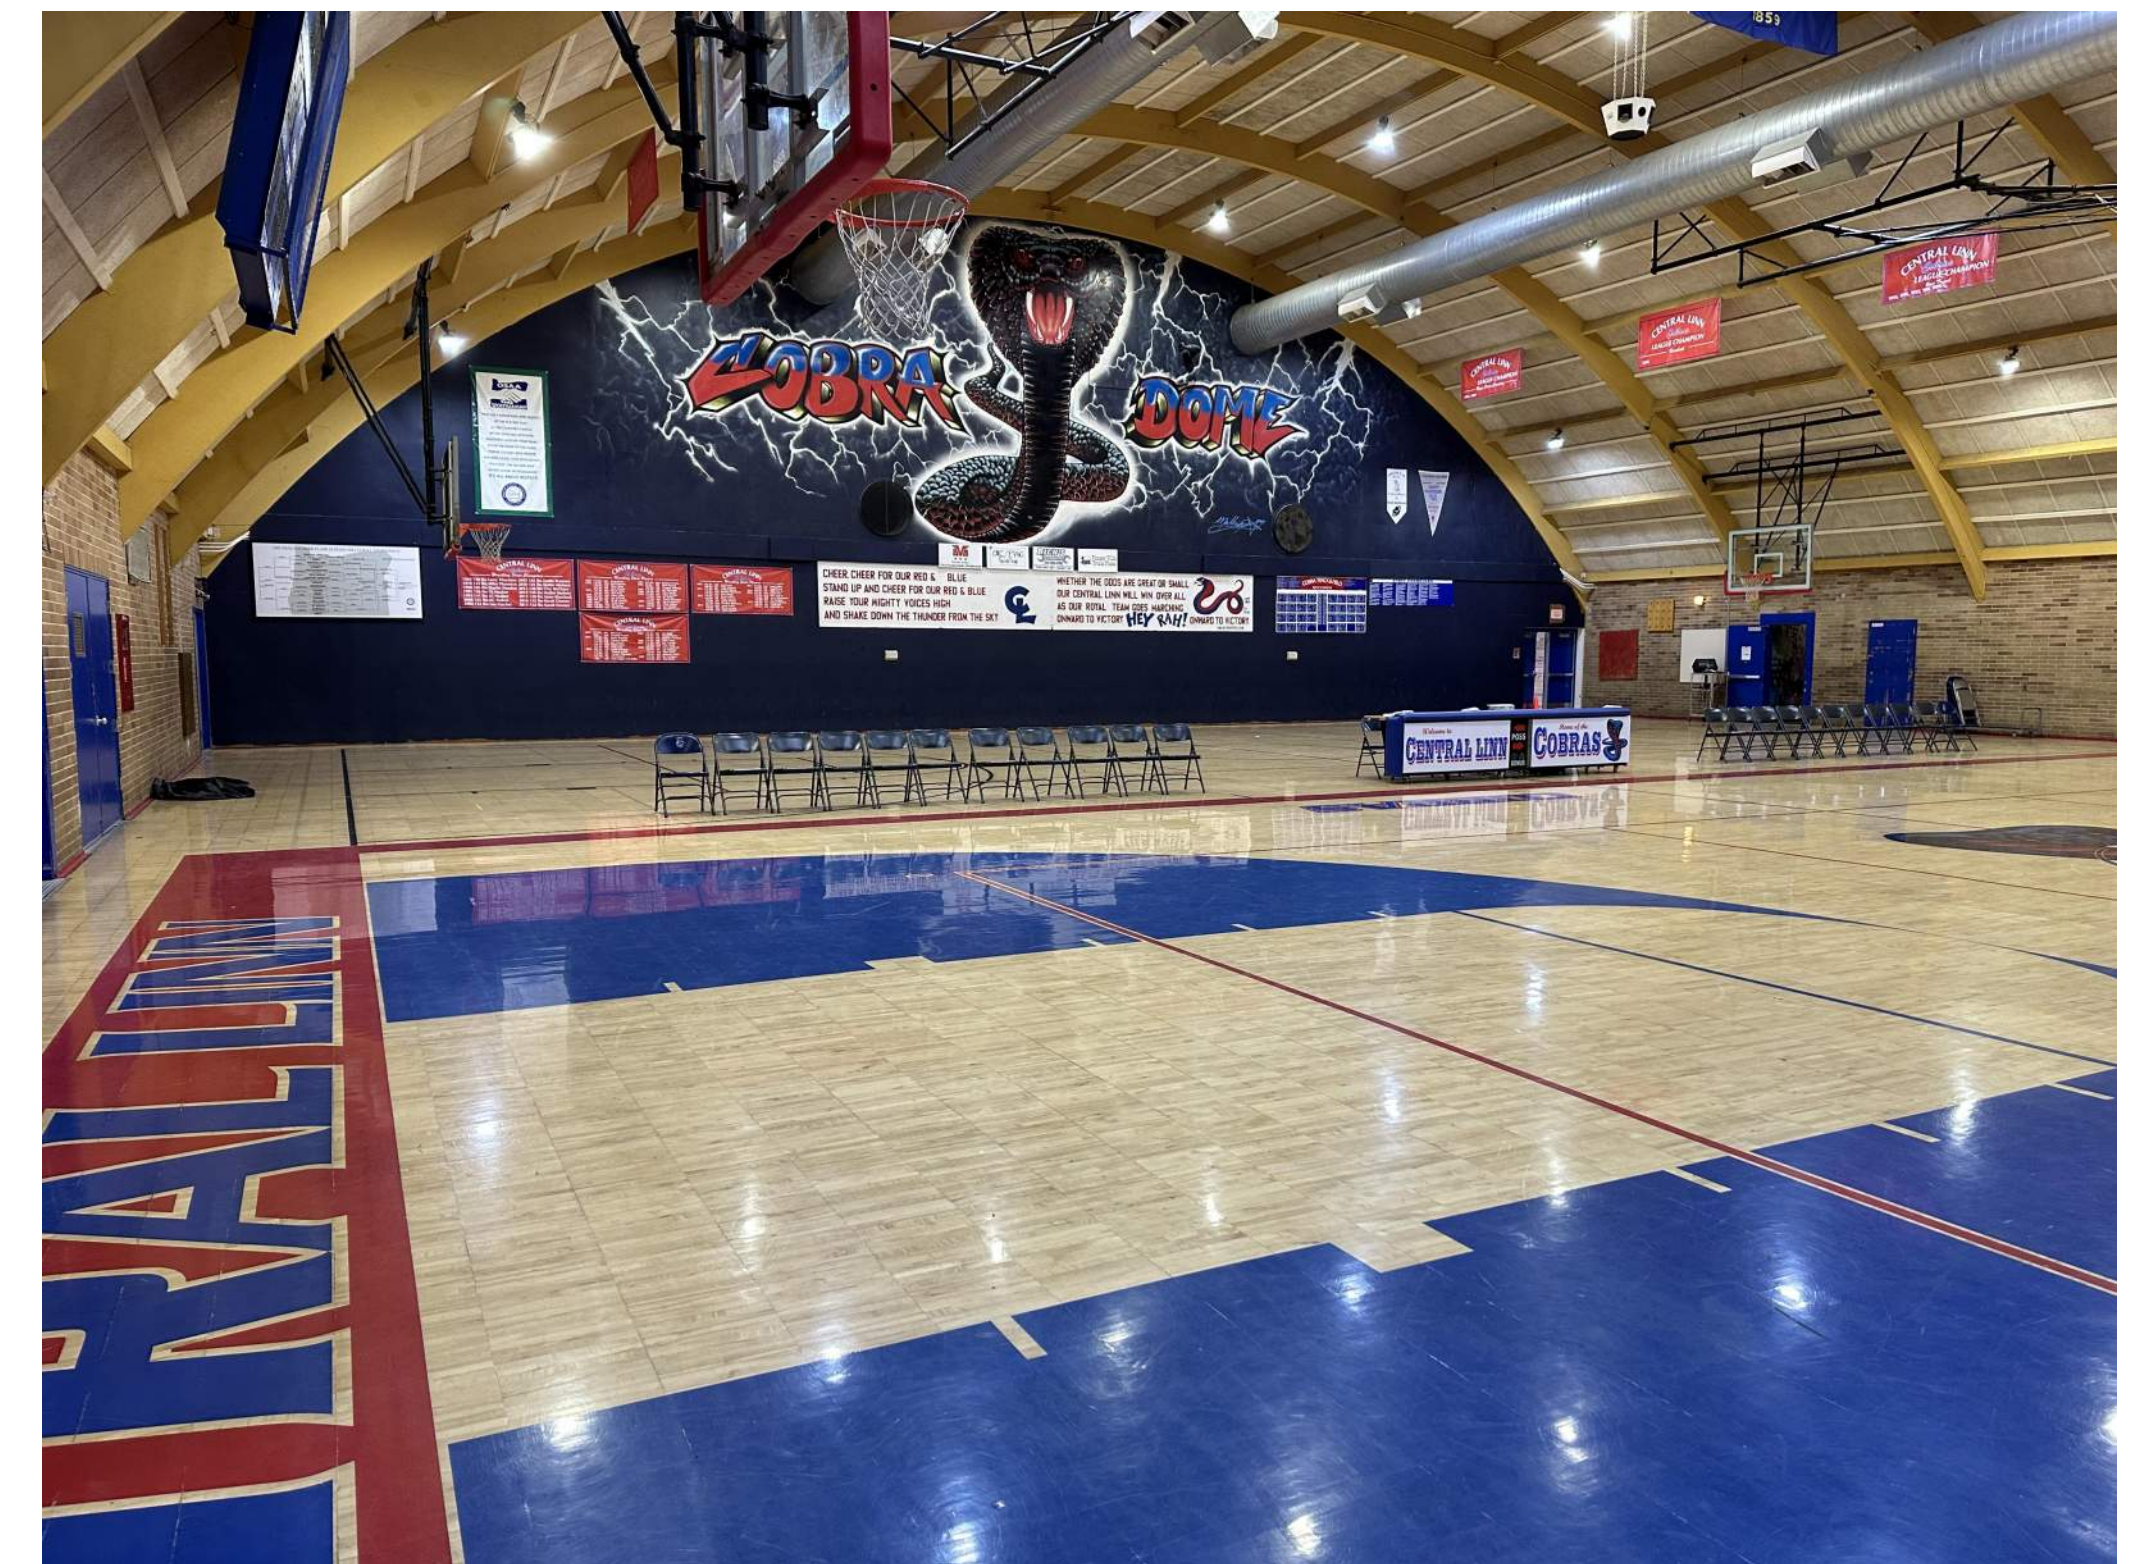
↑ High School

Building Name	Construction Date	Square Footage (SF)	ODE FCA Metrics		
			Replacement Budget per FCA	Physical Condition Budget Total	Facility Condition Index (FCI)
Central Linn High School	1957 original structure; 1997 repave parking lot; 1997 grandstand addition; 2020 seismic improvement to gym and cafeteria	63,560 SF	\$64,959,970	\$25,341,056	39.0%

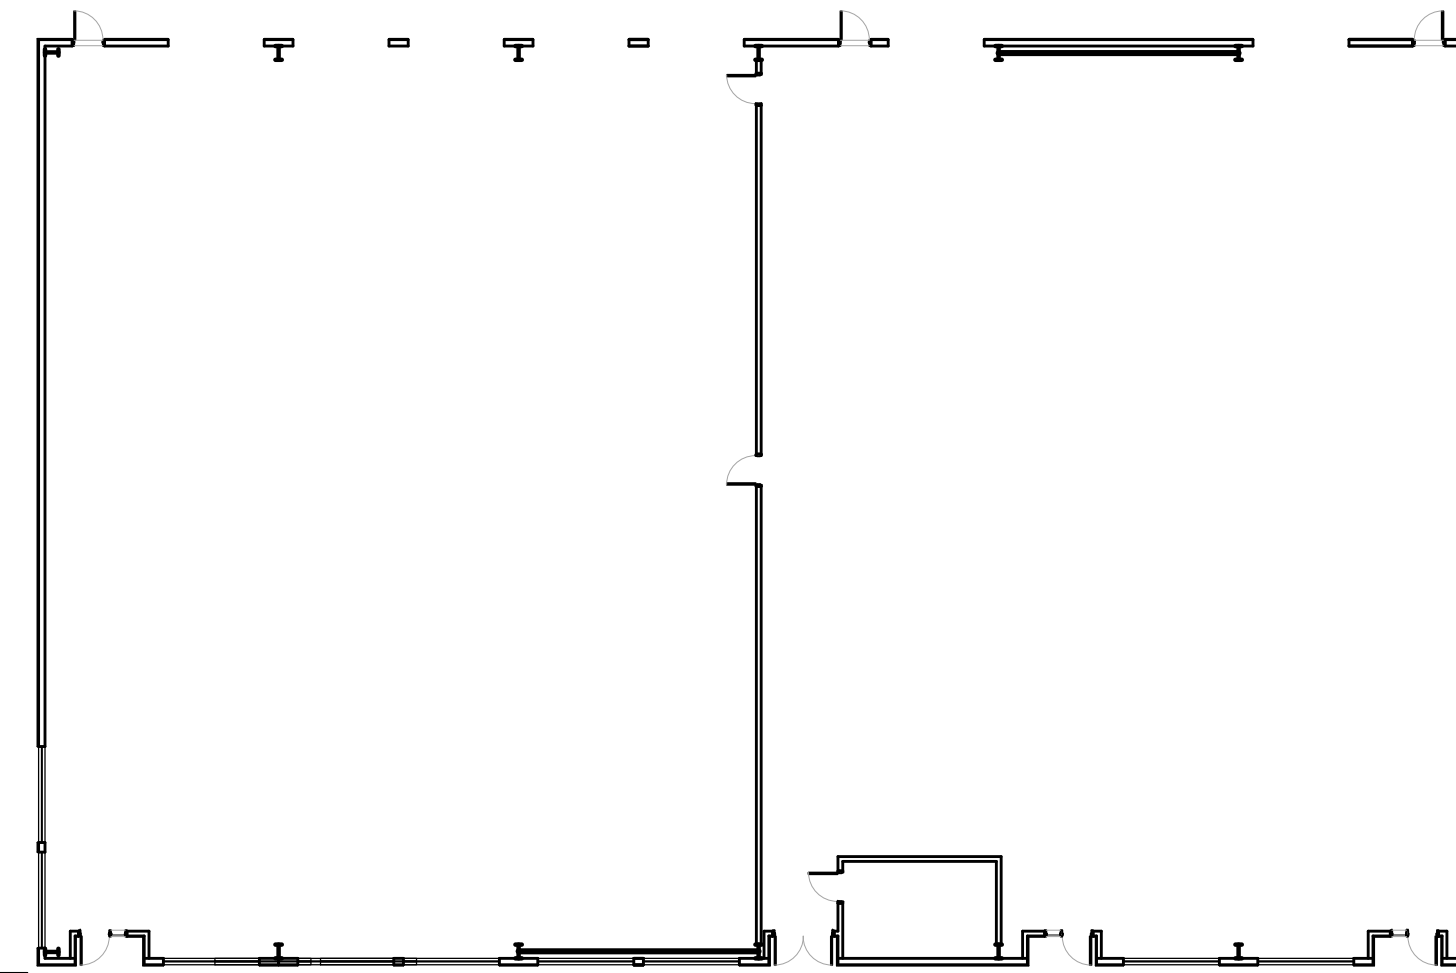
Equipment and storage in science classrooms does not meet current standards.

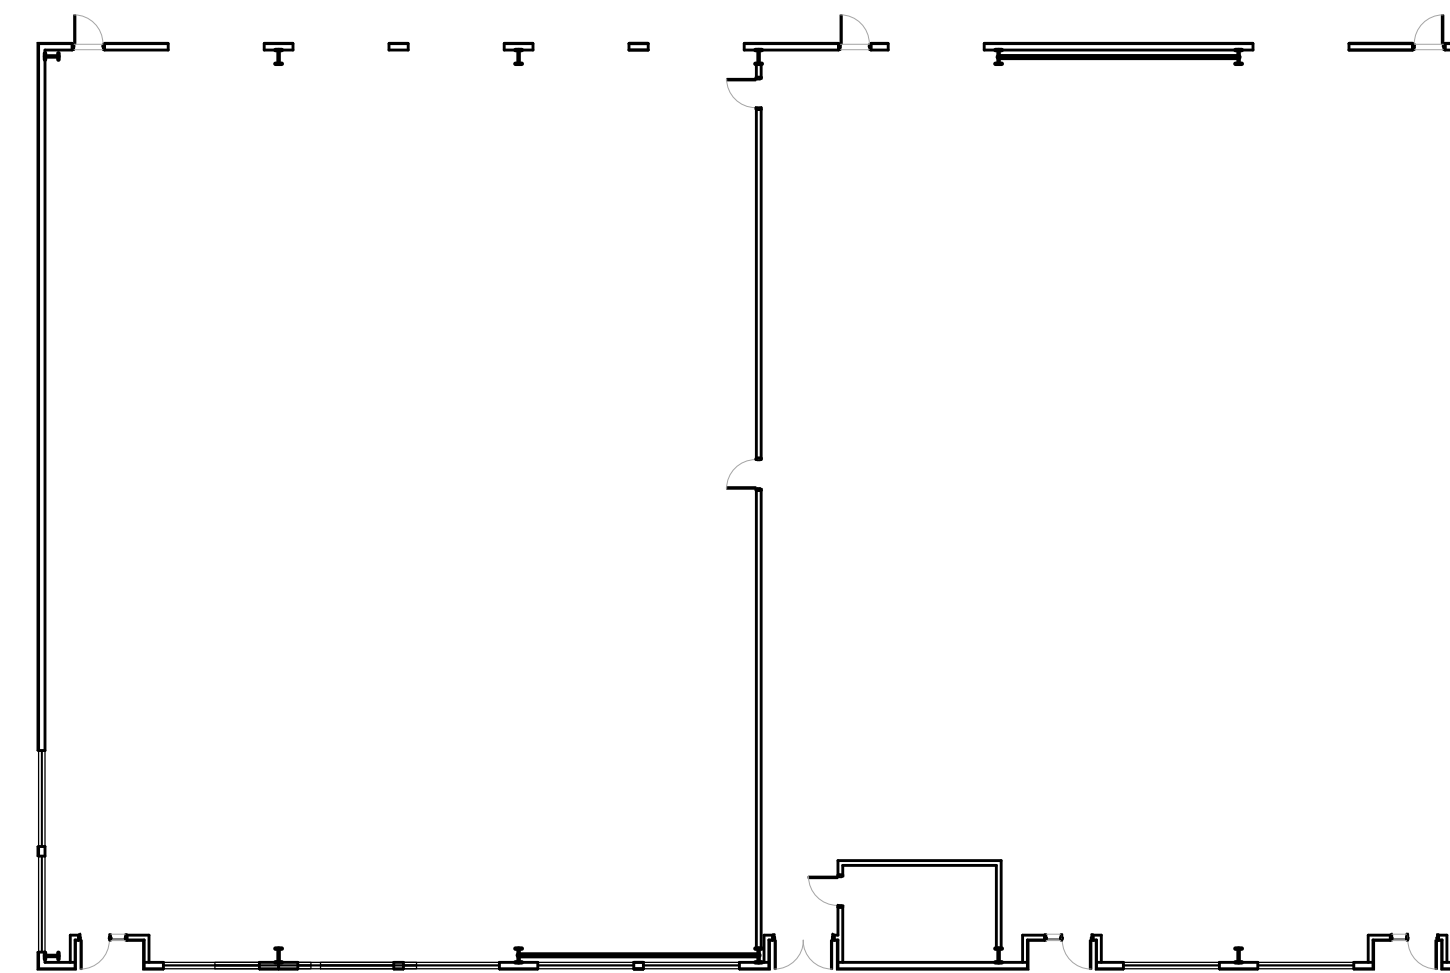
Some classrooms under-utilized
