Central Linn School District Facilities Assessment

March 21, 2024

RE: Central Linn School District – Facilities Assessment

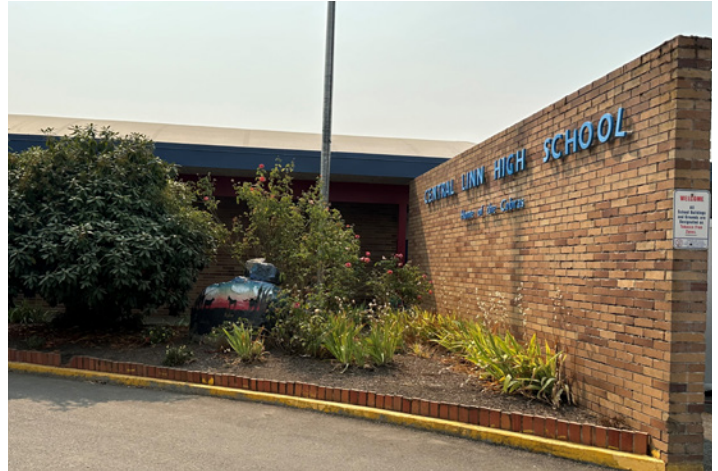
Main entry

- The school does not have a secure main entry - once visitors enter the building front door, they have full access to the rest of the building. The front office has good visibility to the main entry.

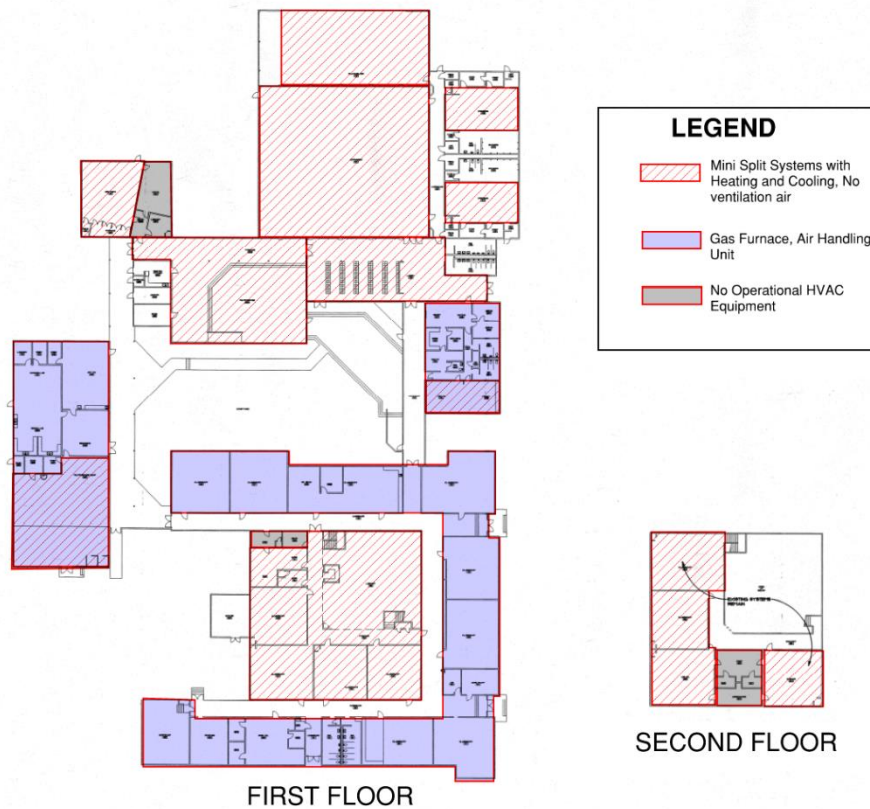
Figure 1 HVAC system type map

The air distribution system at the elementary school was originally vertical fan coil units conditioned with chilled water and heating water coils. All of the original fan coil units were abandoned in place. Currently, the building is served by two types of air systems. Approximately 40% of the spaces are conditioned with Trane air handling units with gas-fired furnaces, and the other 60% of the spaces were conditioned with mini-split heat pump units. The figure below shows which areas were served by each type of system (Figure 1).

- Several rooms have noticeably stagnant air such as the teachers' lounge and the rooms south and adjacent to the library.
- Several rooms have no HVAC Systems as shown in Figure 1.

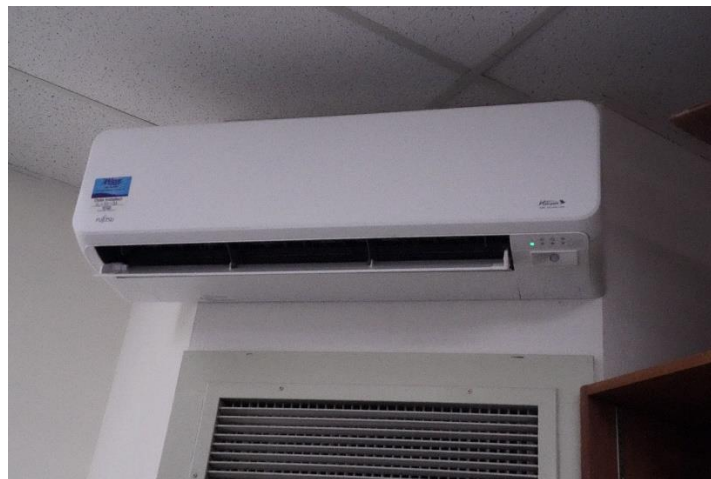
Figure 2 Wall-Mounted Mini-Split System

Mini-split heat pump systems were installed in 2021 in lieu of the original fan coil units to provide heating and cooling to each space. An example of the indoor unit for a wall-mounted mini-split system is shown in Figure 2. The condensing units associated with each mini-split system are wall-mounted on brackets on the exterior of the building.

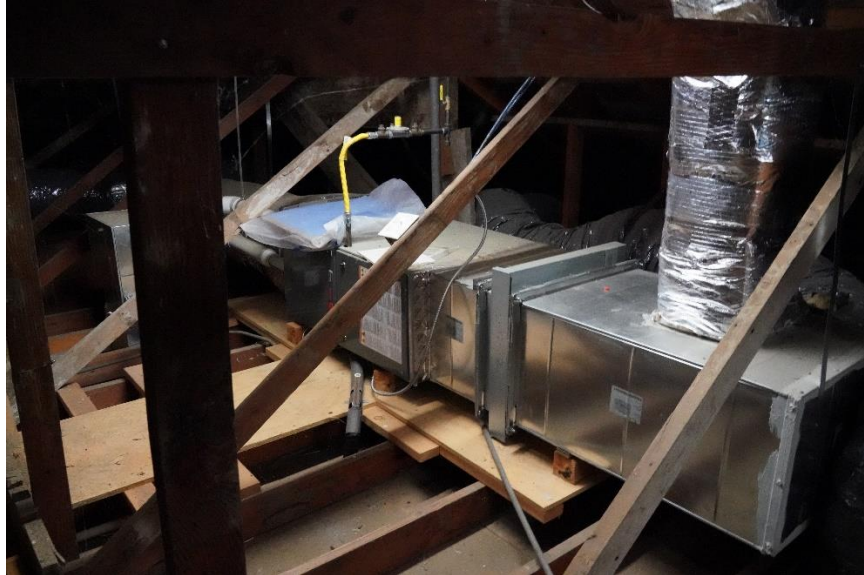
Figure 3 Trane XR95 gas-pack air handling unit

The Trane XR95 gas-pack air handling units appear to be in good condition but the date of installation is unknown. These systems are connected to outside air and provide gas-fired forced air heat. These systems are in ceiling and attic spaces (Figure 3). Figure 1 shows all spaces using the gas-pack air handlers. Ductwork is a combination of metal ductwork, flexible ductwork, and ductboard. Air is delivered to the spaces through ceiling-mounted diffusers and return grilles. Each air handling unit is provided with a MERV8 air filter in the unit return duct. The units are each controlled by a wall-mounted digital controller.

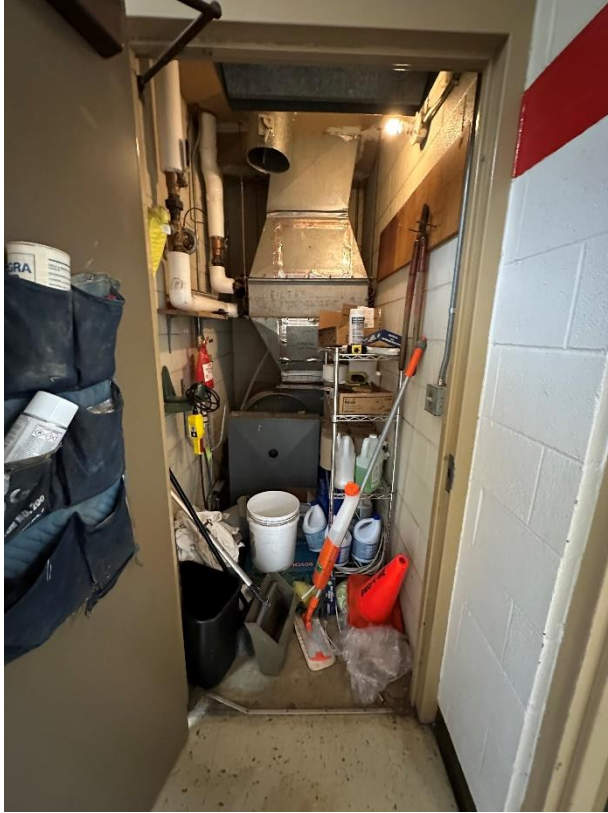
Figure 7 Supply fan closet.

Supply fans serving rooms 327 and 335 returned air from the gymnasium and several small rooms, then reheated it through a duct-mounted, hot-water heating coil and delivered the air to the classroom space. The closet housing the fans was utilized as an intake plenum, with the transfer air open to the closet before being drawn into the fan intake (Figure 7). After being supplied to rooms 327 and 335, the air was drawn through floor grilles to underslab ductwork and then exhausted through the gym air to air heat exchanger and roof exhaust fan.

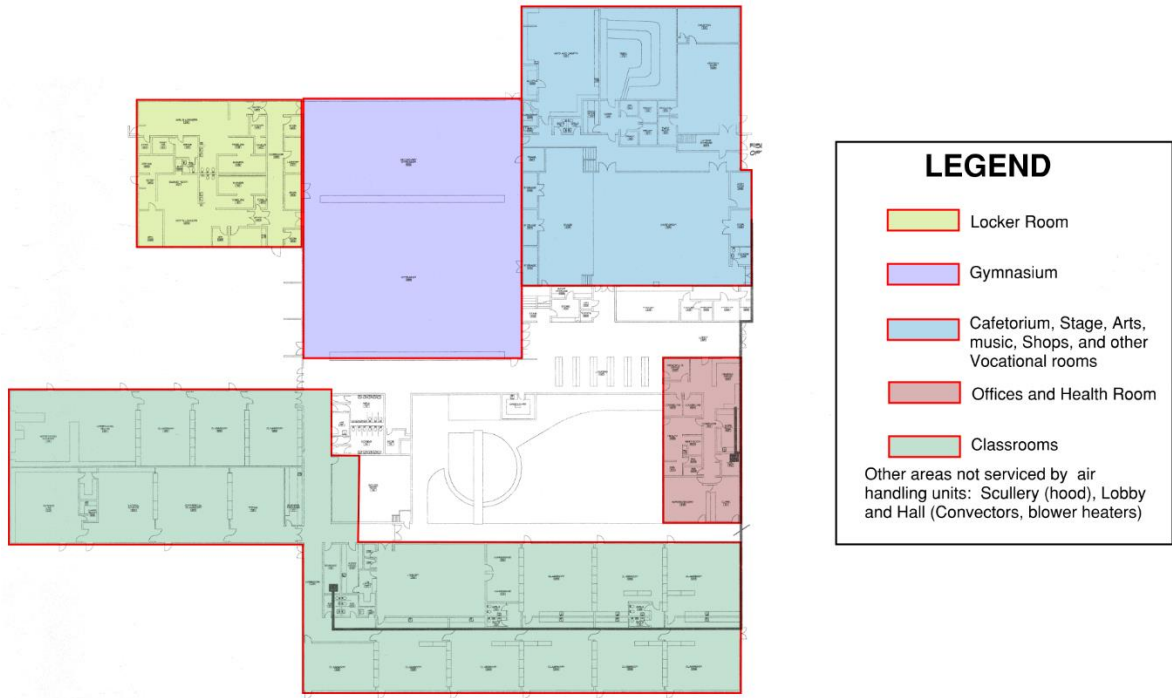
Figure 1 Original HVAC zones for air handling units (Many abandoned in place)

The original building consists of five primary air handling units and steam convectors to serve the school. The school is divided into the following HVAC zones covered by the air handling units, with each zone shown in a different color (Figure 1).

Five air handling units previously provided ventilation air and heating to all the spaces through a dual duct system that mixed warm air with neutral air at a mixing box serving each space. Each air handling unit used low pressure, 5-psig steam to provide heating for the ventilation air. In addition, steam convectors were added for additional heating in areas without air handling units and to supplement heating in other areas. In 1997, a variety of steam convectors were added and replaced. However, the steam boiler has since failed and nearly all of these air handling units have been abandoned in place and are no longer used.

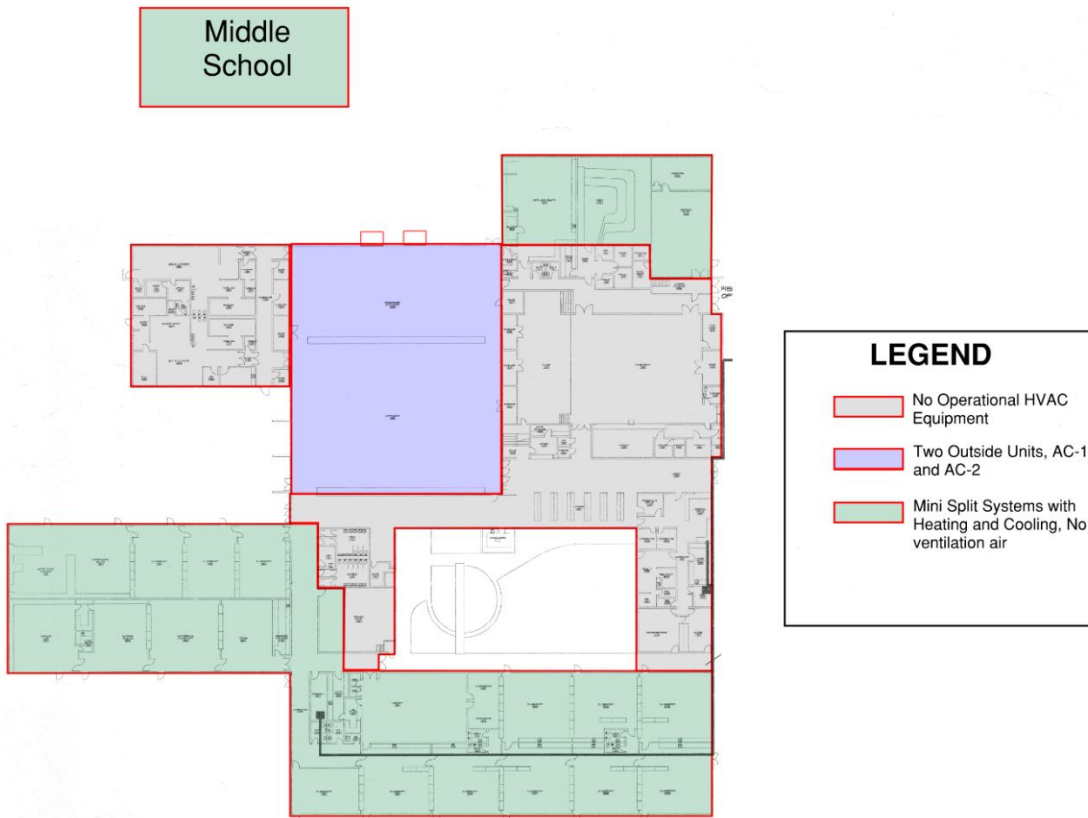
Figure 2 Current HVAC Zones

As a result of the steam boiler failure and nearly all original equipment abandoned, the following map shows the current HVAC zones.

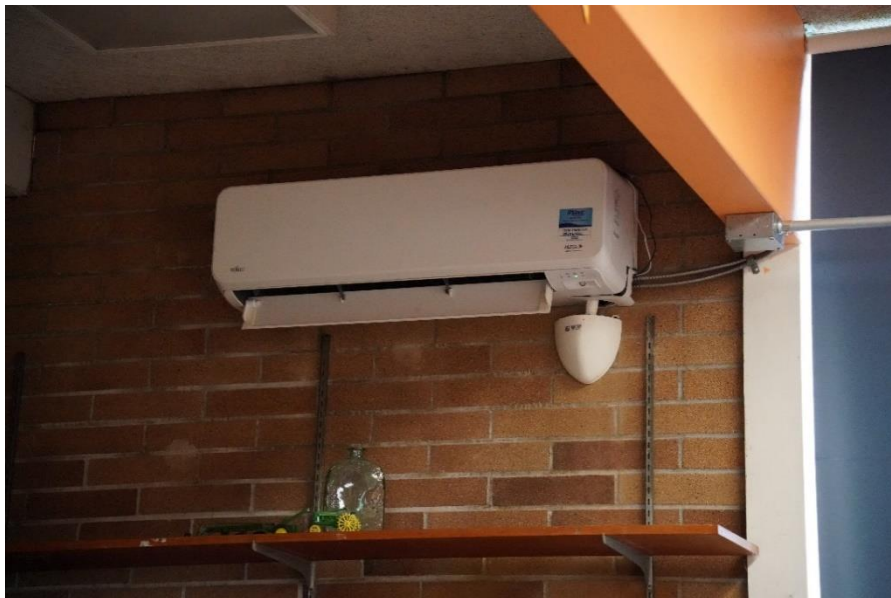
Figure 4 New classroom mini-split unit

The high school classrooms are currently conditioned with mini-split ductless air conditioning and heating units that are wall mounted on each classroom wall to replace the original heating system. The condensing units are located on the roof (Figure 4).

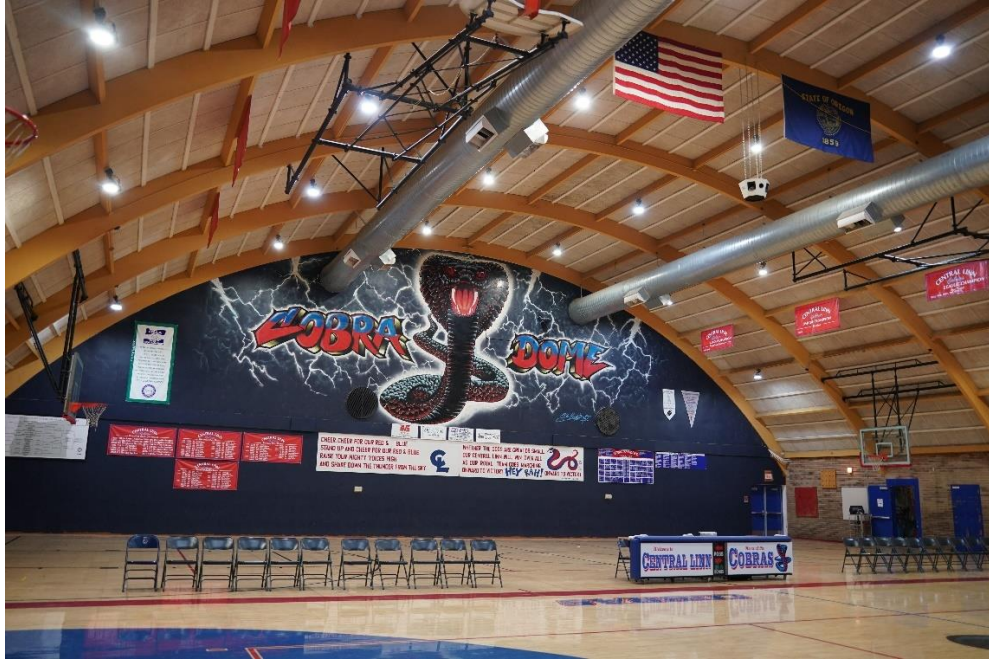
Figure 6 Gymnasium air distribution

The high school gymnasium is cooled and heated with two air handling units: AC-1 and AC-2. AC-1 and AC-2 have natural gas furnaces for heating and R-22 dual compressors for cooling. The units supply air to the gymnasium by overhead supply ducts across the gym with wall-mounted grilles for return air (Figures 6 and 7).

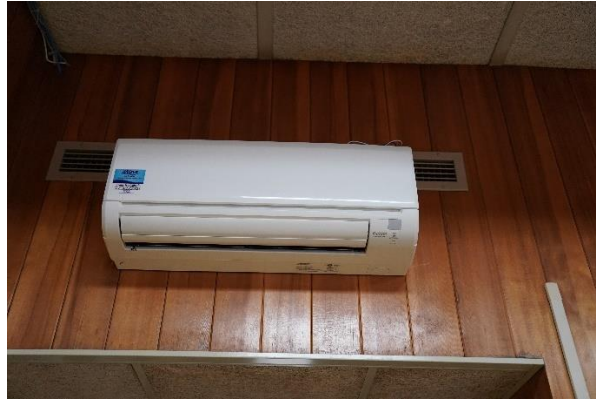
Figure 8 Office mini-split

The offices were originally serviced by air handling unit VU-E1, a 1,400-cfm unit with steam heating that is no longer in service. These areas have steam heating convectors and blower cabinets for additional heating. A mini-split air conditioning unit is installed in one of the offices for heating and cooling (Figures 8 and 9)

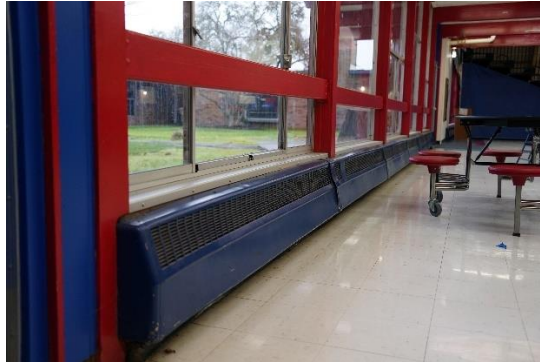
Figure 10 Lobby and commons heating equipment

The lobby area was previously heated with steam convectors. This space never had a dedicated air handling unit; however, operable windows are provided in the commons area (Figures 10 and 11).

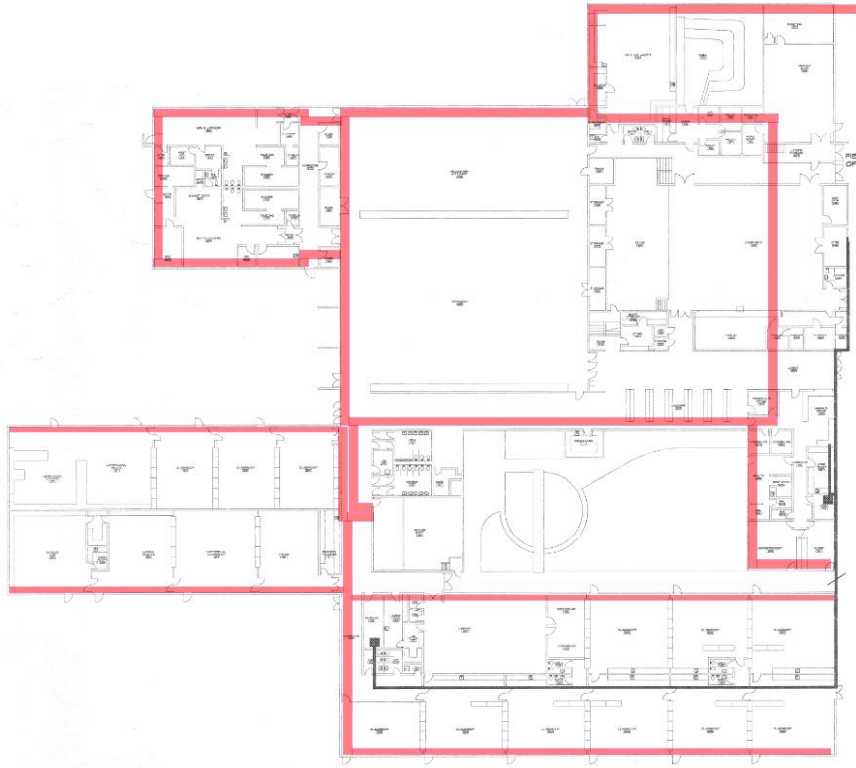
Figure 12 Underground tunnel/trench for steam and condensate

The original source for heating the school was a 5-psig steam boiler and steam distribution system to various steam heating equipment. Much of the original steam piping was installed in the late 1950s or early 1960s. The piping is distributed through much of the school in a tunnel/trench system and some overhead (Figures 12 and 13). The original boiler was replaced in 1997 by a Kewanee natural gas forced draft boiler with a firing range of 2,093 to 10,460 MBH. The steam boiler is out of commission and no longer functional (Figure 14).

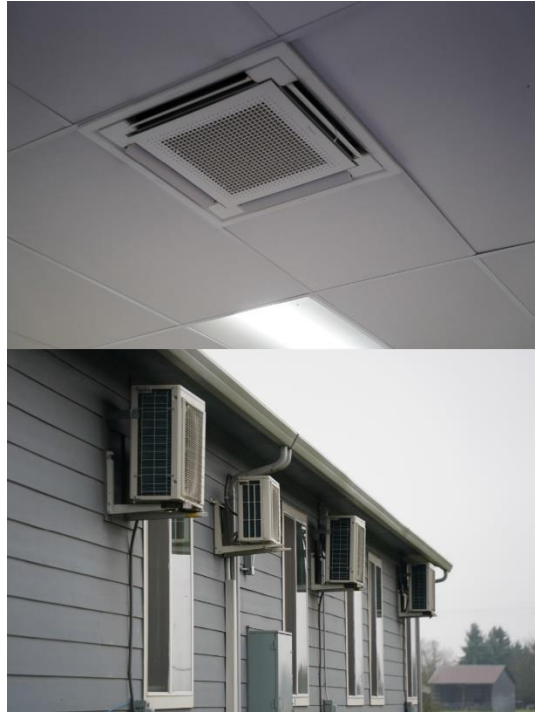
Figure 15 Junior high indoor and outdoor units

The junior high is in a modular building separated from the high school. Each room in the junior high has an independent split air conditioning and heating system with ceiling-mounted cassette units coupled with an outdoor heat pump (Figure 15). The ceiling-mounted cassette unit pulls air in through the center of the cassette with an integrated fan and heating/cooling coil and discharges downwards through directional louvers at the edge of the cassette. The modular building has wall-mounted electric unit heaters for the restrooms. A small closet space for a network server and data equipment is cooled with a wall-mounted ductless mini-split system. The associated condensing units are mounted on wall brackets at the exterior of the building.
